RS-15-155

May 29, 2015

Subject: Response to Preliminary RAI Regarding Braidwood and Byron Stations
Relief Request for Alternative Requirements for the Repair of Reactor Vessel
Head Penetrations

TECHNICAL BASIS FOR OPTIMIZATION OR ELIMINATION OF LIQUID PENETRANT EXAMS FOR THE EMBEDDED FLAW REPAIR

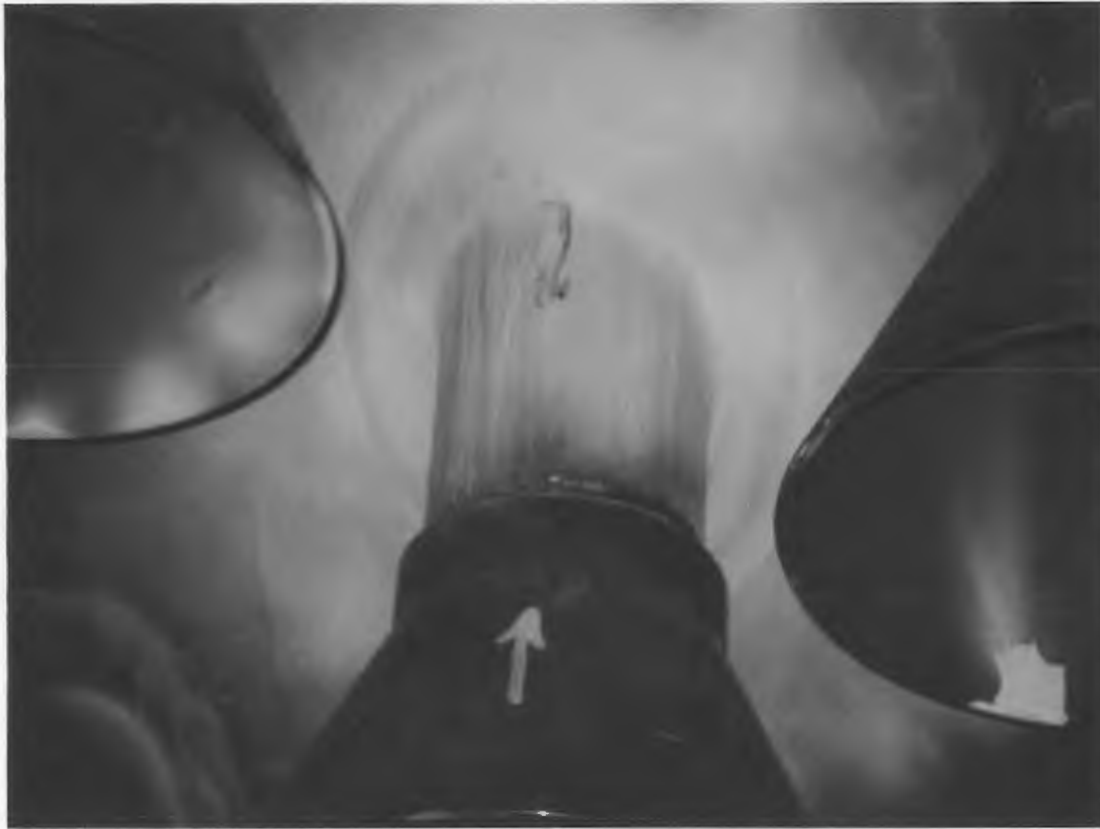
Figure 1: Example of an indication at the boundary of the vertical weld passes on the penetration tube, and the elliptical weld passes on the head

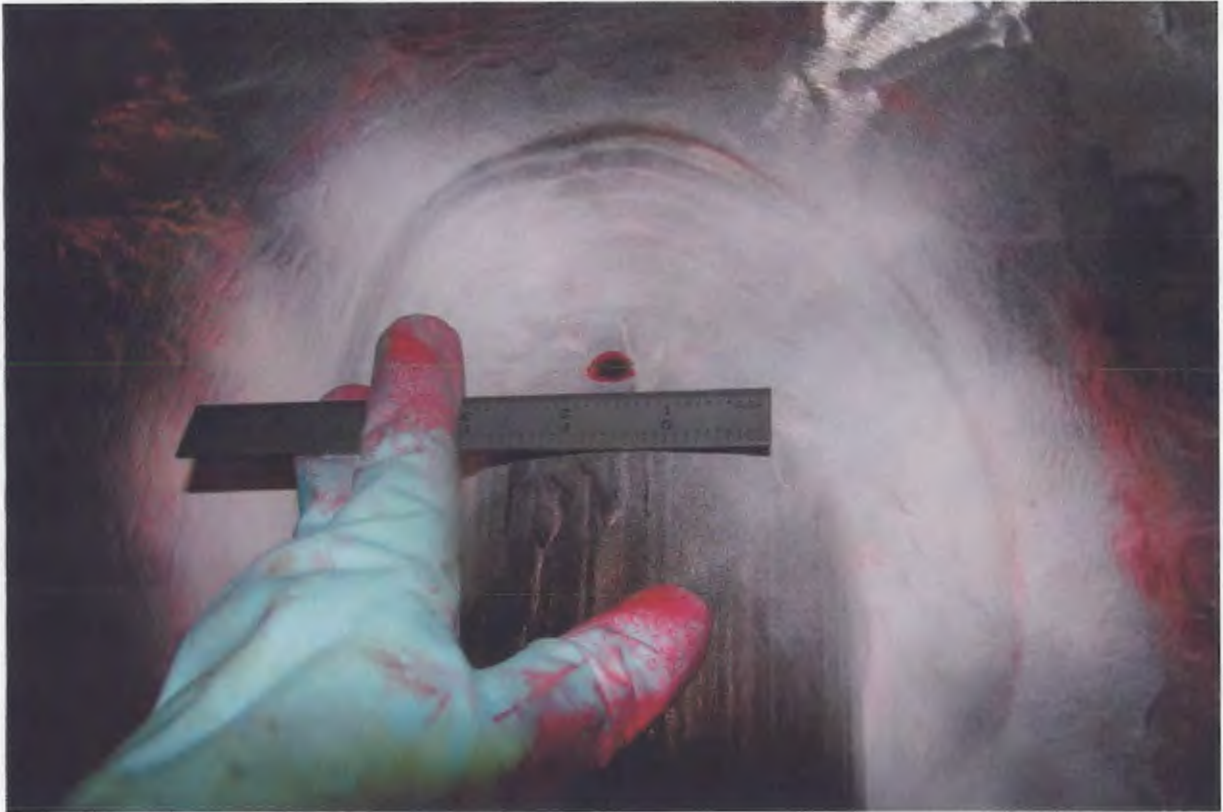
Figure 2: Closer View of the indication of Figure 1

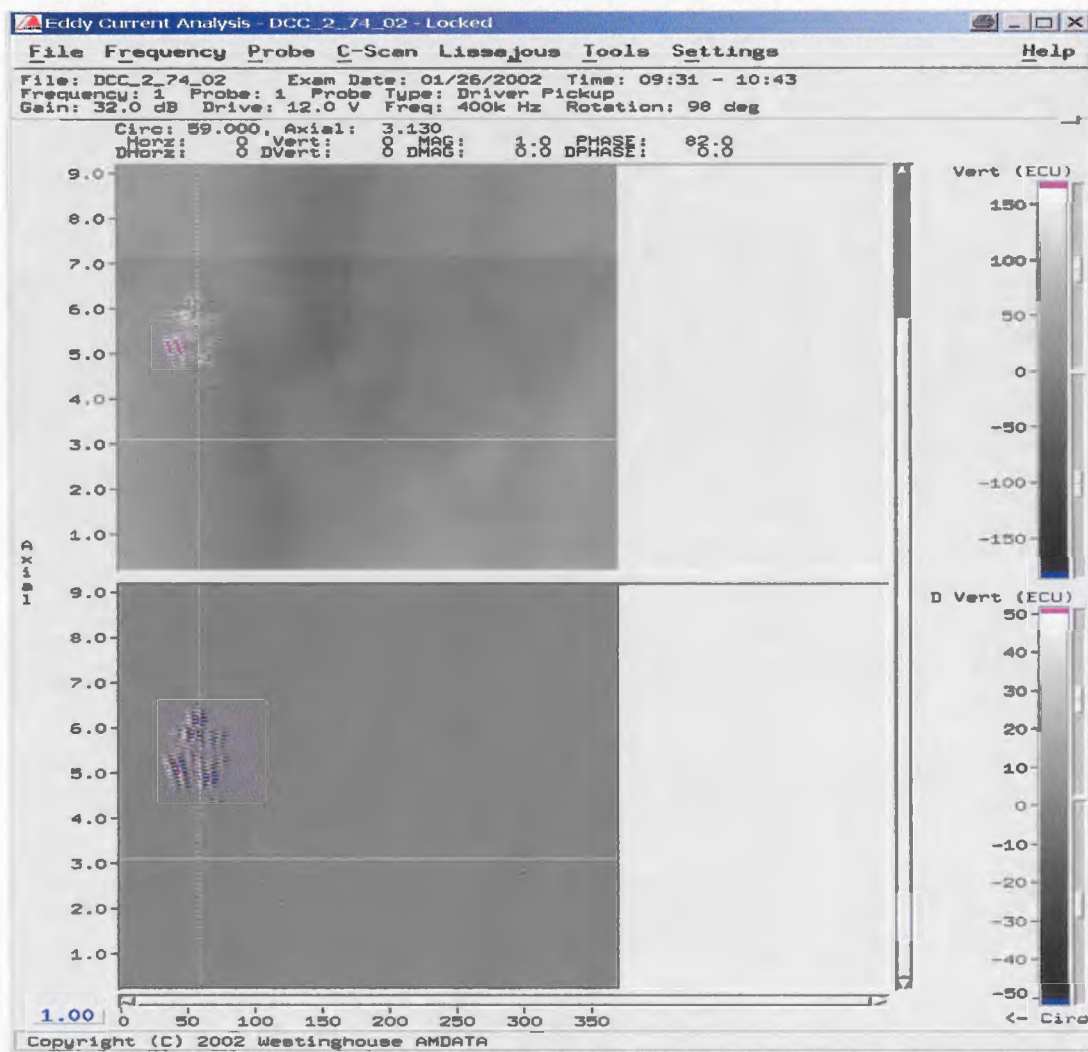
Figure 1
ECT View of Craze Cracking

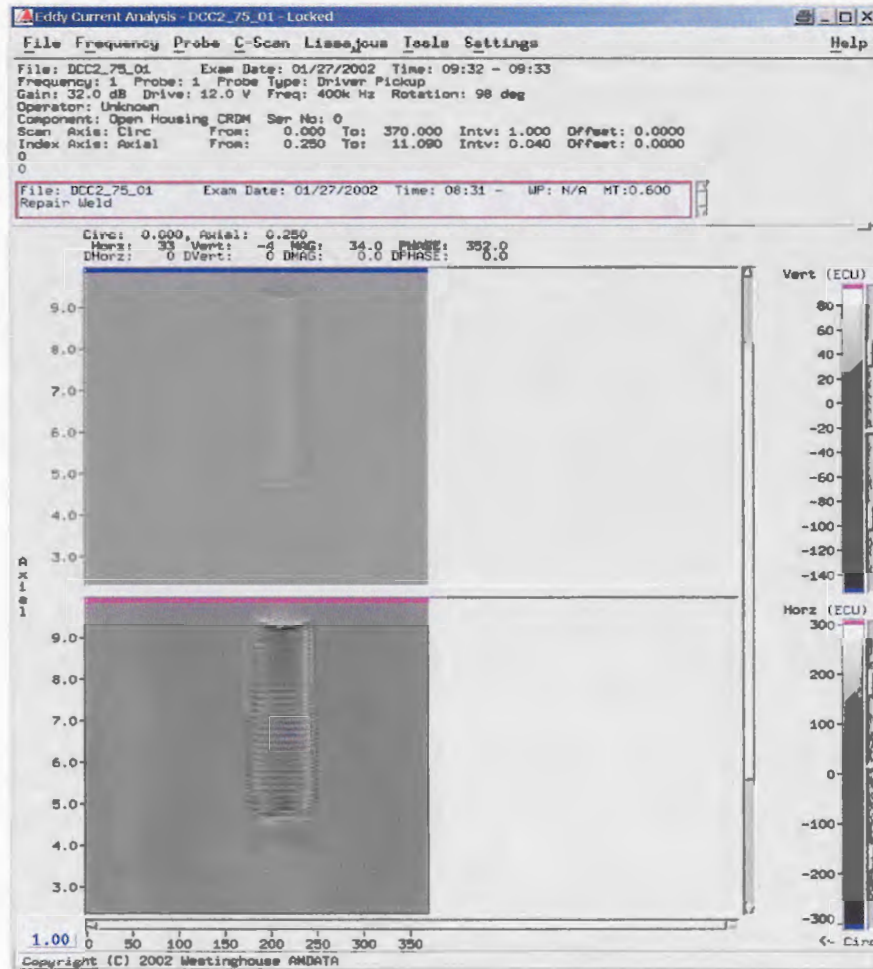
This eddy current testing and display process was applied to the D.C. Cook penetration 75 in January 2002, and the results are shown in Figure 2. The results show no evidence of cracking after six years of service. Further inspections conducted up until the head was replaced in 2006 also showed no evidence of cracking. Therefore, the ID embedded flaw repair was confirmed to last at least 10 years with no deterioration.

Figure 2
ECT View of 1996 Repair, Taken in 2002
