UNITED STATES
NUCLEAR REGULATORY COMMISSION
OFFICE OF NUCLEAR REACTOR REGULATION
OFFICE OF NEW REACTORS
WASHINGTON, DC 20555-0001

October 3, 2013

NRC INFORMATION NOTICE 2013-20: STEAM GENERATOR CHANNEL HEAD AND
TUBESHEET DEGRADATION

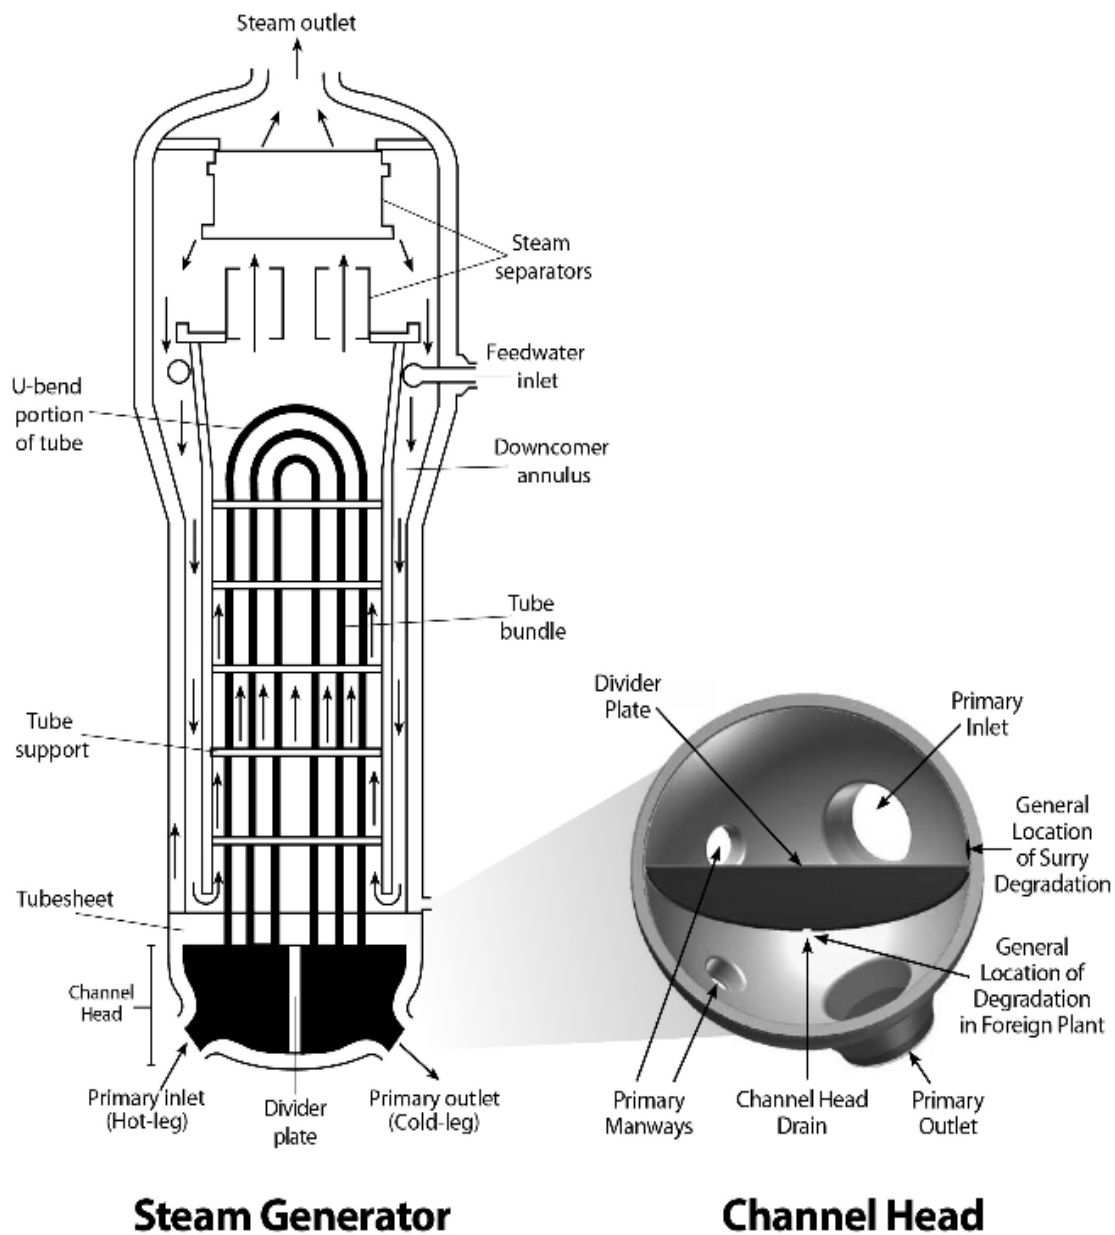
**Figure 1:
Steam Generator Channel Head Assembly**

The primary side of a recirculating steam generator consists of several components, including the channel head, divider plate, tubesheet, and tubes (refer to Figure 1). The channel head is hemispherically shaped and is divided into two chambers by a divider plate. One chamber receives the primary coolant from the reactor through the primary inlet (hot-leg) nozzle, and the divider plate channels this coolant through the tubes. After exiting the tubes, the primary coolant enters the other chamber of the channel head and exits the steam generator through the primary coolant outlet (cold-leg) nozzle(s) so that it can be pumped back into the reactor.
