## Tube support plate clogging up of French PWR steam generators

*Herve BODINEAU & Thierry SOLIER*

IRSN - Reactor Safety Division

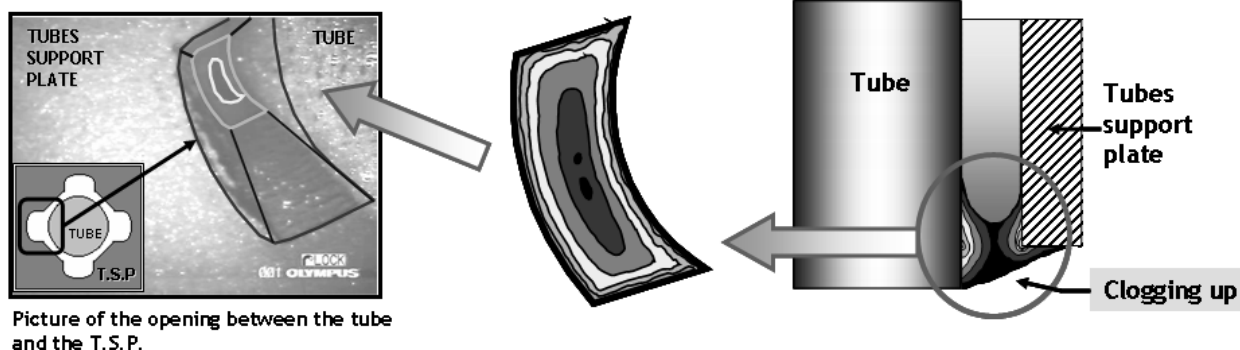
Picture of the opening between the tube and the T.S.P.

Pic. # 2: Representation of the clogged quadrifoil-shaped holes in the TSPs

The initial inspections carried out inside the steam generators on the Cruas units showed significant clogging of the highest TSPs: on average, the cross-section of the quadrifoil-shaped holes was reduced by about 70% and some of them were completely blocked up.

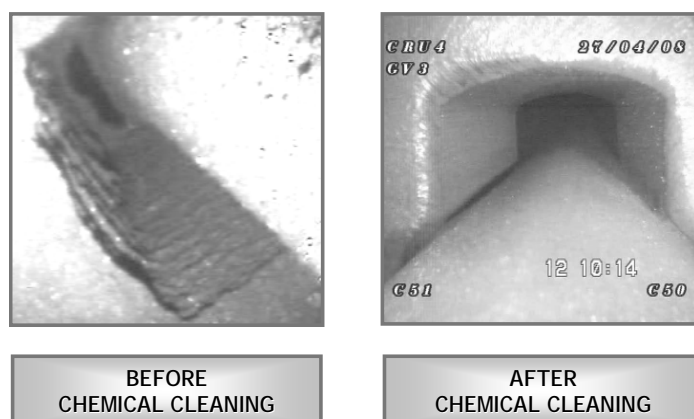
Pic. # 11: View of a quadrifoil-shaped hole before and after chemical cleaning on Cruas unit 4

Given the analyses described above, ASN granted EDF authorization to carry out the chemical cleaning of steam generators on the units listed above in the table. These operations took place in 2007 and 2008. Based on eddy current testing and direct visual examinations, EDF considers that all the chemical cleanings were effective. However, IRSN considers that the operational feedback from both the implementation of the procedure and its impact on the plant should be analysed in details and used to optimize the next chemical cleaning.
