Edwin I. Hatch Nuclear Plant – Unit 2
Inservice Inspection Program
Owner's Activity Report for Outage 2R23

SNC and SI Evaluation Core Shroud Axially Oriented Flaw

BWRVIP EVALUATION

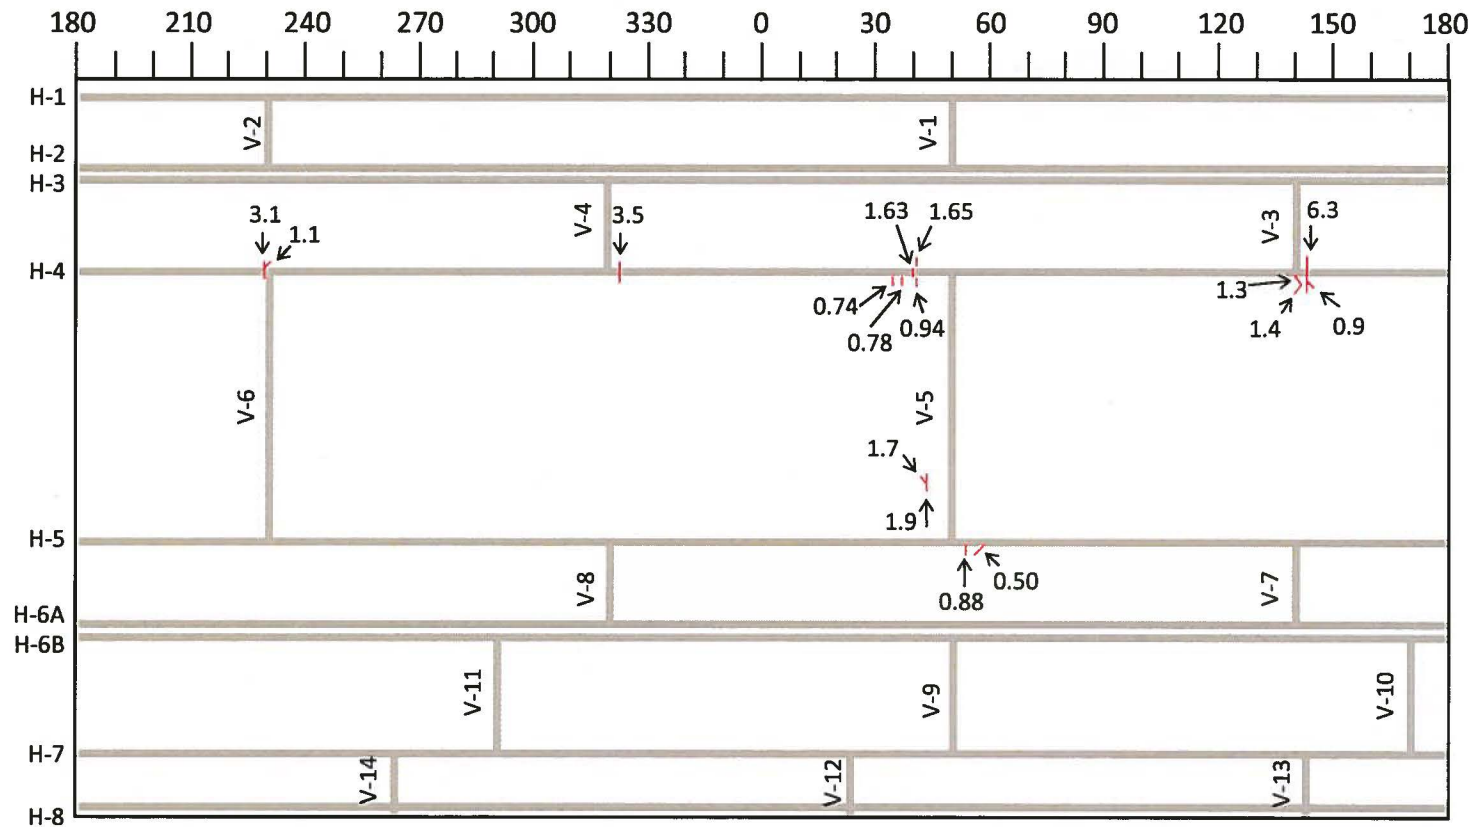
Figure 2. Map of HNP2 core shroud ID indications based on 2R23 inspection results [1]. Annotations show approximate location, orientation, and length in inches.

1. INR 15-03 - VT-3 exam of cell lane (42-47) identified five total axially oriented flaws measuring a maximum of 1.65". One of these flaws crosses the entire H-4 weld.
2. INR 15-05 - Shroud lane (42-07) identified four total flaws in the vicinity of the V-3/H-4 intersection, the largest of which was 6.3" running somewhat parallel to the V-3 weld and passing completely through the H-4 weld.
3. INR 15-06 - Two flawed areas were identified during examinations of cell lane (46-43), both of which were outside of weld heat affected zones. Two indications measuring a maximum of 1.9" were found roughly 3" CCW from V-5 and 12" inches above H-5. These indications are axially oriented and located in an area showing signs of heavy surface grinding. Two additional axially oriented indications (0.86" maximum) were found just below the H-5 weld and slightly CW of V-5.

4. INR 15-04 - EVT-1 exams performed on vertical weld V-6 noted two axially oriented indications with a maximum length of 3.1". One of these indications starts on the CCW side of the V-6 weld toe and extends upward, through the H-4 weld and beyond the heat affected zone above H-4. It should be noted that the previously noted V6 indication that was tracked during 1R18 and reinspected 2R19 was determined to be non-relevant during 2R23, although the non-relevant

5. INR 15-07 - EVT-1 examination of weld V-4 noted a 3.5" axially oriented indication running from above the H-4 weld roughly 1.5" CW of V-4 to a location roughly 0.92" below H-4.

On February 21, 2015, inspection personnel performing scheduled visual VT-3 examinations of the Edwin I. Hatch Nuclear Plant – Unit 2 Core Shroud reported new crack-like indications not associated with a horizontal or vertical weld. The indications were reported to SNC via INR H2R23-IVVI-15-03,-05 and -06 and are located at 40°, 45° and 140° azimuths and in the areas of and between horizontal welds H4 and H5.

The two indications detected at 40° from cell location 46-43 were measured to be 1.7" and 1.9" in length. These indications were located roughly 3" ccw from the V-5 weld and 12" above the H-5 weld. As noted in INR 15-06, inspection personnel noted evidence of heavy surface grinding in the area.

An additional indication extending beyond the H-4 HAZ was identified at 45° during inspection of cell lane 42-47. Horizontal indications were noted within the weld HAZ, although one indication branches axially outside of the HAZ. This indication branches up and away from H-4 extending a distance of 1.65" beyond the toe of H-4. Four other indications were noted within INR 15-03 but in all instances these other indications are associated with the H-4 weld.

The final indications are noted within INR 15-05 at roughly 140° near the V-3 / H-4 intersection seen in cell 42-07. The major indication noted here is 6.3" in length which runs roughly parallel to V-3. This indication starts roughly 1" CW of V-3 in the base metal and terminates below H-4, still approximately 0.75" CW of V-3. Two additional axial indications measuring 0.9" and 1.4" are seen below the H-4 weld but outside of its HAZ. A fourth indication of 1.3" in length is seen branching axially below the toe of H-4.

The above-referenced structural evaluation justifies a 10-year re-inspection interval, however due to additional evaluation limitations which will be applicable after 2R26, re-examination of V-4, V-6, and flaws reported at lanes 42-47, 46-43(V-5), and 42-07(V-3) are recommended for reinspection during 2R26 to apply up to date inspection results for re-evaluation. In addition, the flaws seen in cells 46-43, 42-07 and 42-47 that are not associated with either vertical or horizontal welds will be dealt with using the rules within ASME Section XI. Because of these ASME code rules, shroud ID lanes (42-47), (42-07) and (46-43) must be examined using the VT-3 method in each of the three ISI periods in the 5th ISI interval beginning 1 January 2016. See attached document for ASME Section XI re-examination frequency discussion.
