ENCLOSURE 1

MFN 15-042 R0

Description of Evaluation

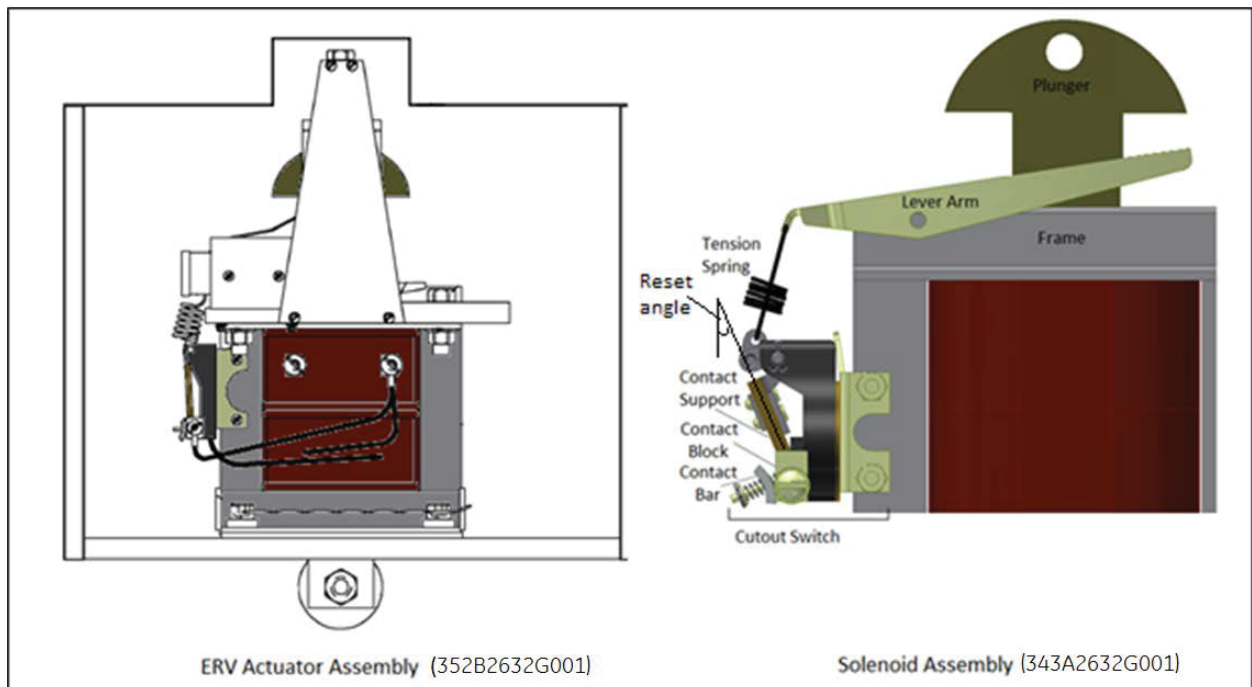
Figure 1 Actuator and Solenoid Assembly in the reset position

GEH provides various parts and components that are designed to actuate Electromatic Relief Valves (ERVs). The only manner in which these valves can be opened is from an electrical signal received by the actuator. The ERV Actuator Assembly contains the Solenoid Assembly which contains the cutout switch assembly as shown in Figure 1.

The cutout switch bypasses the secondary holding coil in order to develop the magnetic field energy to engage the plunger. When the plunger is fully seated the cut out switch is open allowing current flow thru the secondary coil providing additional inductance to be introduced into the circuit. Upon the actuation of the solenoid the plunger lowers and impacts the back end of the plunger lever arm. The lever arm pivots, raising the front end of the arm which is connected to the tension spring. This causes the contact support to rotate (clockwise in Figure 2) creating a gap between the contact blocks and the contact bar. The gap between the contact bar and the contact blocks removes the bypass of the secondary coil. The purpose of the secondary coil is to prevent burnup of the primary coil. When the electrical signal is removed the plunger lifts allowing the plunger lever arm to lift which releases the tension on the tension spring and allowing the torsion spring to close the contacts, resetting the actuator. The resetting force is provided by a torsion spring by F2 which may be seen in Figure 1. If the secondary coil is not bypassed before the actuation signal is received the actuator will fail to provide the force necessary to actuate its valve.

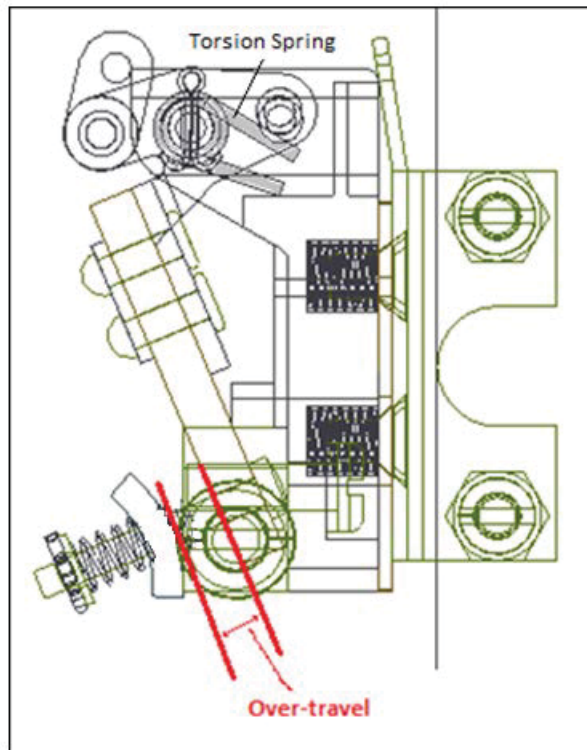
Figure 2 Over travel of cutout switch

Following the observed failures, an investigation was initiated to determine the cause of the failures, and to determine whether the condition applied to components previously supplied to and accepted by licensees. The investigation concluded that the ERV actuator assemblies failed to change state because of the failure of the cutout switch to fully close and provide the appropriate current path. When Unit #5 failed, a 0.003 inch gap was present between the contact bar and one of the contact blocks. When Unit #8 failed, a 0.001 inch gap was present between the contact bar and one of the contact blocks. For both Unit #5 and Unit #8 contact existed between the contact bar and one of the blocks but a gap existed between the contact bar and the other contact block.

Multiple contributing factors were discovered which could have led to the presence of the gaps. The most significant of these factors is tolerance stack-up causing high forces in the tension spring which prevent proper closure of the cutout switch. Manufacturing tolerances and shop practices allowed for such a condition to exist at the extreme range of the combined tolerances. Additionally, insufficient clearances may have contributed to increased frictional forces in the part, becoming a second contributing factor.

Proper contact in the cutout switch is dependent on the reset angle. For discussion purposes the term reset angle refers to the angle of the contact support after the plunger lifts and the part resets. The solenoid assembly in Figure 2 is in the reset position therefore the contact support is in the reset angle. Unreliable performance occurs when the reset angle for a given part does not consistently ensure adequate contact. Conversely, reliability is achieved when the reset angle always ensures sufficient contact between the contact bar and the contact blocks.

Further, if site maintenance procedures confirm visual over travel of the cutout switch in the final assembly, this then provides reasonable assurance that functionality is maintained. As the number of successful cycles of the component increases so does the confidence in the successful operation of the cutout switch.

If positive over travel has not been previously confirmed during maintenance activities, perform inspection at the next available opportunity to verify that the condition does not exist.

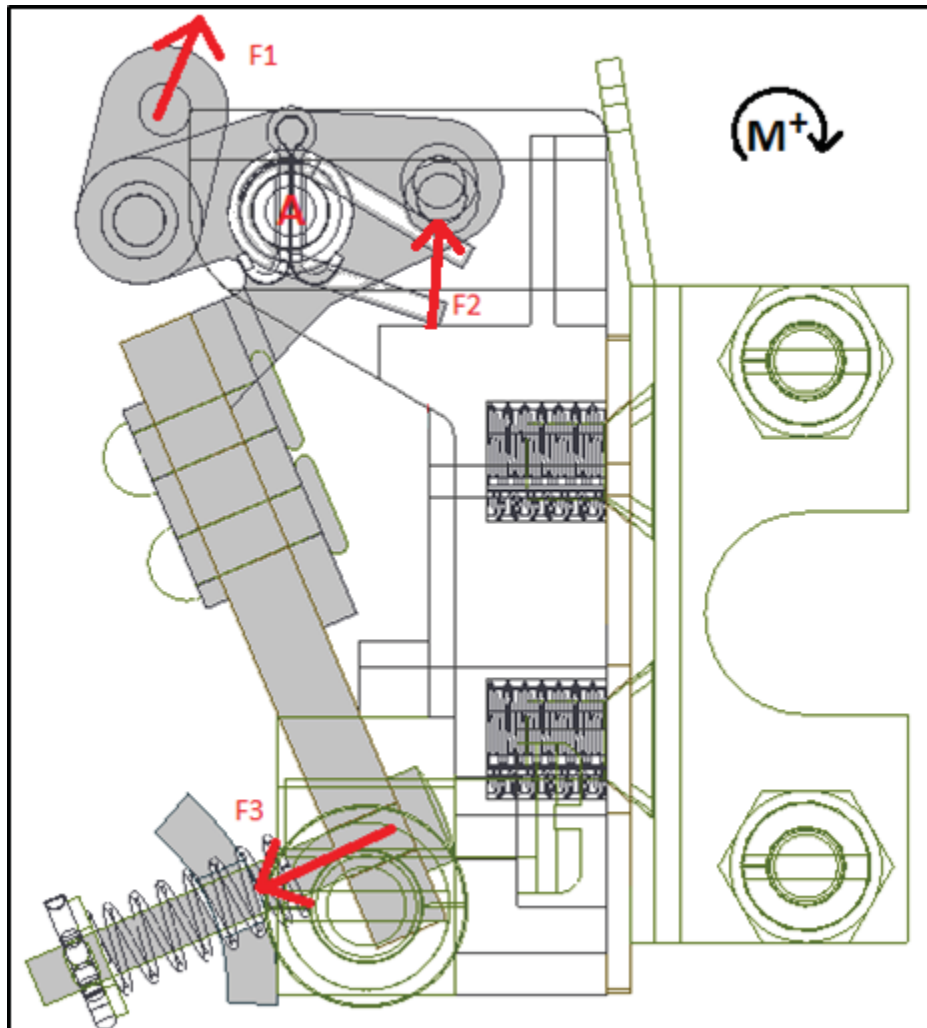
Figure 3

When a part resets there are four moments that determine the reset angle. Three of these are caused by the forces shown in Figure 3. The fourth is caused by friction. For a given part the moments caused by forces F1, F2, and, F3 are only dependent on the angle of the contact support. Therefore any variance in the reset angle is due to variation of the moment due to friction in the part. The amount of over travel, as shown in Figure 1, is a good indication of the susceptibility of an assembly to unreliable operation. Positive over travel ensures proper contact is made despite frictional variation.

Friction is present when the assembly is reset, not allowing the contact support to proceed entirely to its neutral, zero friction reset angle. As energy is added to the system sufficient to overcome the frictional moment, the contact bar will tend to drift towards its zero friction angle. This means an assembly that doesn't consistently make contact when initially reset would be
