Clinton Power Station
8401 Power Road
Clinton, IL 61727

Clinton Power Station, Unit 1
Facility Operating License No. NPF-62
NRC Docket No. 50-461

Subject: Clinton Power Station Regulatory Conference Supplemental Information

Regulatory Conference Clinton Power Station Division 3 SX Pump

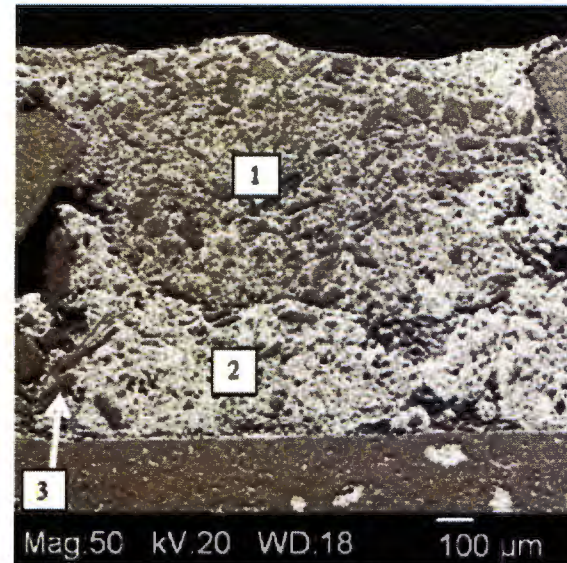
- Conclusion:
 - Plugging/blockage of cooling channel on failed bushing was a result of the bushing failure. The cooling channels were blocked with failed hardfacing material, not silt.
- Basis:
 - No evidence of silt in the cooling channels was found – Exelon PowerLabs re-performed Scanning Electron Microscopy (SEM) analysis of material in the cooling channel and concluded that silicon was present; however, this silicon was concluded to be from the hardfacing material (the hardfacing has 4.2% by weight silicon) as it was always found with other hardfacing constituents. No other minerals associated with silt were identified.
 - The suction bell bushing is no more likely to accumulate silt than some of the other pump bearings.
 - Remaining bushing cooling channels not blocked.

SEM photo of a metallurgical section of the failed bushing through a deformed and blocked cooling slot. Light areas 1 and 2 were examined and found to be mixtures of lead and hardfacing material. The spectrum from Dark Area 3 is shown on the next slide and it was also primarily hardfacing with a small amount of lead. No calcium or silicon rich sediment was detected. All the silicon in spectrum was associated with hardfacing.

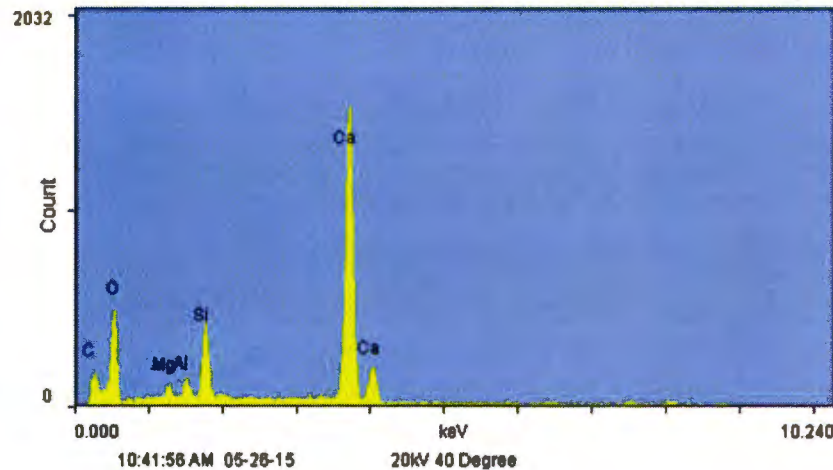
- This spectrum is from deposits on a bushing section that was part of the bushing pieces in an area that was outside normal contact zone.
- Example of water mineral deposits as evidenced by the high calcium and silicon peaks in the SEM-EDS spectrum

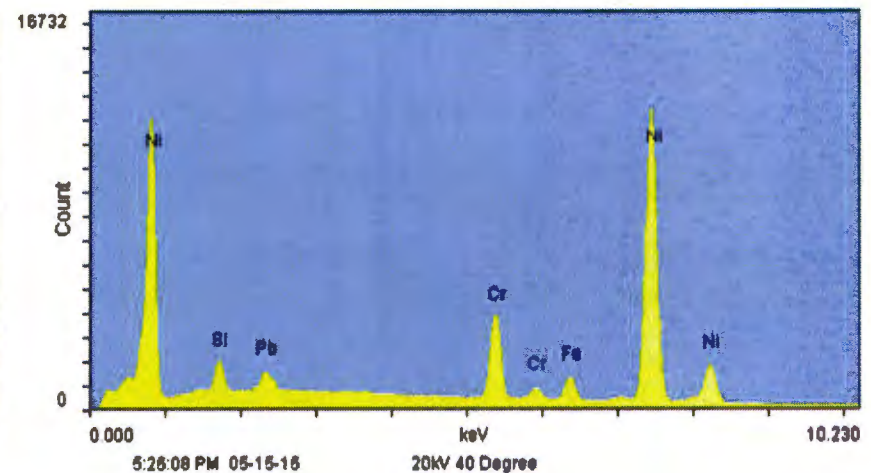
- This spectrum is from area three (previous slide) of the hardfacing debris in the cooling channel.
- Chromium and/or nickel were always present in large quantities with the silicon rich phases.

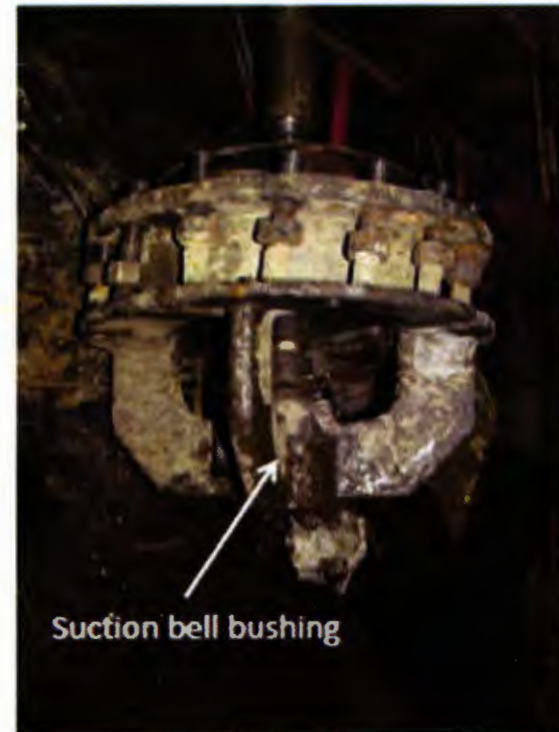
- Conclusion:
 - Silt is no more likely to accumulate at the suction bell bushing location than at the other locations.
- Basis:
 - The open design of the suction bell does not physically support silt accumulation.
 - Observations of large amounts of silt were noted at the lower column bushing locations and the areas surrounding the bowl bushings. The suction bell area was not noted to be packed with silt.
 - The area around the suction bell bushing is relatively open and ~12 ft. above the bottom of the suction bay, which limits preferential sites on which silt can build-up (as compared to column bushing or bowl bushings).

Suction bell bushing (during disassembly, picture rotated to show approximate orientation as installed)
– note open design

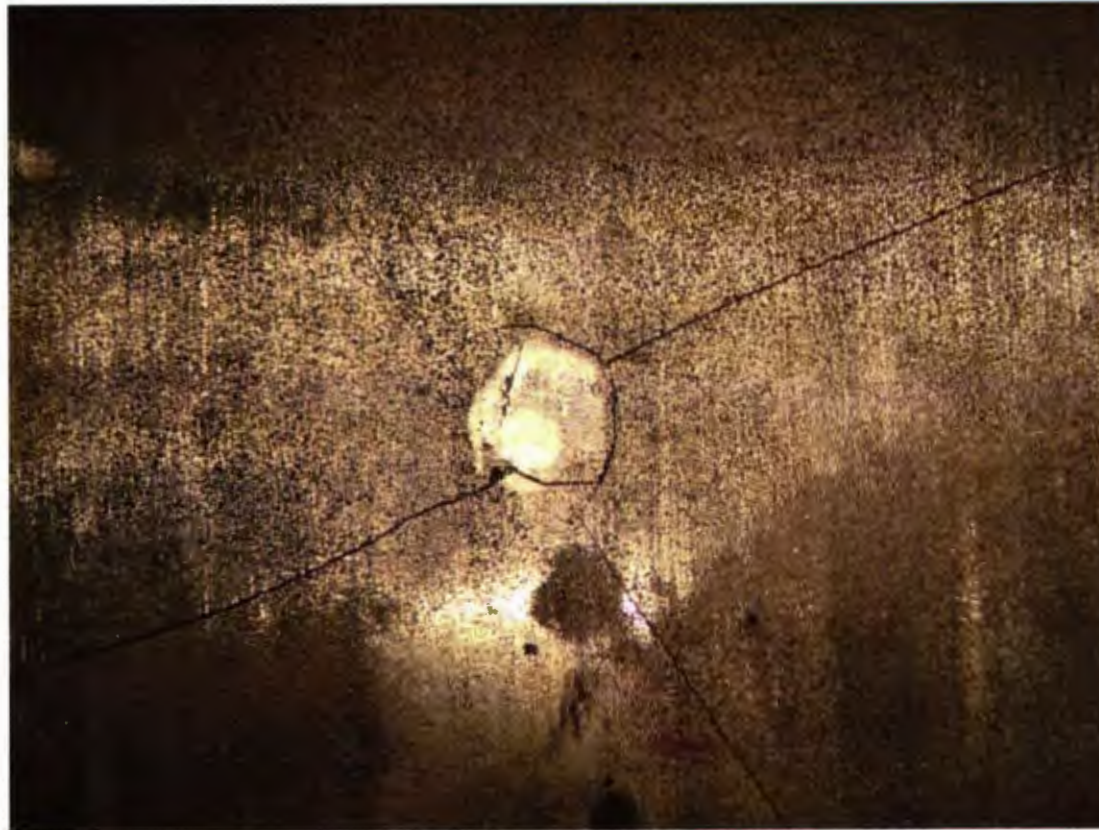
Other Sleeve Cracked with Wear Mark

- Cracking was observed in five of the remainder of intact sleeves, including column bushing sleeves. The column bushings are lightly loaded and their cooling channels were stated to be free of silt upon disassembly. There was no evidence of high temperatures at these other locations.
- Cyclic temperatures and stresses in the failed suction bell bushing due to pump operating/shutdown cycle were shown not to result in cracking of the hardface, even with no cooling water flows.
- The bushing loads and heat generation are small. Thermal stress analyses performed assuming no cooling flow indicates peak thermal stresses are below the expected endurance strength of material based on published fatigue testing results of a similar hardface.

- Representative photograph of cracks found on other bushing sleeves in pump assembly.
- This sample shows circular "polished" appearing surface area at intersection of sleeve cracks. This surface imperfection is not common.
- Metallurgical section shows delamination presumably contacting the bushing during operation.

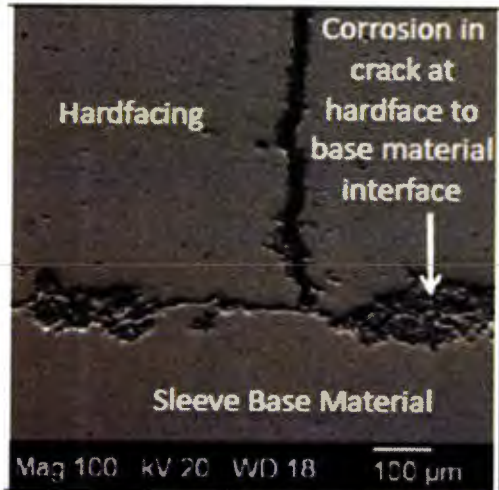
- Cracking found in the hardfacing on five of the sleeves in the pump above the failed sleeve.
 - Cracks were generally axial near the bottom; some cracks tended to become more circumferential near the top of the bushing mating area.
- Evidence of widespread, but shallow, surface corrosion on five of the pump sleeves was observed.
 - The corrosion is not considered significant enough to be the cause of crack initiation.
- Corrosion was evident in the cracks found on the sleeves, and at the hardface-base metal bond.
 - Corrosion accelerated and/or propagated bond degradation after the crack formed.

Surface crack propagates radially inward to hardface bond, then follows hardface-to-base material interface circumferentially
