SUBJECT: NRC INSPECTION REPORT 40-8502/98-02

Report No. 40-8502/98-02

Licensee: COGEMA Mining, Inc.

Facility: Irigaray Central Processing Facility

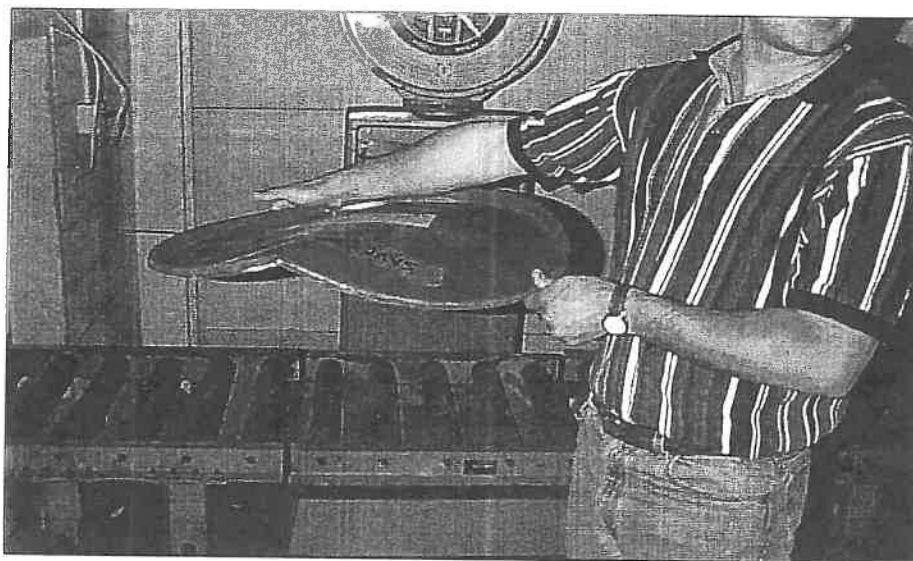
seal ring was sufficiently loose, pressurized gases in the drum were relieved. The force of the release blew yellowcake material out of the drum and onto the worker as well as into the drum room. The pressure relief was great enough not only to bend the drum lid but to cause yellowcake material to be ejected from the drum room through the two access doors. (The doors were normally closed but were not secured with any sort of latching assemblies.) The pressure release resulted in the ejection of about a fourth of the drum's contents, or roughly 200 pounds of yellowcake material.

An investigation was performed by the licensee to ascertain why the drum was pressurized because this type of incident had not occurred before. The licensee's investigation concluded that the incident was apparently caused by oxygen buildup in the drum. The oxygen was generated by the decomposition of hydrogen peroxide into water and free oxygen. (The licensee used hydrogen peroxide in the precipitation of the yellowcake product.) The operator inadvertently released this pressured oxygen following the removal of the drum seal. The actual pressure buildup in the drum could not be determined, but subsequent testing demonstrated pressure buildups in the range of 9-15 pounds per square inch.

Damaged drum lid.

Corrective actions taken by the licensee included revising the drum filling procedure to include a delay time prior to installation of the drum lid and associated seal. Revision 3 to Standard Operating Procedure IR-12, "Drypack - Yellowcake Drying and Drumming," added the instruction to not bolt the lid onto the drum for a minimum of three hours to avoid a pressure buildup in the drum. The licensee speculated that this revised method of drum filling and sealing should prevent a recurrence of the incident.

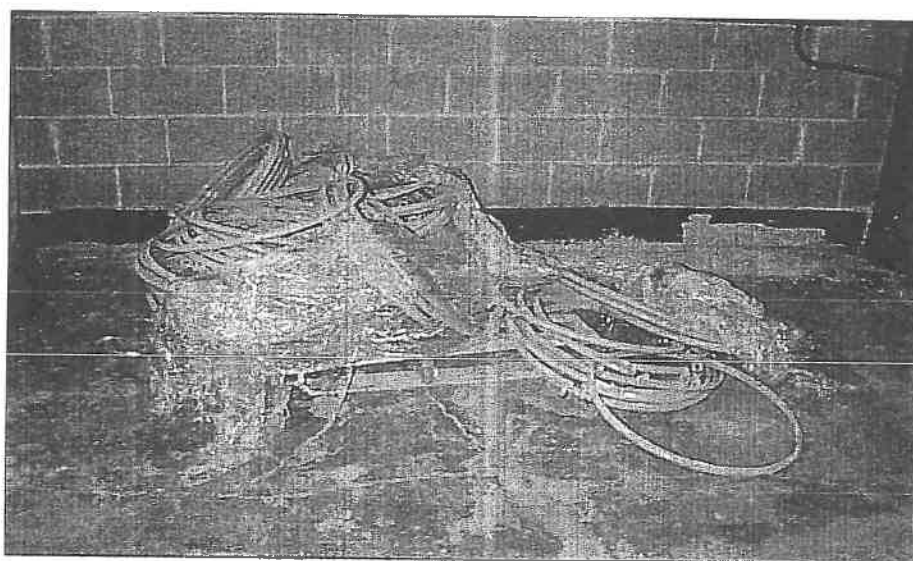
The licensee's review of the incident also revealed that these four drums had new gasket seals and metal seal rings. The licensee typically recycled the drums, including the drum seals, and replaced the rubber seals and seal rings only on an as-needed basis. The new seals apparently sealed the drums in a more efficient manner than the old, recycled seals. The new seals apparently inhibited the dissipation of the internal gas, preventing reduction in drum pressures more effectively than old seals.

New/spare drum seal rings.

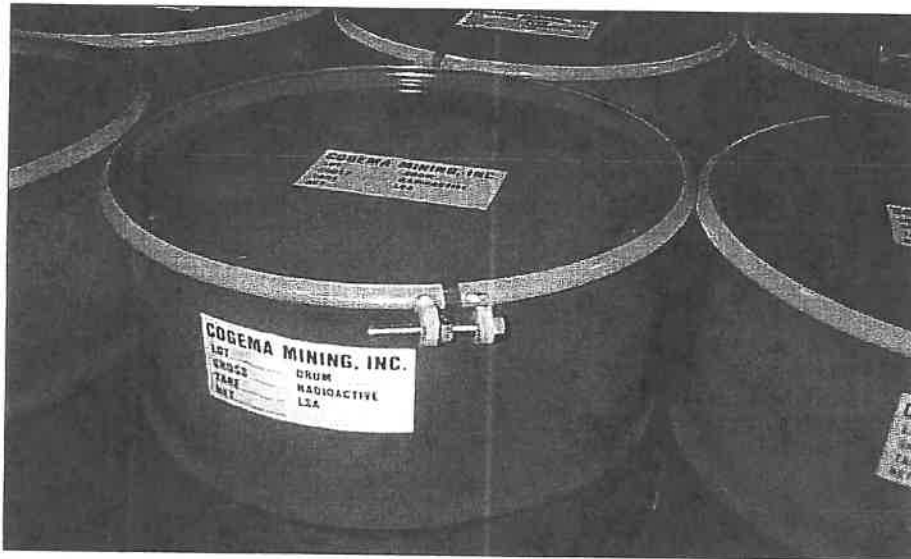
New/upgraded drum lid seal ring.

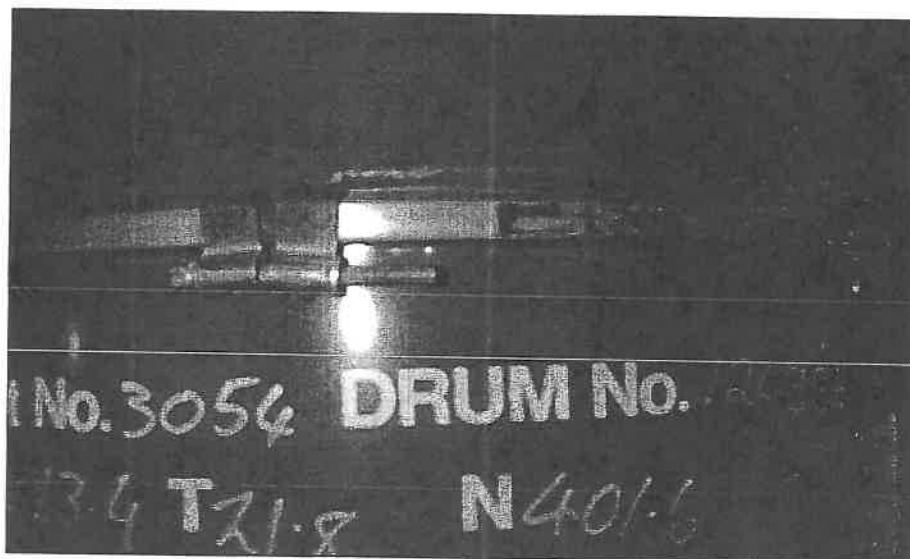
been installed with a recycled seal because the older seals would not inhibit gas dissipation as effectively as new seals.

Older drum seal ring.
