Clinton Power Station
8401 Power Road
Clinton, IL 61727

Subject: Clinton Power Station Regulatory Conference Supplemental Information

Regulatory Conference Clinton Power Station Division 3 SX Pump

Summary of Preliminary White Finding (Inspection Report 05000461/2015001)

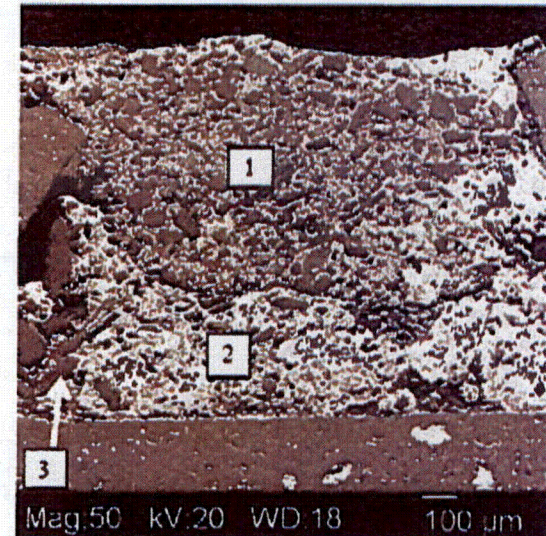
- Conclusion:
 - Plugging/blockage of cooling channel on failed bushing was a result of the bushing failure. The cooling channels were blocked with failed hardfacing material, not silt.
- Basis:
 - No evidence of silt in the cooling channels was found – Exelon PowerLabs re-performed Scanning Electron Microscopy (SEM) analysis of material in the cooling channel and concluded that silicon was present; however, this silicon was concluded to be from the hardfacing material (the hardfacing has 4.2% by weight silicon) as it was always found with other hardfacing constituents. No other minerals associated with silt were identified.
 - The suction bell bushing is no more likely to accumulate silt than some of the other pump bearings.
 - Remaining bushing cooling channels not blocked.

SEM photo of a metallurgical section of the failed bushing through a deformed and blocked cooling slot. Light areas 1 and 2 were examined and found to be mixtures of lead and hardfacing material. The spectrum from Dark Area 3 is shown on the next slide and it was also primarily hardfacing with a small amount of lead. No calcium or silicon rich sediment was detected. All the silicon in spectrum was associated with hardfacing.

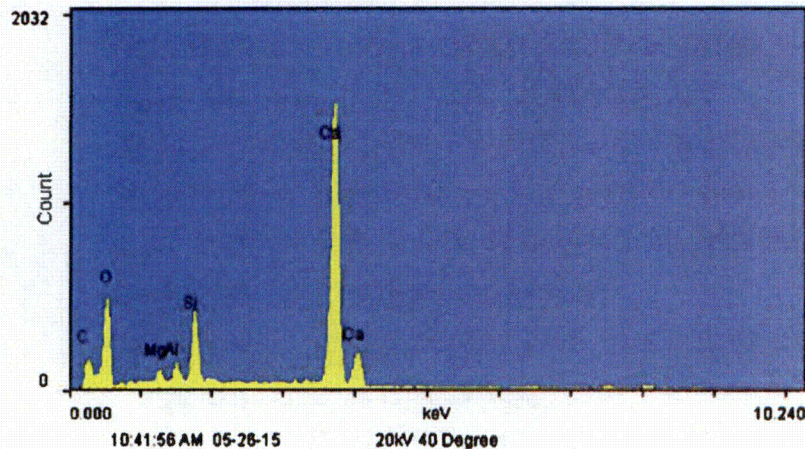
- This spectrum is from deposits on a bushing section that was part of the bushing pieces in an area that was outside normal contact zone.
- Example of water mineral deposits as evidenced by the high calcium and silicon peaks in the SEM-EDS spectrum

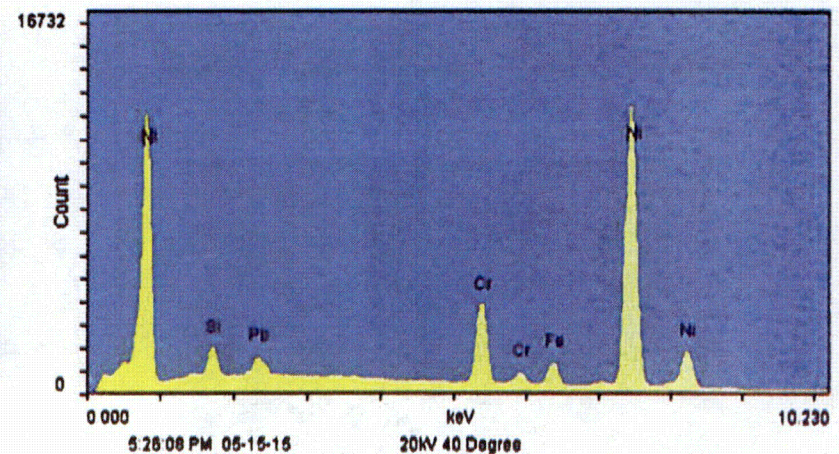
- This spectrum is from area three (previous slide) of the hardfacing debris in the cooling channel.
- Chromium and/or nickel were always present in large quantities with the silicon rich phases.

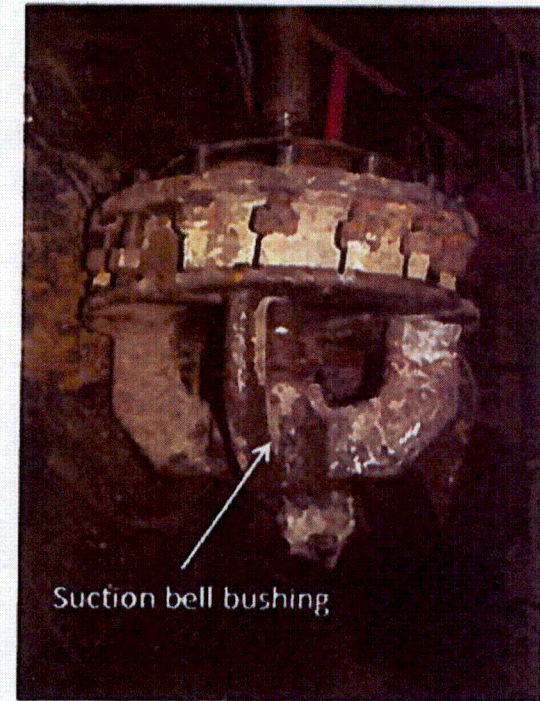
- Conclusion:
 - Silt is no more likely to accumulate at the suction bell bushing location than at the other locations.
- Basis:
 - The open design of the suction bell does not physically support silt accumulation.
 - Observations of large amounts of silt were noted at the lower column bushing locations and the areas surrounding the bowl bushings. The suction bell area was not noted to be packed with silt.
 - The area around the suction bell bushing is relatively open and ~12 ft. above the bottom of the suction bay, which limits preferential sites on which silt can build-up (as compared to column bushing or bowl bushings).

**Suction bell bushing (during disassembly, picture rotated to show approximate orientation as installed)
– note open design**

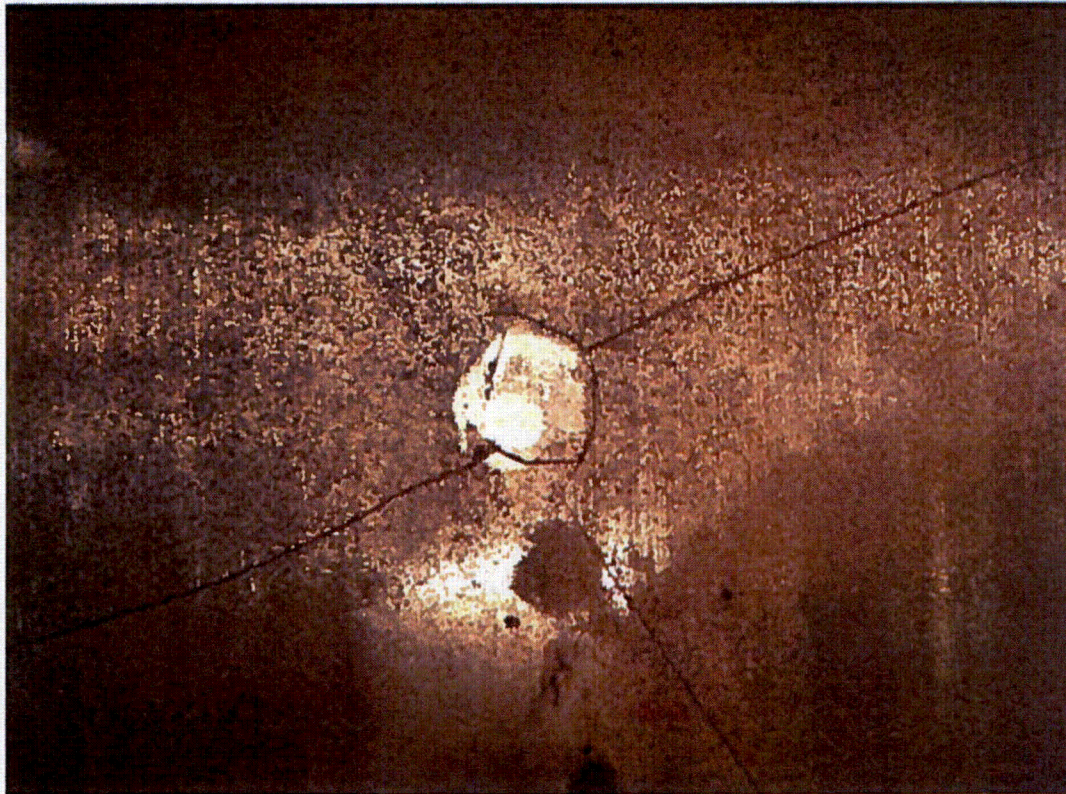
- Representative photograph of cracks found on other bushing sleeves in pump assembly.
- This sample shows circular "polished" appearing surface area at intersection of sleeve cracks. This surface imperfection is not common.
- Metallurgical section shows delamination presumably contacting the bushing during operation.

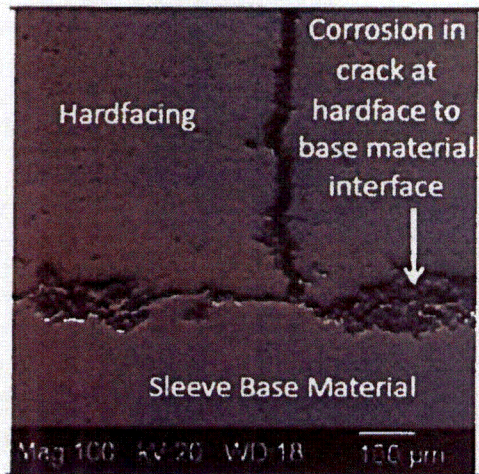
- Cracking found in the hardfacing on five of the sleeves in the pump above the failed sleeve.
 - Cracks were generally axial near the bottom; some cracks tended to become more circumferential near the top of the bushing mating area.
- Evidence of widespread, but shallow, surface corrosion on five of the pump sleeves was observed.
 - The corrosion is not considered significant enough to be the cause of crack initiation.
- Corrosion was evident in the cracks found on the sleeves, and at the hardface-base metal bond.
 - Corrosion accelerated and/or propagated bond degradation after the crack formed.

Surface crack propagates radially inward to hardface bond, then follows hardface-to-base material interface circumferentially
