AUDIT REPORT

REQUEST FOR RISK-INFORMED SOLUTION TO GSI-191

SOUTH TEXAS PROJECT NUCLEAR OPERATING COMPANY

APRIL 2, 2015, CONTAINMENT WALKDOWN PICTURES

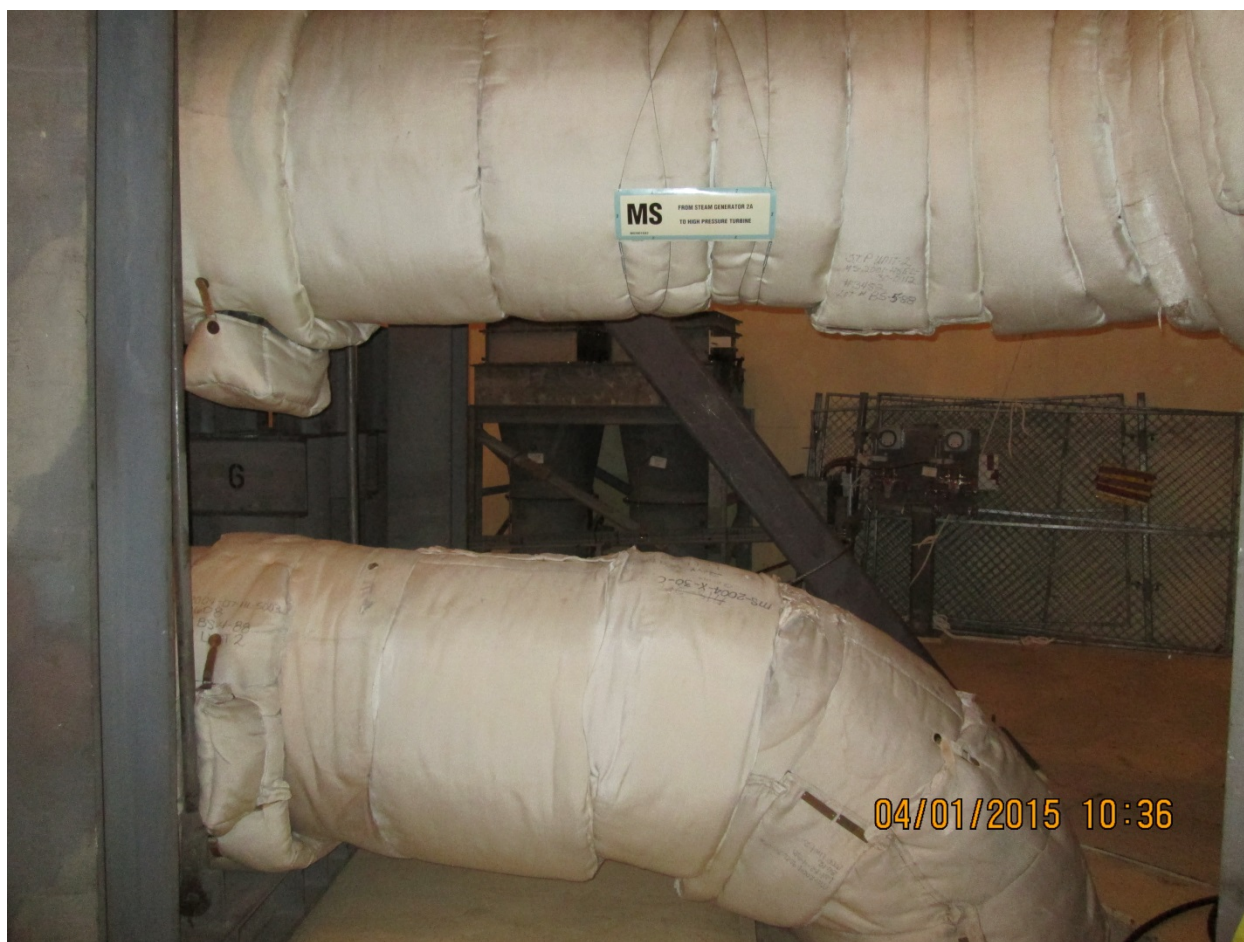
Insulation on Main Steam Line

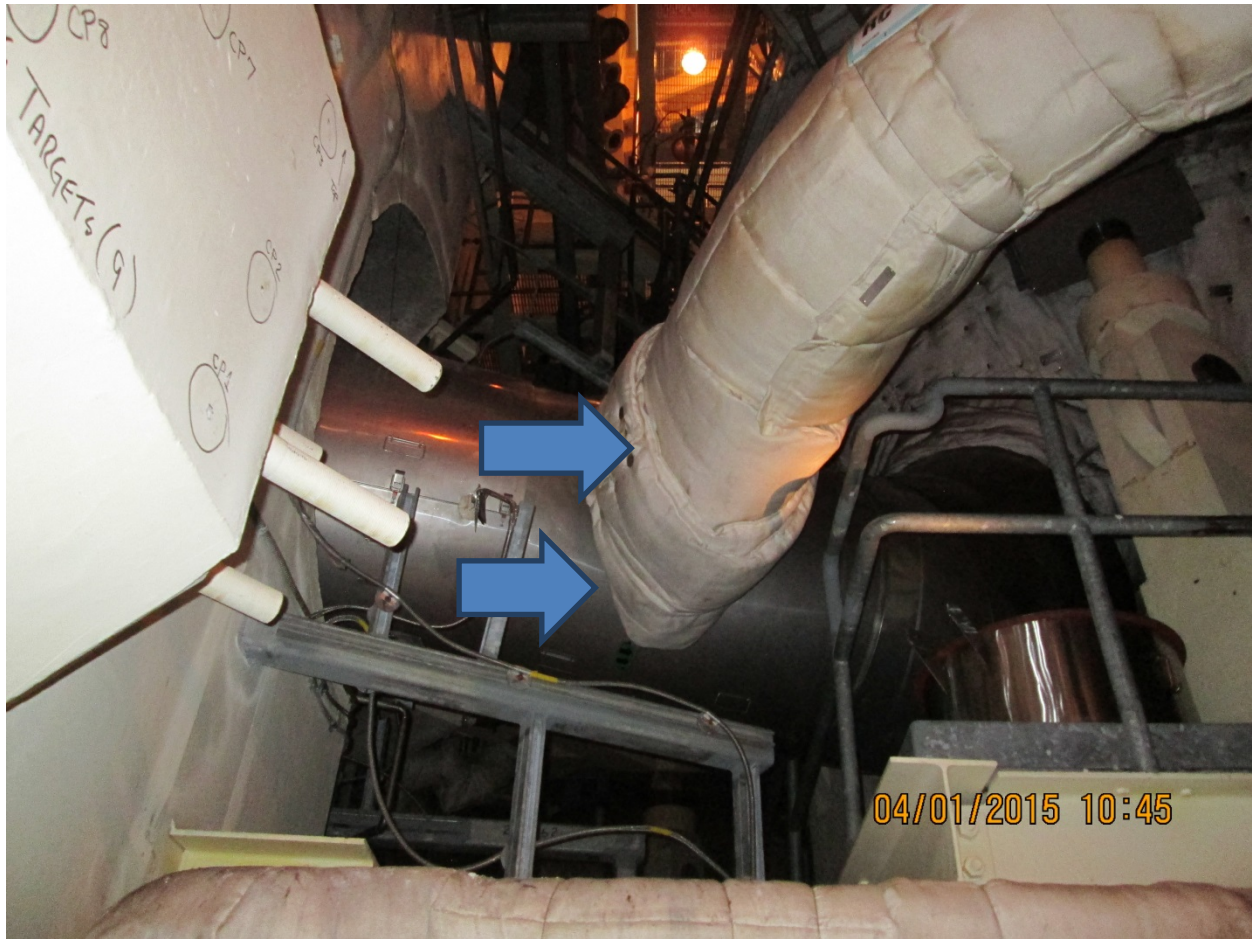
Weld Location #3 on Hot Leg and #2 on Surge Line

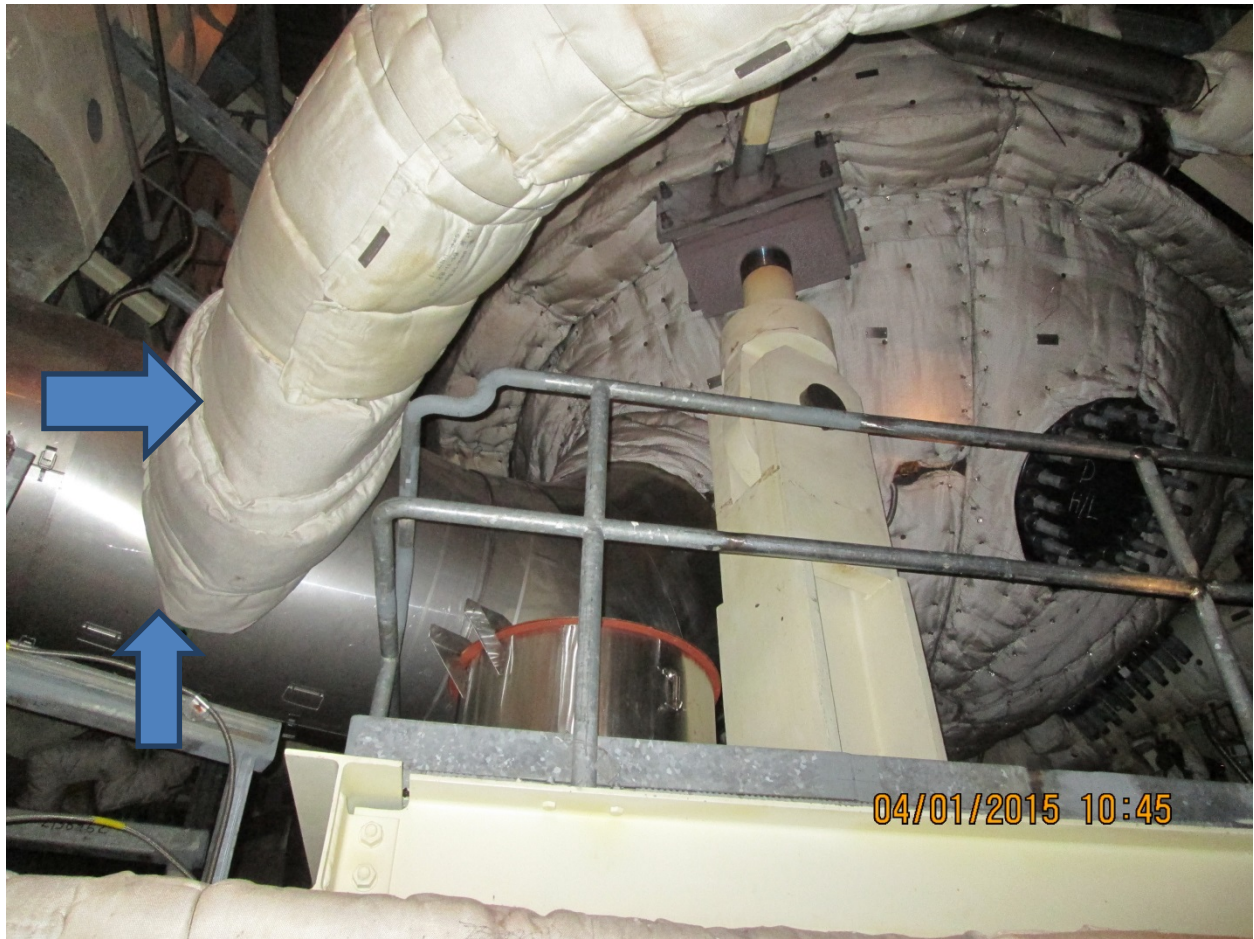
Weld Location #3 on Hot Leg and # 2 on the Surge Line

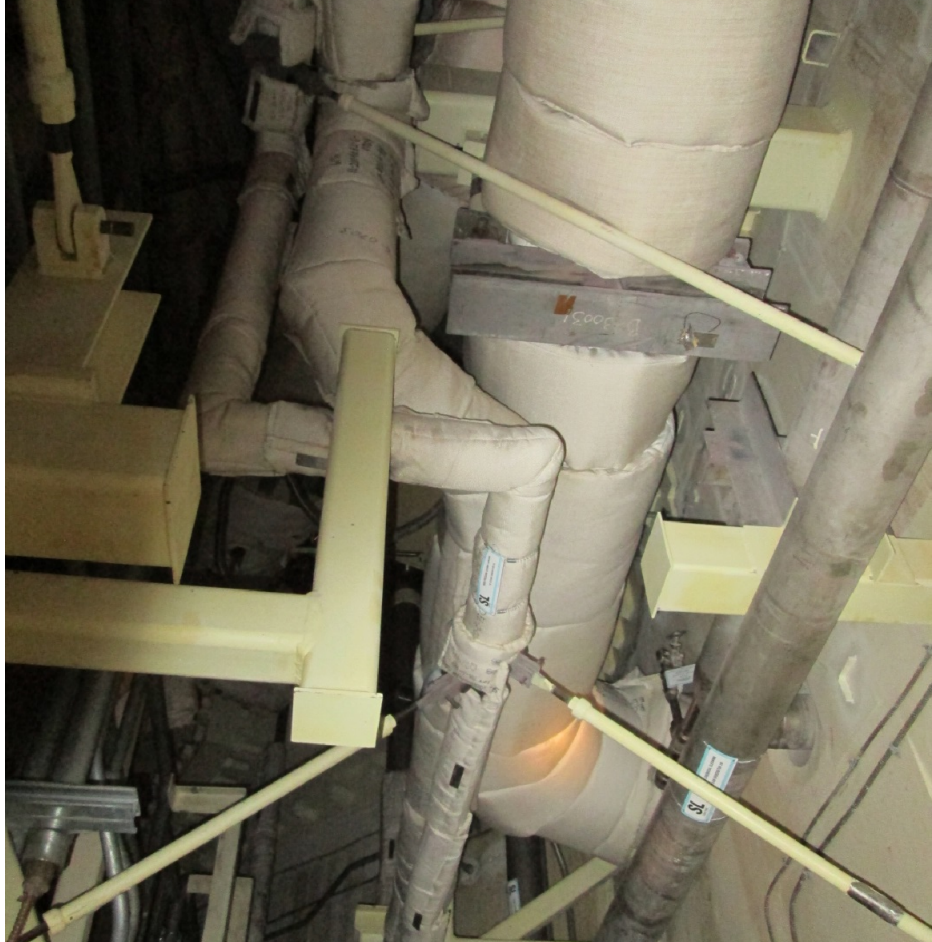
Piping Near Weld Location #2 on Pressurizer Surge Line near Hot Leg

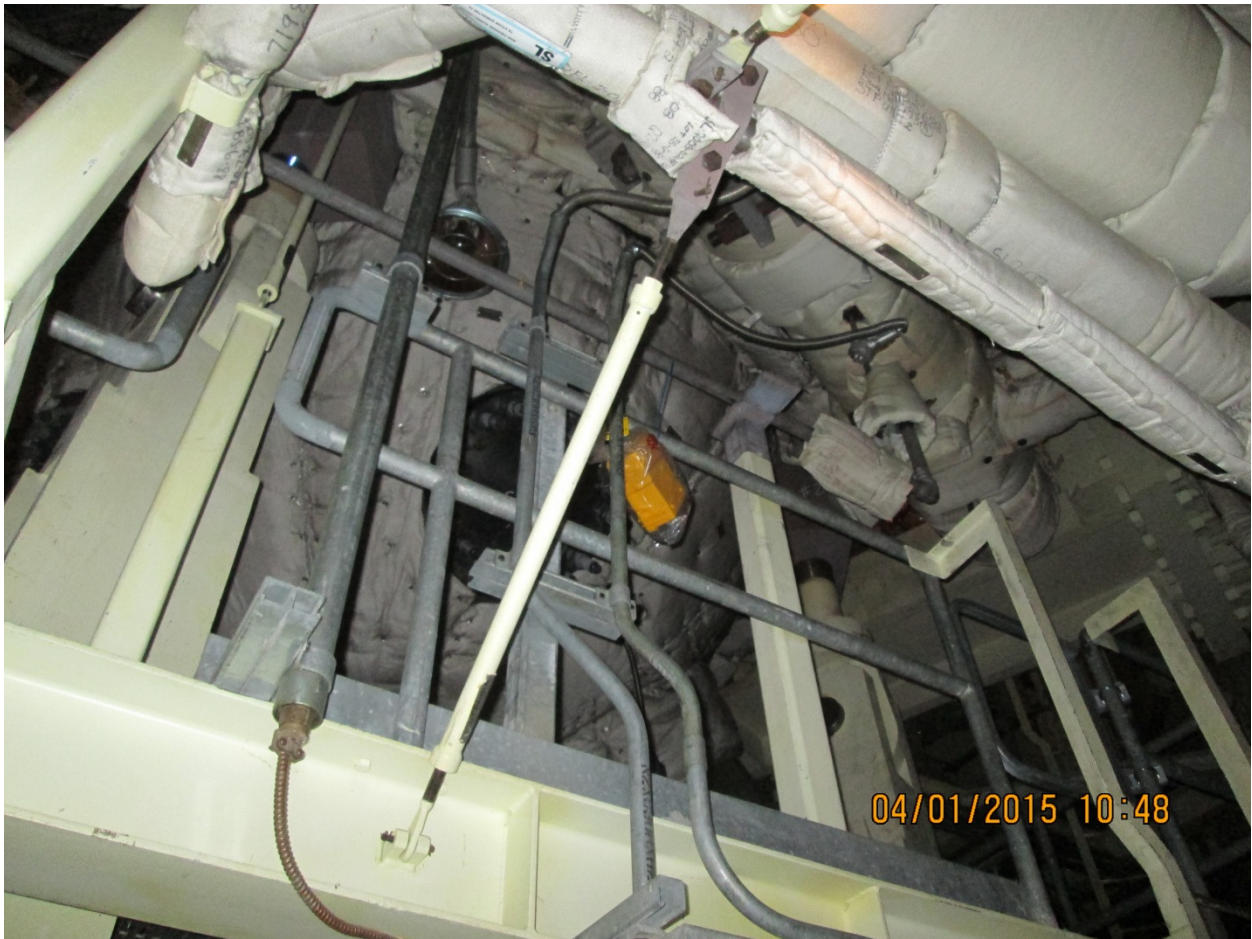
Piping Near Weld Location #2 on Pressurizer Surge Line near Hot Leg

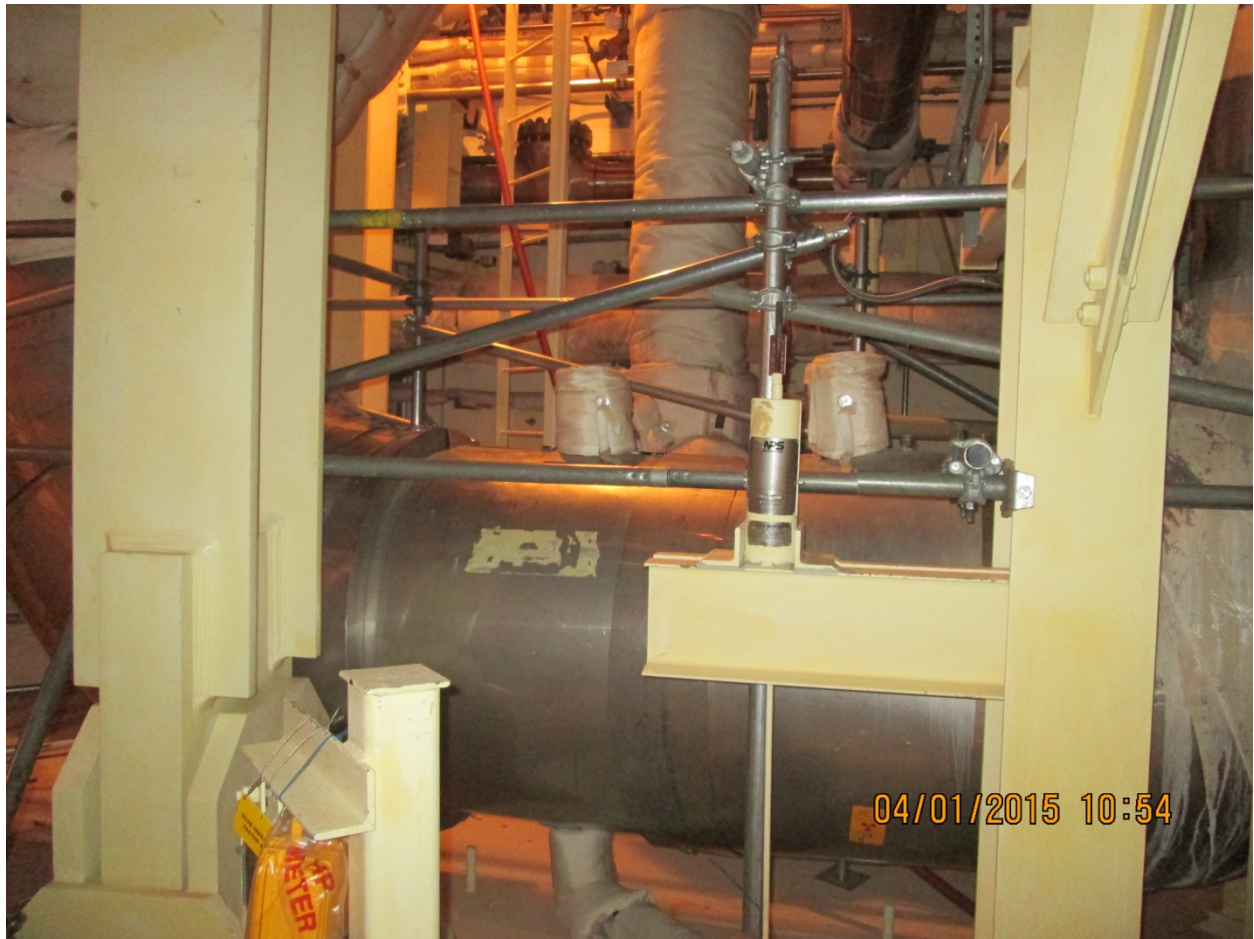
Piping Near Weld Location #1 on Pressurizer Surge Line

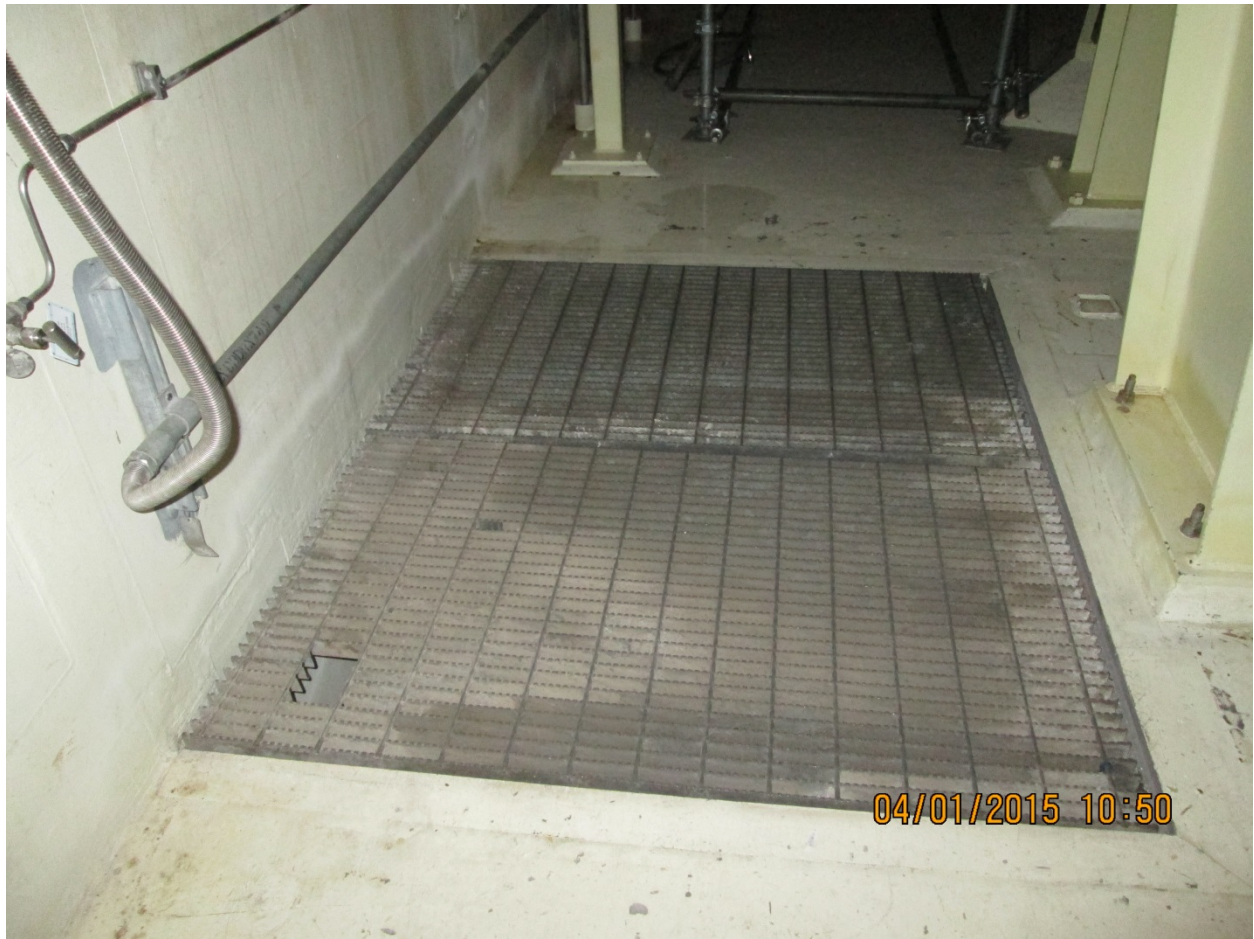
Grating in the floor of containment near observed weld locations

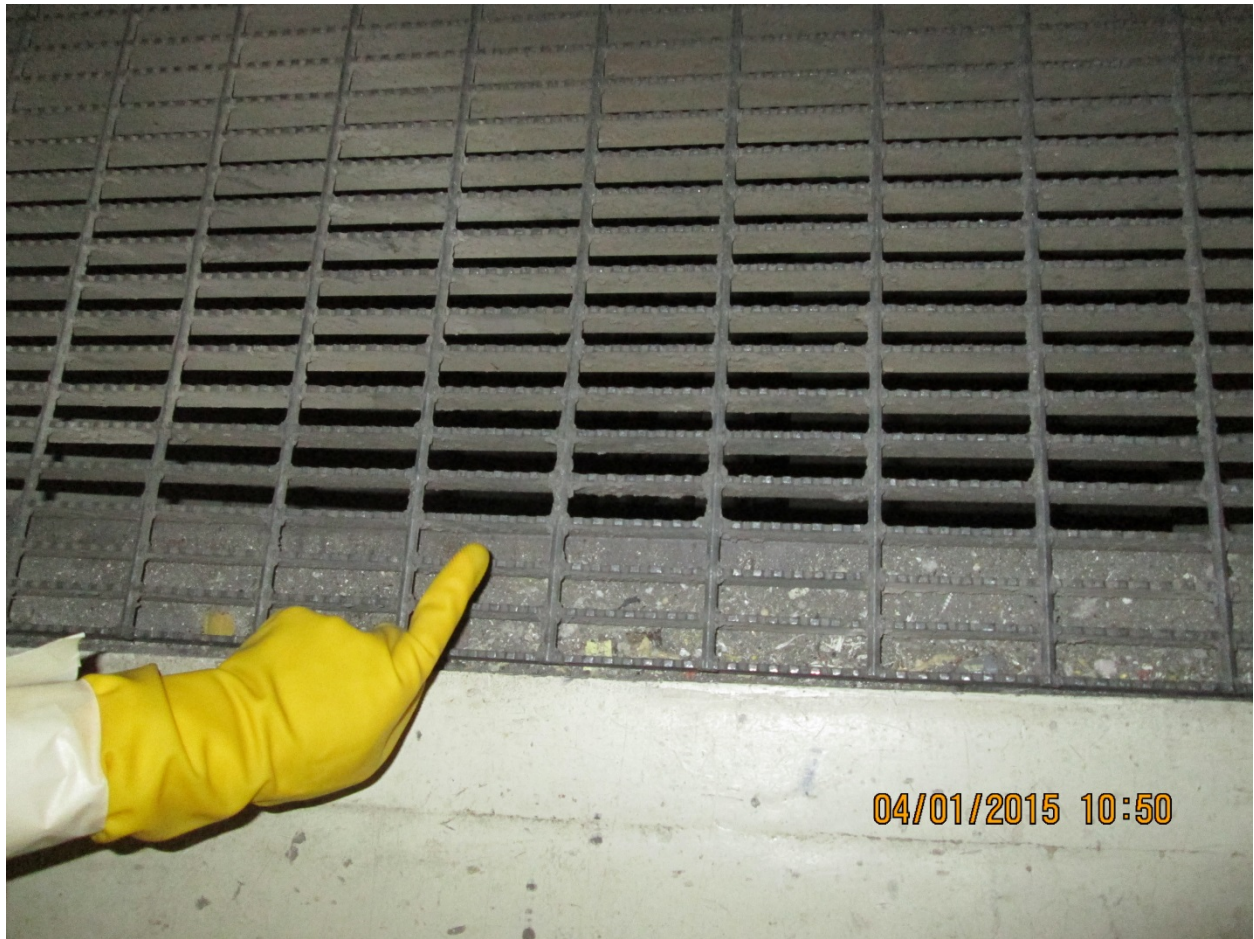
Grating in the floor of containment

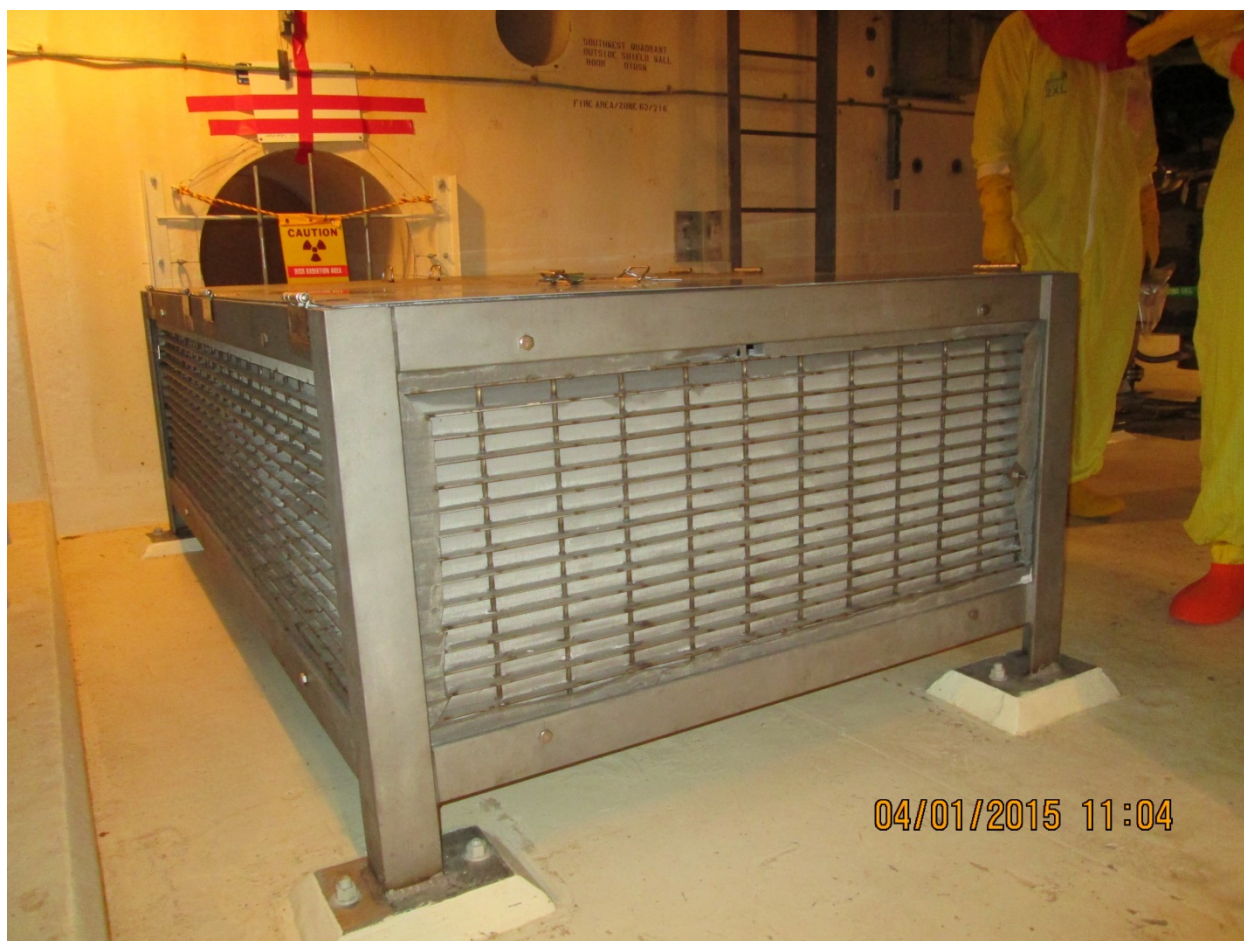
TSP baskets

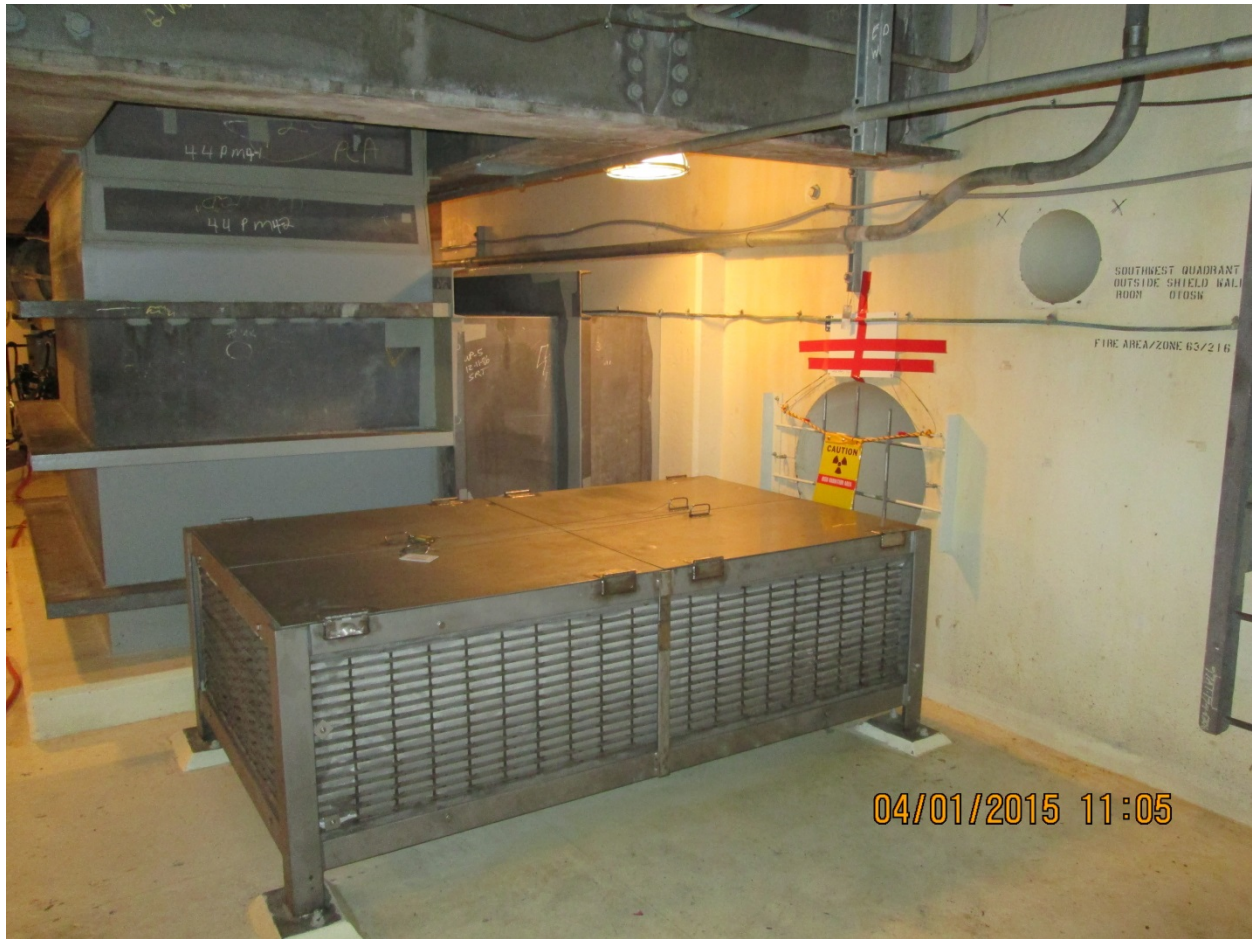
TSP baskets

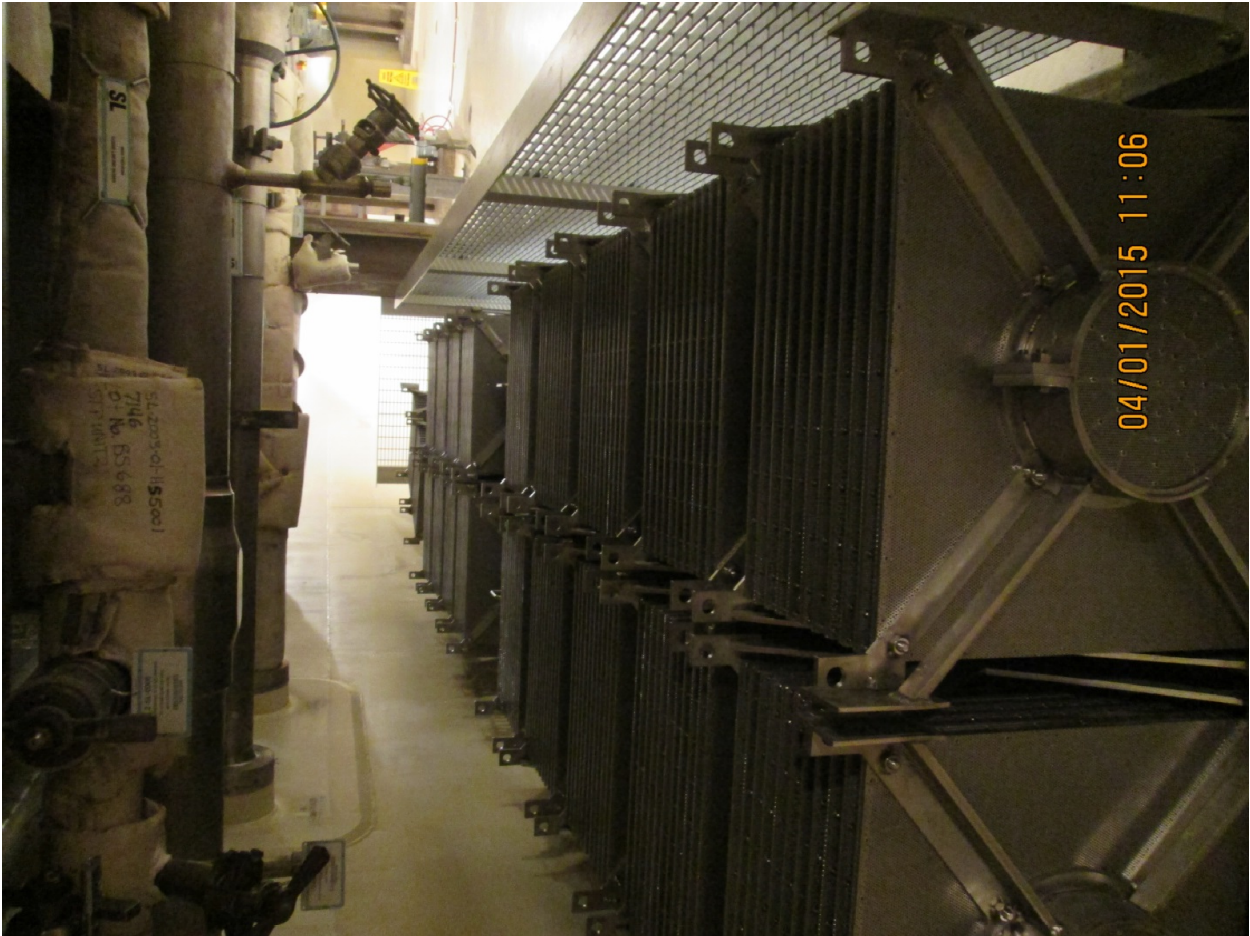
A bay of Recirculation Sump Strainers

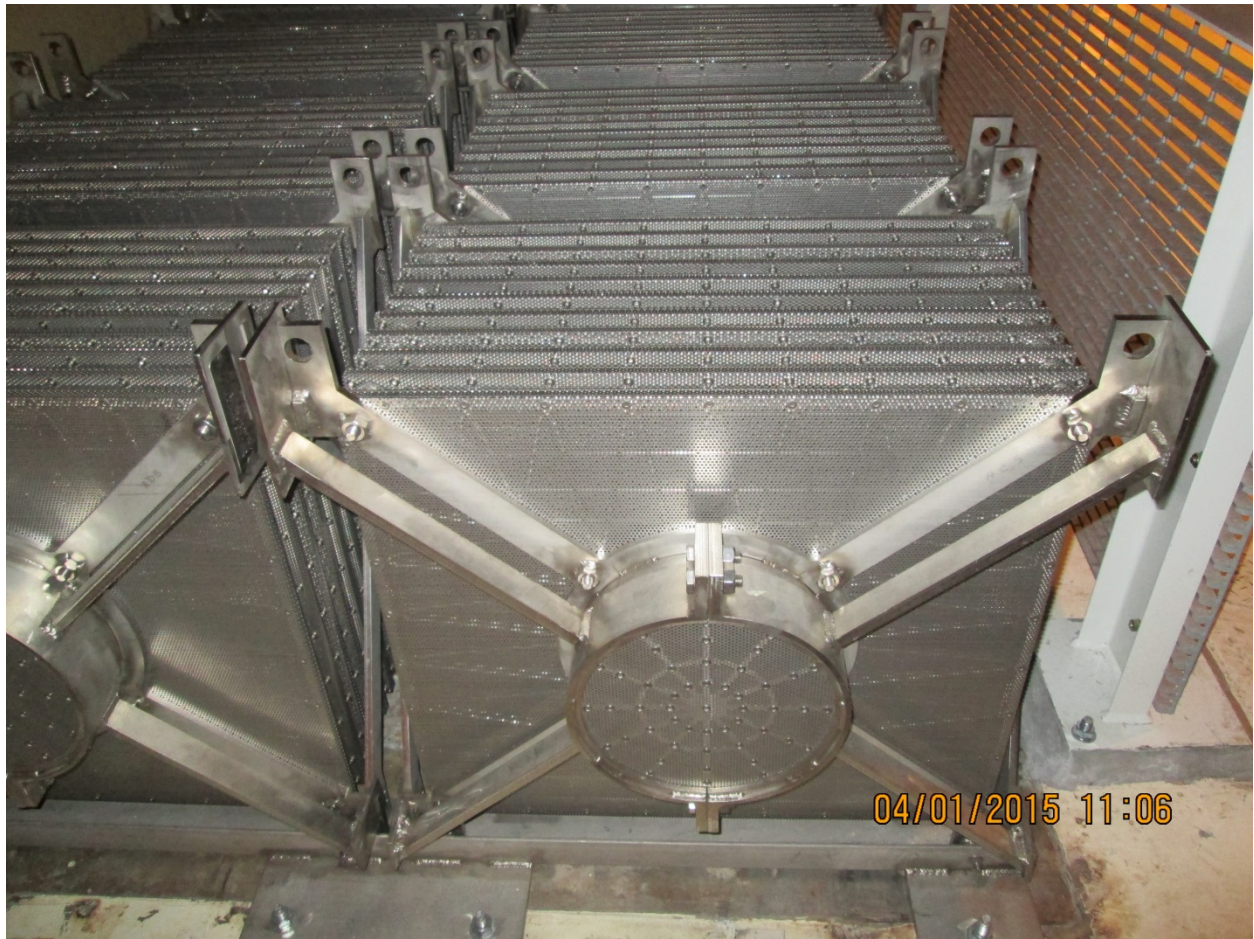
Recirculation Sump Strainers

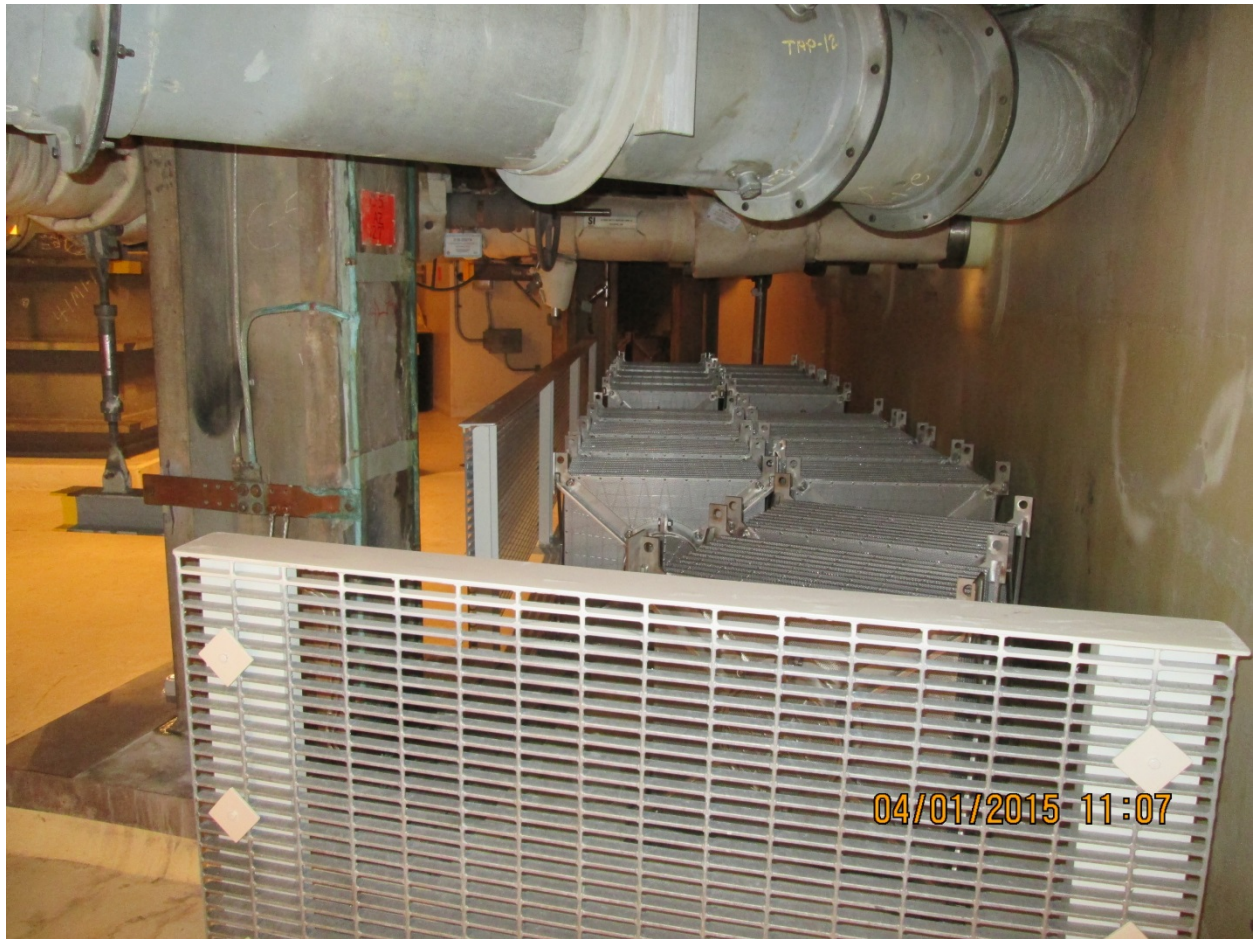
A bay of Recirculation Sump Strainers

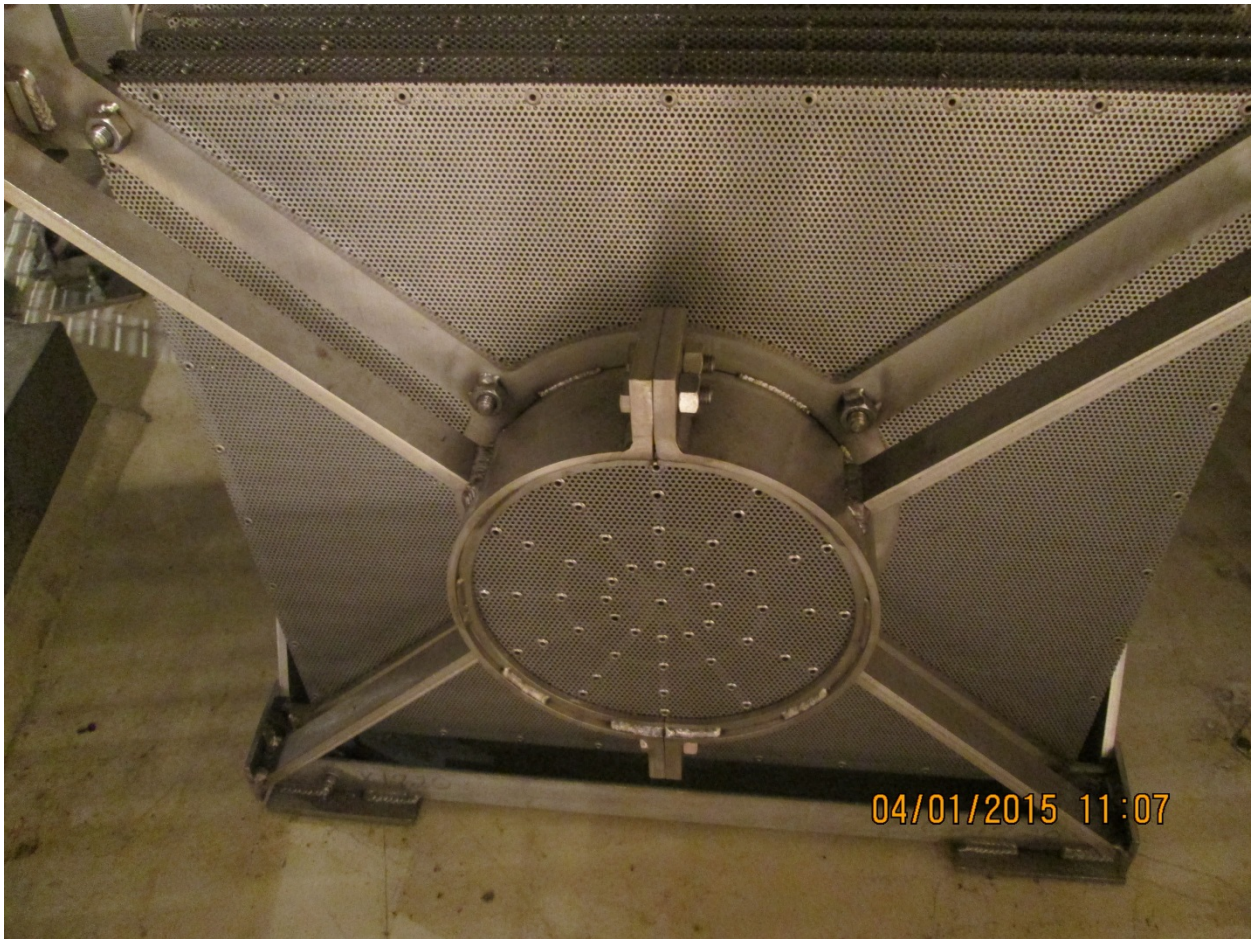
End of a Recirculation Sump Strainer

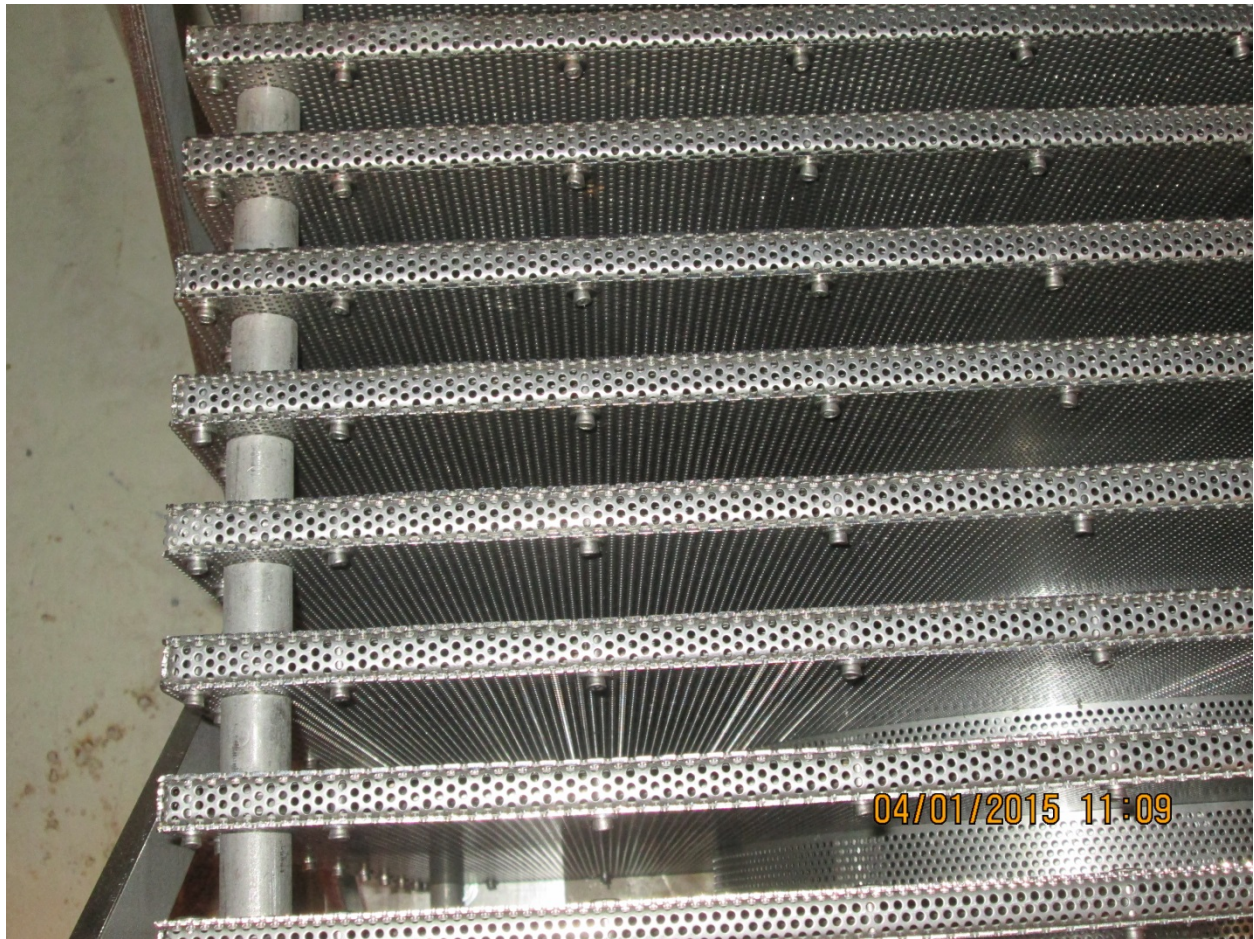
Recirculation Sump Strainers up close

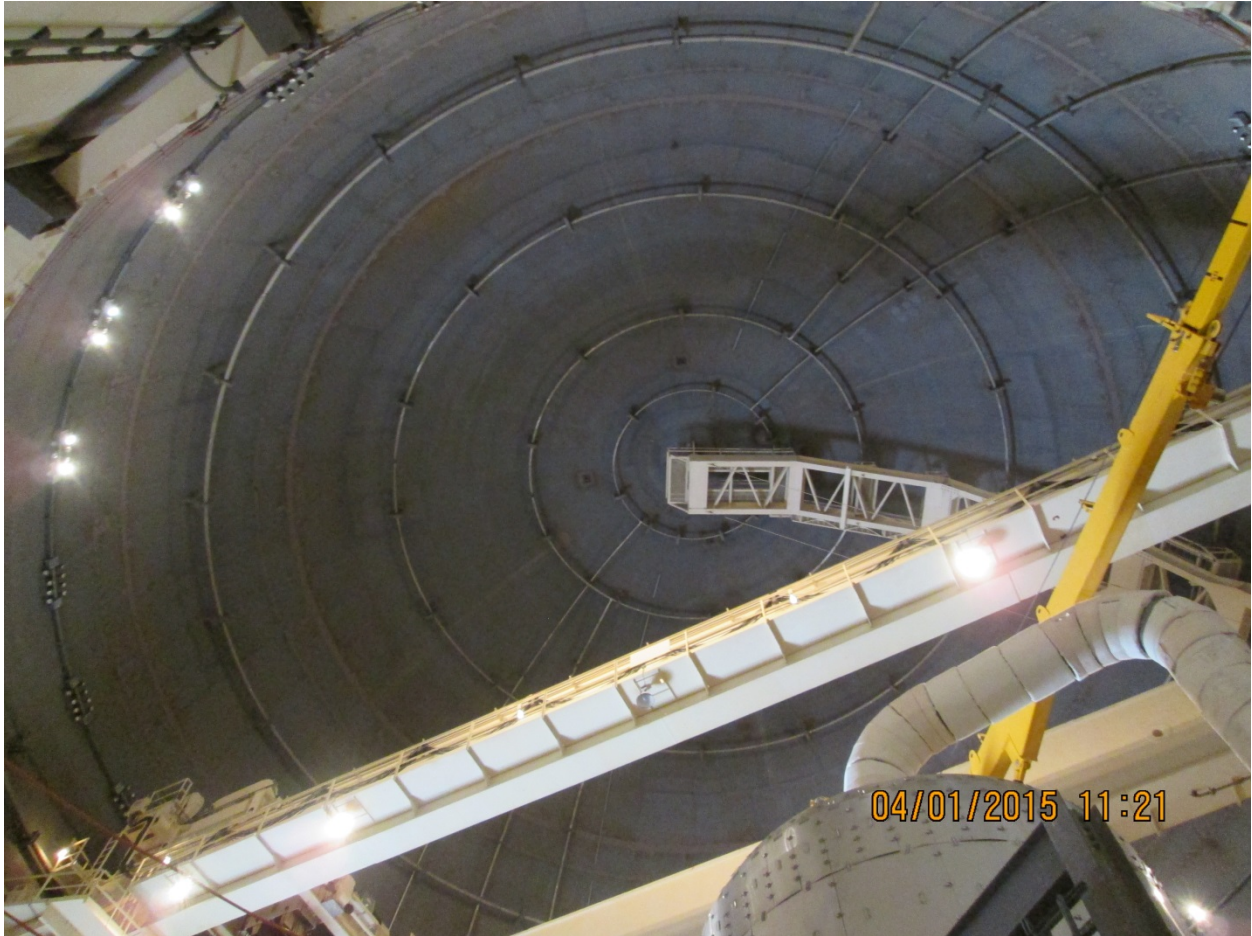
Containment spray ring headers at the top of containment

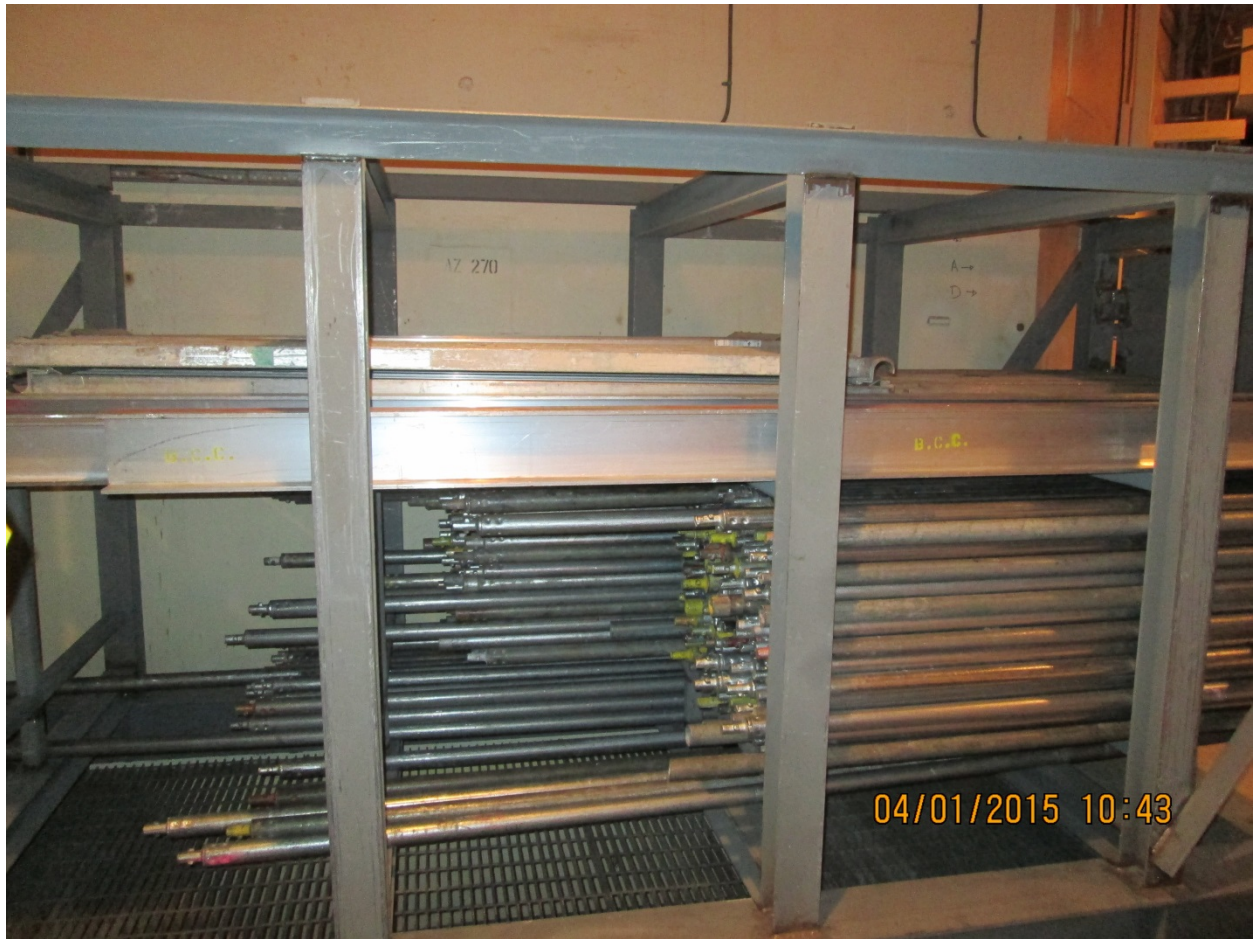
Storage Rack

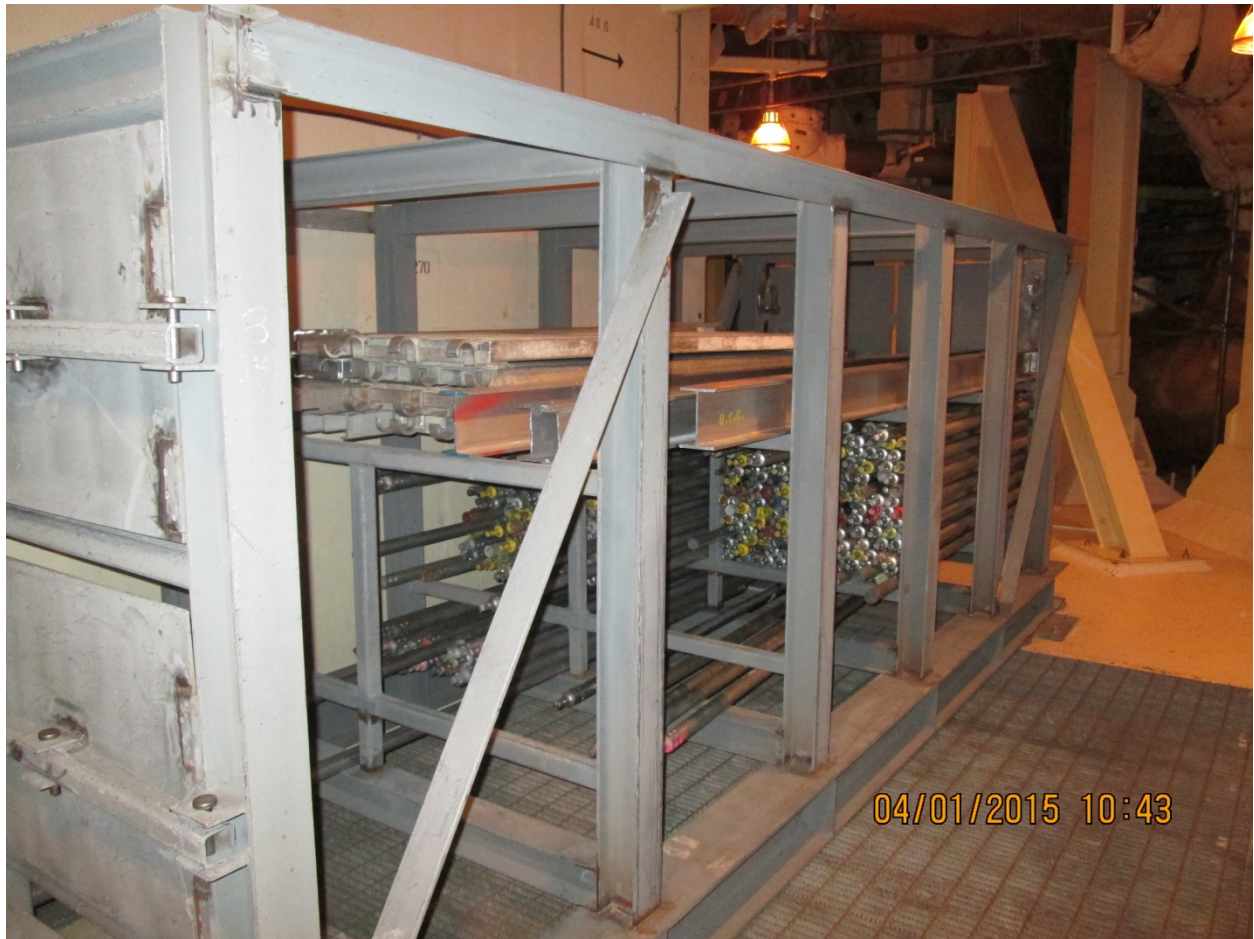
Storage Rack

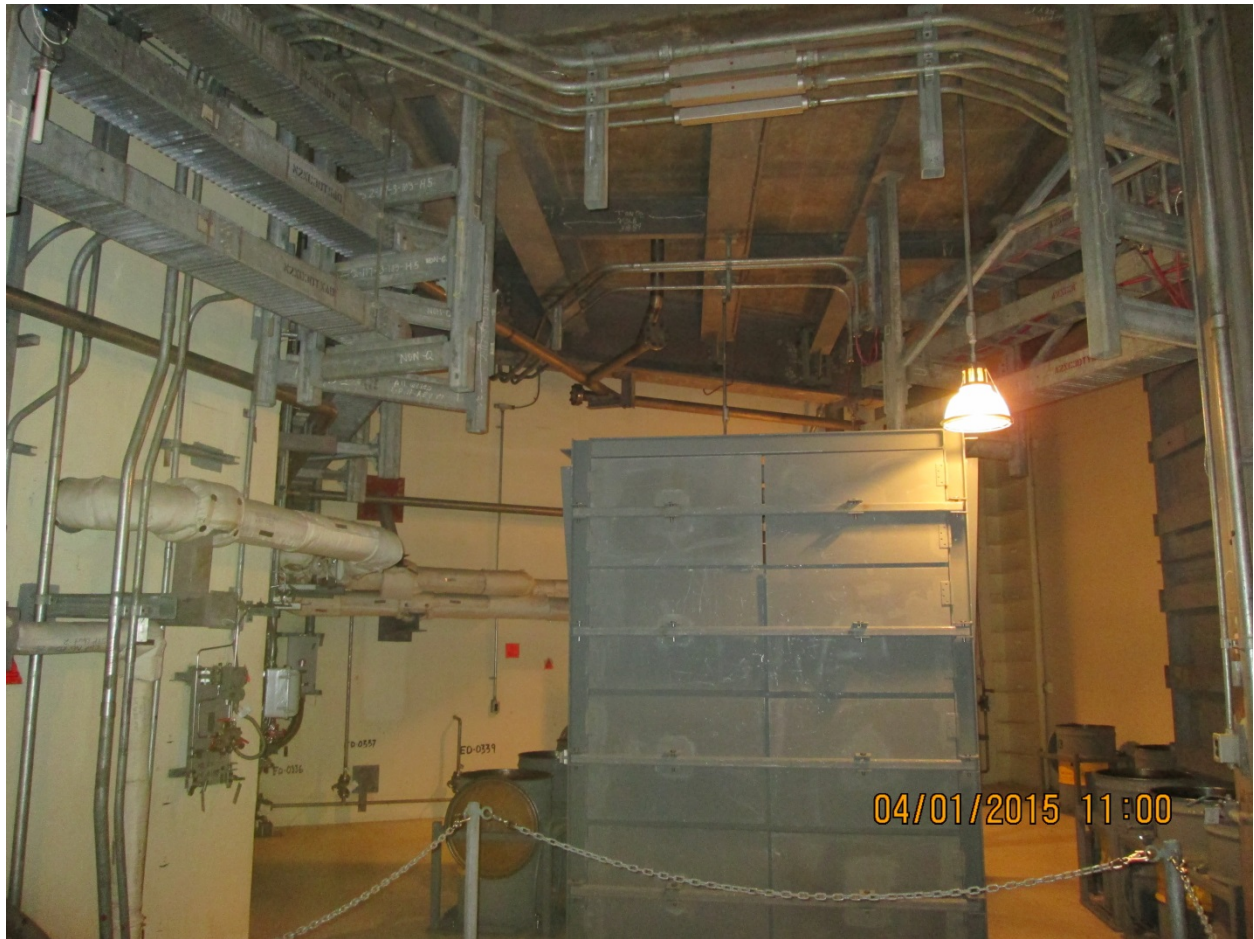
Storage Rack
