TEST PLAN 72-S2 REPORT

MODEL 680-OP

AEA Technology QSA, Inc.
Burlington, MA

This report describes the results of Model 680-OP tests which were performed in accordance with Test Plan 72, Supplement 2. The tests were conducted from 26JAN99 through 30JAN99. The Test Plan specified testing necessary to satisfy the requirements in 10 CFR Part 71 and IAEA Safety Series No.6 for "Hypothetical Accident Conditions", specifically 10CFR 71.73(c)(4) - Thermal Test Requirements. Evaluation of the compliance of the Model 680-OP with these requirements is provided in the Safety Analysis Report.

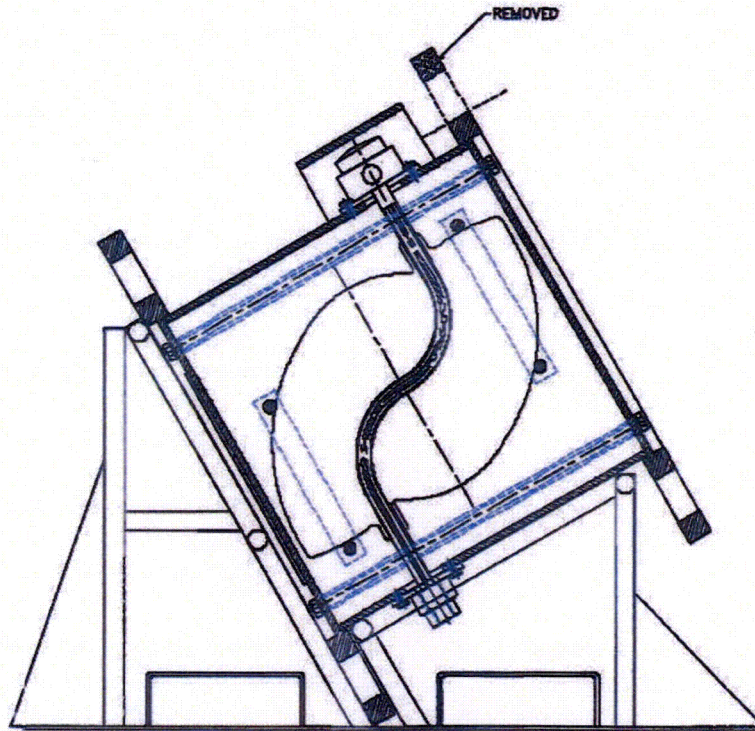
FIGURE 1. SPECIMEN TP72-S1(B) (SN#B198)

The projector was placed in the oven orientated as shown in Figure 1. The unit was supported by a jig constructed of $\frac{1}{4}$ " diameter steel rod, which held the unit in position, but afforded minimal insulation from direct radiation. This orientation was selected based on an assessment of which orientation had the potential to result in the largest relative motion between the shield and the source. (Note that as shown in Figure 1, the top 1 inch of the right side plate was cut off prior to the test. This was done to allow the camera to fit in the test oven and has no impact on the test results.)

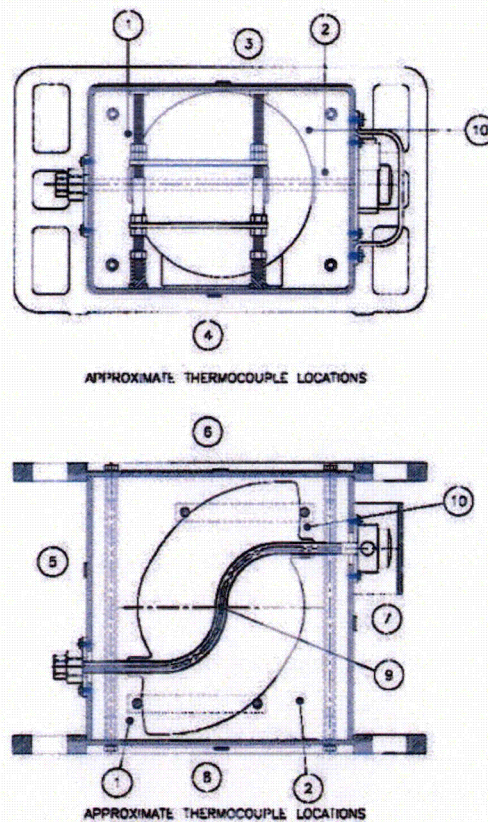
FIGURE 2. THERMOCOUPLE LOCATIONS

Thermocouples were placed on the unit as shown in Figure 2. An additional thermocouple was placed within the oven chamber approximately 8 inches away from the left side of the unit. Readings from this thermocouple were used as the actual oven temperature. The temperature read from the oven controller was recorded at various intervals, but used only as an indication of when the oven coils were powered and not as the documented environmental temperature.

<u>Thermocouple</u>	<u>Initial</u>	<u>Final</u>
3 - Left	800	881
4 - Right	1004	1005
5 - Bottom	804	912
6 - Rear	991	951
7 - Top	912	945
8 - Front	862	924
9 - Source tube	617	924
Oven Ambient	951	800

The temperature of the left side (thermocouple 3) was 800°C when the test time was started, 10° below the stated temperature in the test plan. This side took approximately one (1) minute to reach 810°C. However, the time weighted average of the thermal input to this side far exceeded that required by the regulations, as evidenced by the final temperature. Consistent with the Test Plan, the test time was started when all the shell temperatures (thermocouples # 3,4,5,7) were at 800°C.

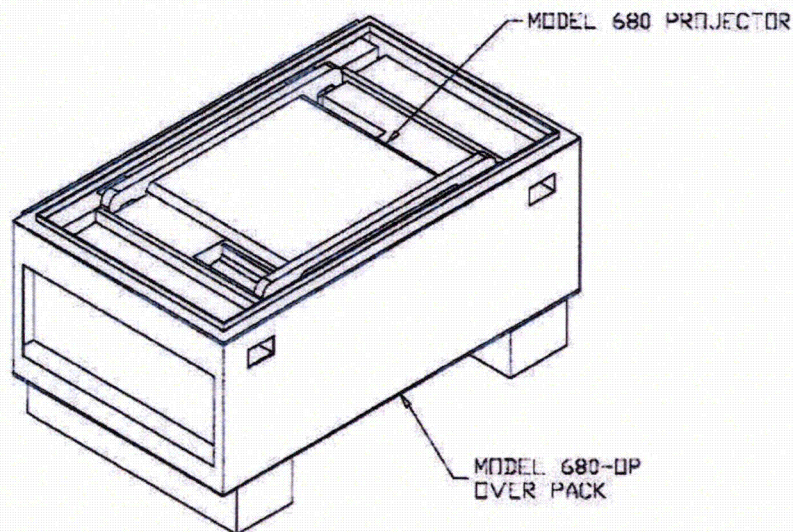
FIGURE 3. SPECIMEN TP72-S1(C) (SN#B199)

The projector was placed in the oven orientated as shown in Figure 3. The overpack was placed length-wise with the short sides toward the back and front of the oven. Information from this orientation is being used to quantify the effects of the combustion of the overpack on the projector temperatures. These results will be used in conjunction with the test of the worst case camera orientation discussed in Section 6.0 to assess the potential combination of a projector in an overpack placed in the worst case orientation.

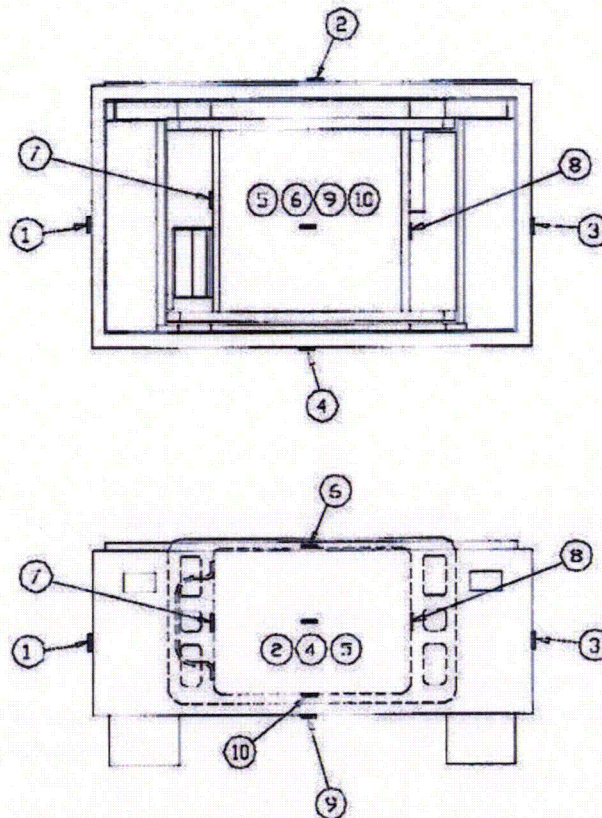
FIGURE 4. THERMOCOUPLE LOCATIONS

Thermocouples were placed on the unit as shown in Figure 4. An additional thermocouple was placed within the oven chamber approximately 8 inches away from the left side of the unit. Readings from this thermocouple were used as the actual oven temperature. The temperature read from the oven controller was recorded at various intervals, but used only as an indication of when the oven coils were powered and not as the documented environmental temperature.

Thermocouple	Initial	Final
1 - Box Rear	1022	974
2 - Box Right	951	920
3 - Box Front	827	840
4 - Box Left	955	926
5 - Source Tube	1004	979
6 - Projector Top	975	959
7 - Projector Rear	991	972
8 - Projector Front	981	964
9 - Box Bottom	800	816
10 - Projector Bottom	990	967
11 - Projector Left	977	960
12 - Oven Ambient	953	919

The temperature of the Box Bottom (thermocouple 9) was 800°C when the test time was started, 10° below the stated temperature in the test plan. The time weighted average of the thermal input to this side did exceed that required by the regulations, as evidenced by the final temperature and the area under the graph. Consistent with the Test Plan, the test time was started when all the external surface temperatures (thermocouples # 1,2,3,4,6,9) were at 800°C.

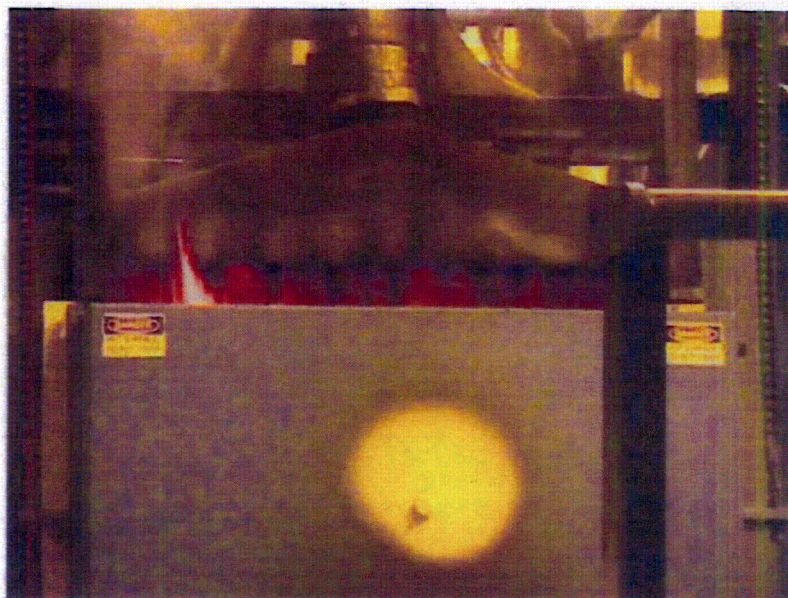
FLAMES FROM SPECIMEN B198 IN OVEN

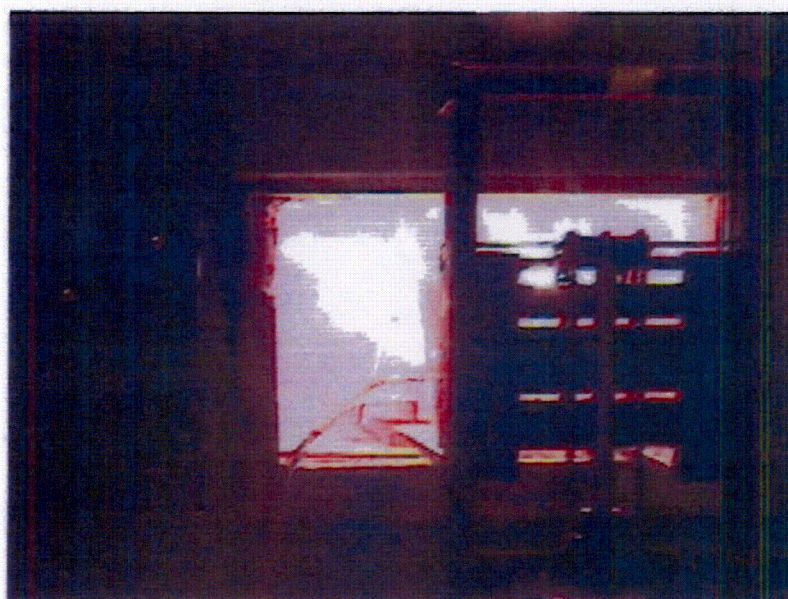
Upon removal from the oven, the gas escaping from the unit continued to burn for about 2 hours. Immediately on removal, two (2) white jets of flame were emanating from the small seam between the side plate and shell on the left side of the projector. These jets died down and extinguished in three (3) to four (4) minutes. The unit was left to self-extinguish. This took an additional time of approximately 125 minutes.

SPECIMEN B198 BEING REMOVED FROM OVEN

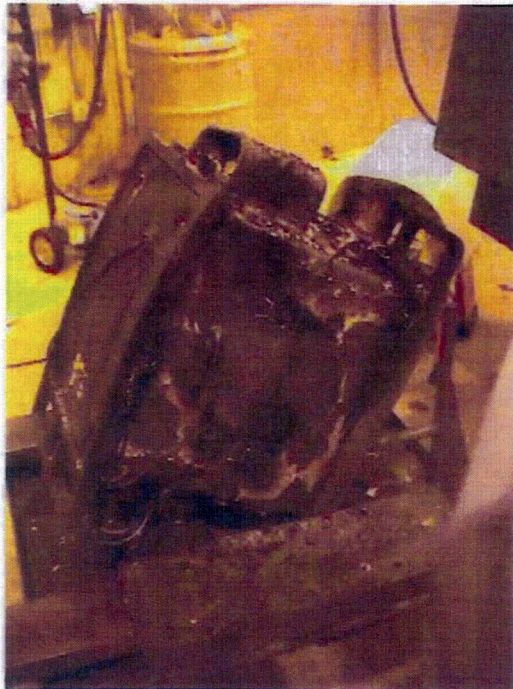
- Most paint vaporized. Radiation labels legible.
- Lead dripping out of bottom of unit.
- Outward bow of upper side plate, and the right and left sides of the shell. This resulted in small 3-4" long by 1/16" wide gaps to form on both sides, at the intersection of the upper side plate and shell.
- Shipping cover and Posilock in place and undamaged. Plunger lock melted.

SPECIMEN B198 EXTINGUISHED

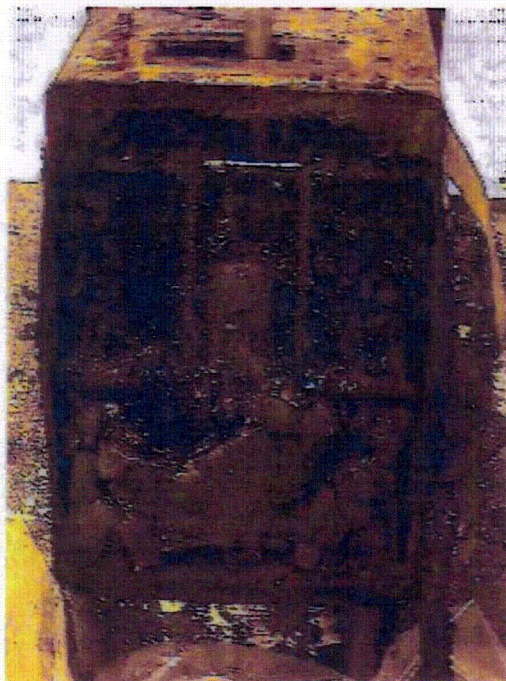
Upon removal of the top side plate it was noted that the carbon char matrix filled approximately 95% of the space the foam had occupied. Partially melted lead sheet was found near the top and sides of the shield. Some molten lead had percolated down to the lower corner and was dispersed throughout the matrix. The lower source tube and lower leveling jig could not be observed, even after removal of most of the carbon char. The lower rod of the upper jig had disengaged from the cleats due to bowing of the shell. However, both upper rods showed essentially no deformation. The carbon char was removed in sections and replaced with Vultafoam to ensure the shield would not move during shipment.

SPECIMEN B198 WITH TOP SIDE PLATE OPEN

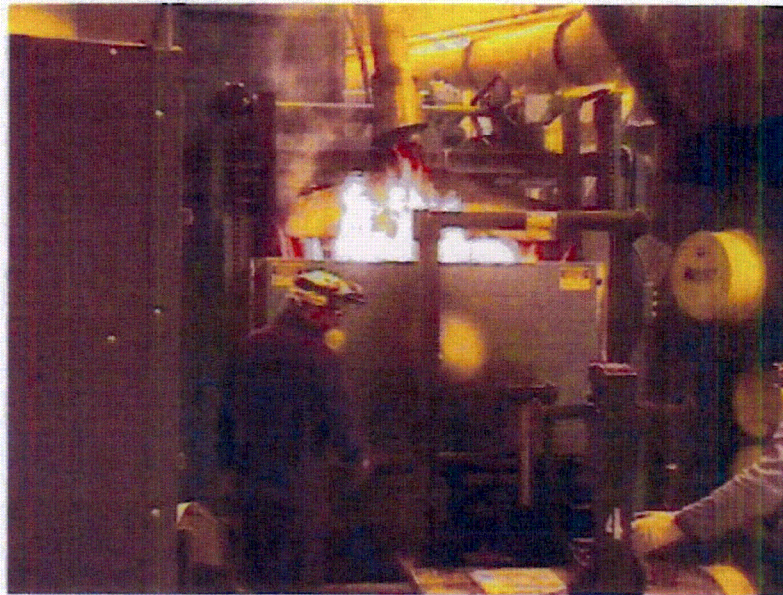
FLAMES FROM SPECIMEN B201 AND OVERPACK

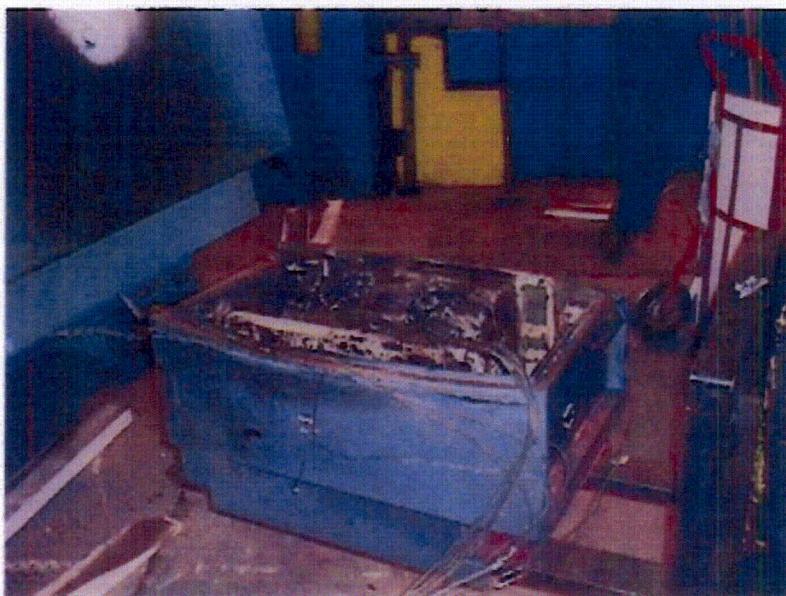
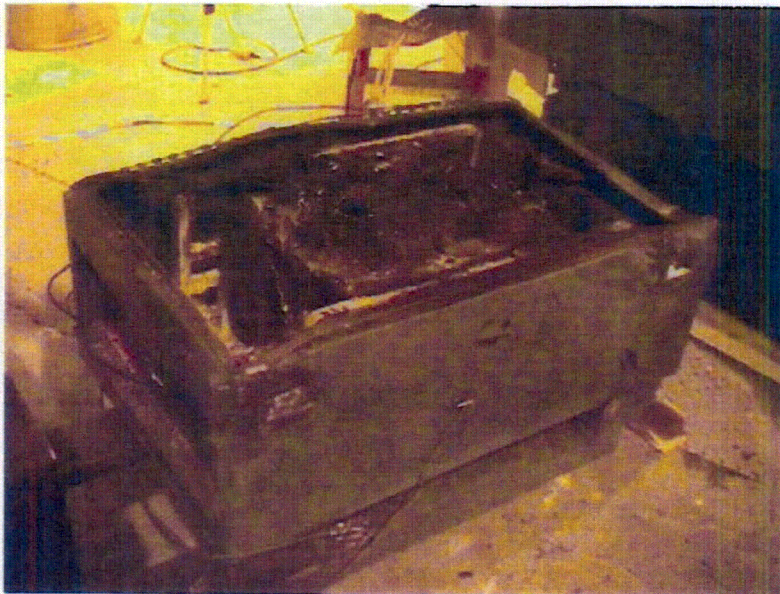
Upon removal from the oven, the packing materials within the overpack continued to burn. After a short time, the flame was limited to the top of the projector, burning only escaping gases from the foam and smoldering wood within the overpack. The unit was left to self-extinguish. This took approximately 245 additional minutes. During most of this time the flame consisted of a very cool, small diffusion fire on the top of the projector and smoldering char within the overpack.

SPECIMEN B201 AND OVERPACK EXTINGUISHED

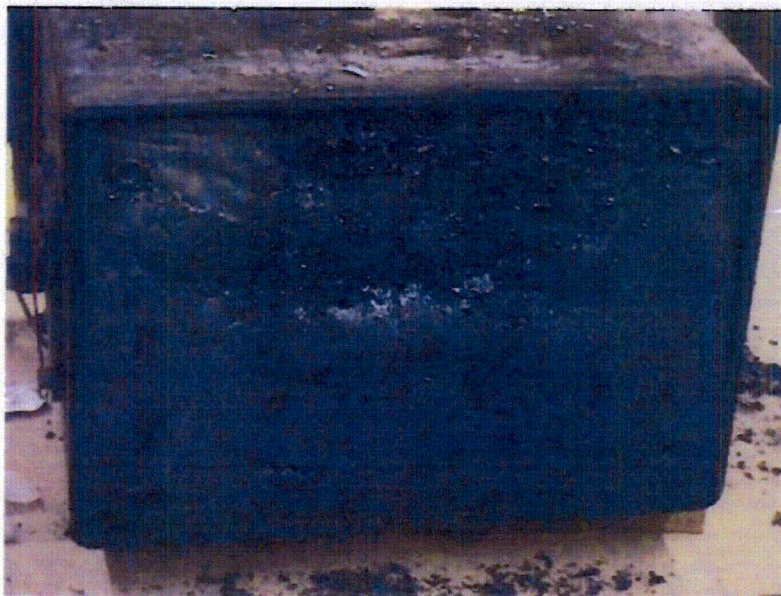
The side plates were removed. The carbon char matrix filled approximately 95% of the space the foam had occupied. The density and resistance to probing of the matrix indicated that the foam had not totally pyrolized. Partially melted lead sheet was found near the top and sides of the shield. Some molten lead had percolated down to the bottom of the projector and was dispersed throughout the matrix. All components showed essentially no deformation.

SPECIMEN B201 WITH SIDE PLATE REMOVED
