appendix B - Lake County Stormwater Management Commission stream inventory photographs

Appendix B includes photographs taken during the Lake County Stormwater Management Commission 2001 stream inventory. Photographs are organized sequentially by reach. The photograph identification numbers correspond to specific Geographic Positioning System coordinates within the watershed, which allows one to review the 2001 conditions in relation to the action plan recommendations (see Appendix H) or to current conditions. Photographs can also be reviewed in relation to the inventory data sheets in Appendix O.

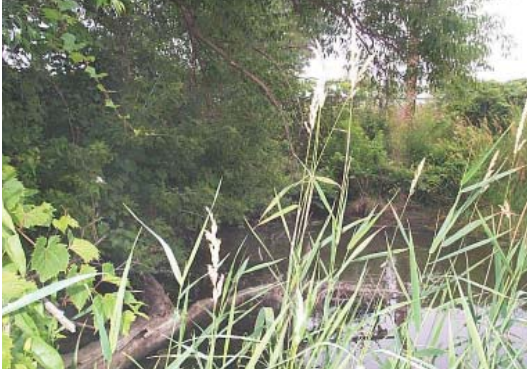
Photo 425 - Lagoon/Marsh

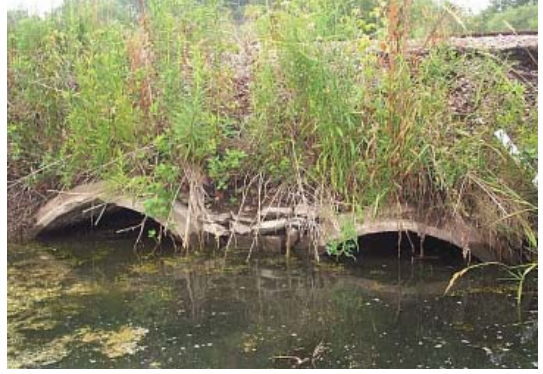
Photo 426 - Culverts under railroad

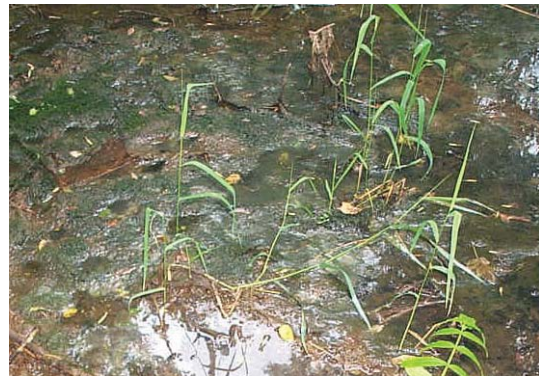
Photo 432 - Oil and grease in water

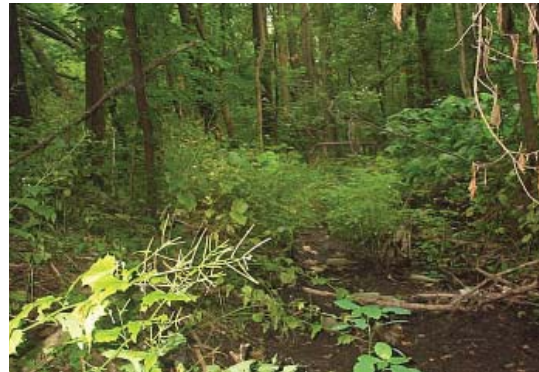
Photo 434 - Open channel with debris

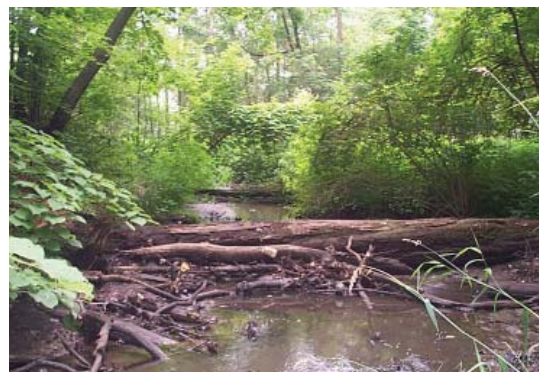
Photo 436 - Debris - log jam

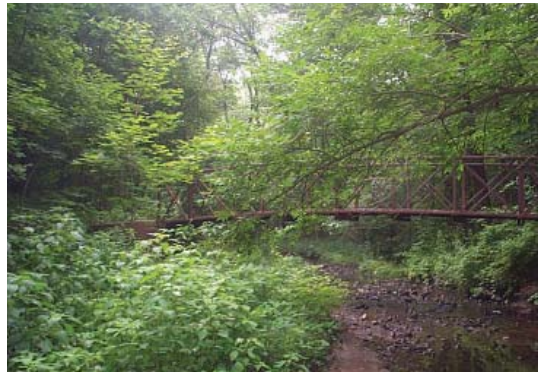
Photo 442 - Bridge

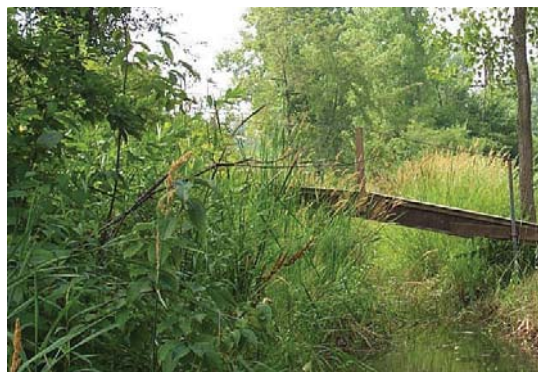
Photo 457 - Bridge (downstream)

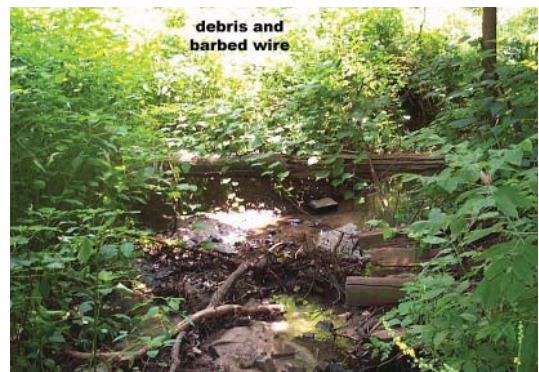
Photo 472 - Debris - barbed wire

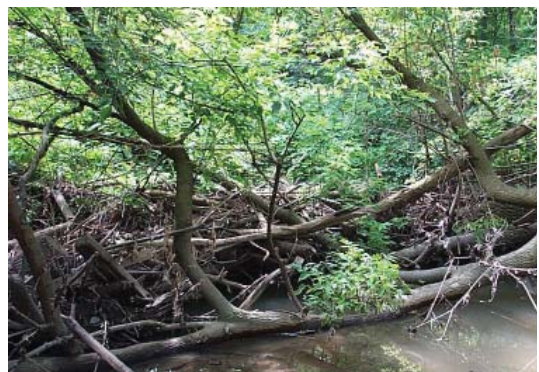
Photo 109 - Debris - log jam

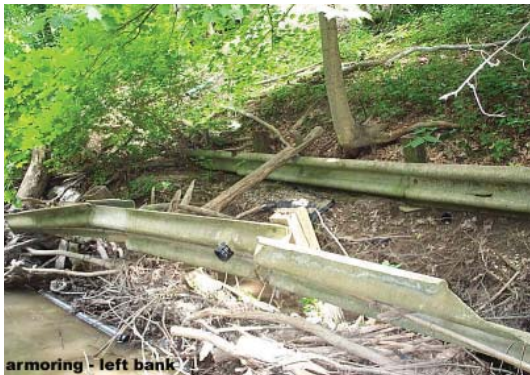
Photo 134 - Armoring - left bank, failed

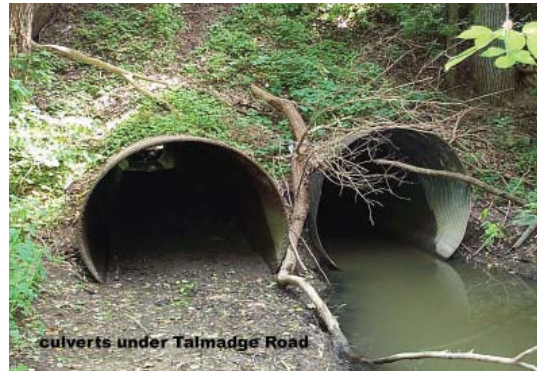
Photo 143 - Culverts at Talmadge

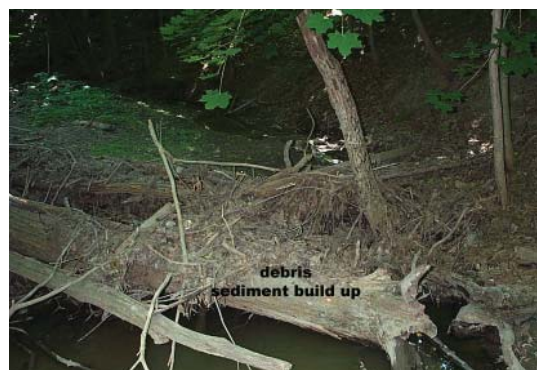
Photo 158 - Debris - sediment build up
