**MRP** Materials Reliability Program \_\_\_\_\_ MRP 2015-025

SUBJECT: EPRI-MRP Interim Guidance for Management of Thermal Fatigue

### NEI 03-08 Needed and Good Practice Interim Guidance for Management of Thermal Fatigue

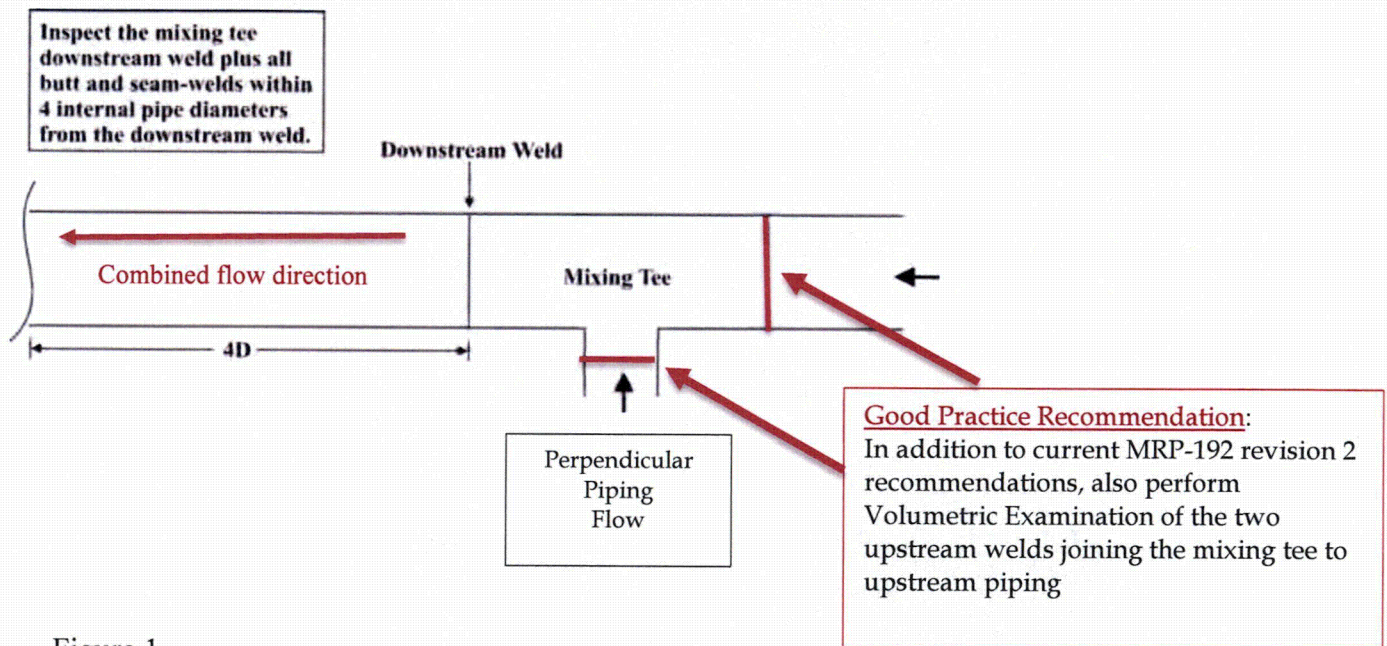
Figure 1

MRP-192 Section 3 specifies examination volumes that include the mixing Tee downstream weld, and all other welds within 4 pipe diameters downstream of the mixing Tee weld. Non-destructive and destructive examinations performed following recent OE identified cracking in the perpendicular branch inlet pipe to the mixing Tee. Computational simulations of thermal transients in mixing Tees have also observed relatively large magnitude thermal cycles in the upstream pipe inner surface. The extent to which thermally stratified eddies penetrate upstream piping is dependent on flow velocities and Mixing Tee geometry. It is possible that under low branch flow conditions, cracking could initiate at upstream piping welds. Based on these observations, the recommended MRP-192 examination volume specified in Section 3 is being expanded to include areas of observed and potential cracking.

Revised volumetric examination recommendations.

In addition to the examination volumes specified in Section 3 of MRP-192, Revision 2, it is recommended that future MRP-192 examinations also include the Mixing Tee weld to the upstream piping as shown in Figure 1.

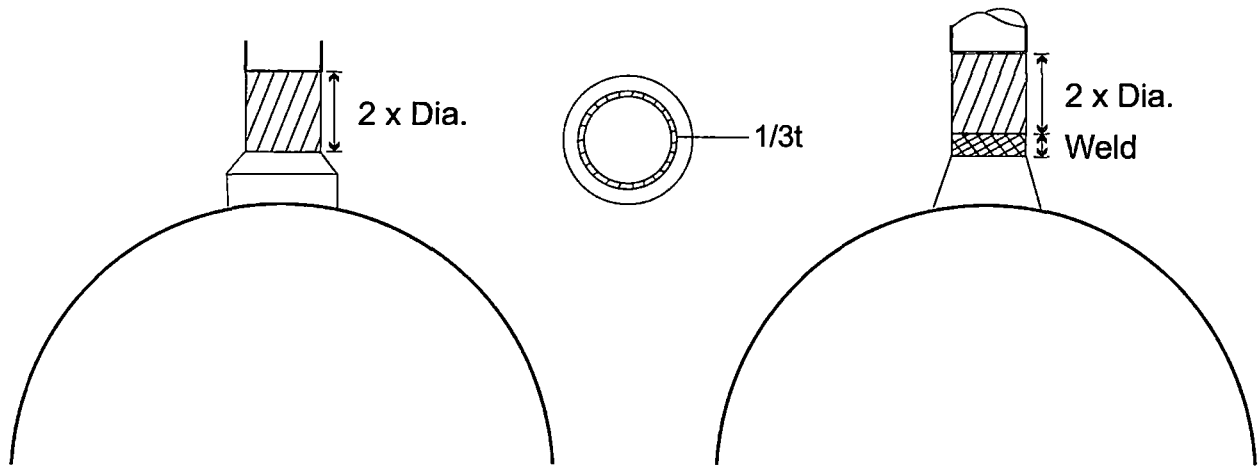
**Figure 2**

Up Horizontal (UH) piping with NPS of 2-inches and smaller was observed to be resistant to turbulent swirl penetration in mockup testing and simulations underlying the current MRP-146 guidance. This resistance to development of swirl penetration in the vertical pipe was assumed to result in resistance to thermal fatigue associated with cold in-leakage. MRP-146 Section 2.1.1 excludes examination requirements for vertical piping based on this presumption. However, in two recent operating events, cracking was discovered in 1 ½ inch NPS lines that had been excluded from examination requirements under MRP-146 Section 2.1.1 screening criteria. This recent OE has revealed an unanticipated mode of thermal cycling and cracking that also occurred at an unexpected location in the vertical pipe to RCS nozzle interface.

> 90% Base Metal (includes elbow)  
> 90% Weld (Fig. 2-16)

Detailed view of the additional examination volume for Up Horizontal configured branch lines between 1 and 4 inches NPS that also have potential for in-leakage.

Normally stagnant UH piping, with nominal pipe sizes greater than 1-inch NPS and not larger than 2 -inches NPS and having a potential for cold in-leakage shall be examined every refueling outage commencing with the first refueling outage starting after June 1, 2016. Examinations shall conform to the requirements of MRP-146 as augmented in this Interim Guidance letter. The examination volume shall include the areas described in Section 2.4.2.1 of MRP-146, the pipe to nozzle (butt) weld and the vertical pipe base metal up to two pipe diameters above the weld or to the elbow if it is less than 2D from the weld as shown in figure 2. Examination of socket welds is not required.

Up-Horizontal (UH) normally stagnant piping with nominal pipe sizes (NPS) of between 2 and 4 inches and having the potential for cold in-leakage, shall be examined using the examination requirements of MRP-146 as augmented in this Interim Guidance letter. This one-time examination shall include the pipe to nozzle (butt) weld, and the vertical pipe base metal up to 2 pipe diameters above the weld or to the elbow if it is less than 2D from the weld as shown in figure 2. Examination of socket welds is not required.
