SUBJECT: NRC REACTIVE INSPECTION REPORT NO. 03001579/2015001(DNMS) –
ST. VINCENT HOSPITAL & HEALTH CARE CENTER

Docket No.	030-01579
License No.	13-00133-02
Report No.	03001579/2015001(DNMS)
NMED No.	150206 (Open)
Licensee:	St. Vincent Hospital & Health Care Center
Facility:	2001 West 86 th Street Indianapolis, Indiana 46260
Inspection Dates:	April 20 through 21, 2015, with continued in-office review through June 12, 2015
Exit Meeting Date:	June 12, 2015
Inspectors:	Deborah A. Piskura, Senior Health Physicist Luis A. Nieves Folch, Health Physicist
Approved By:	Aaron T. McCraw, Chief Materials Inspection Branch Division of Nuclear Materials Safety

St. Vincent Hospital & Health Care Center NRC Reactive Inspection Report 03001579/2015001(DNMS)

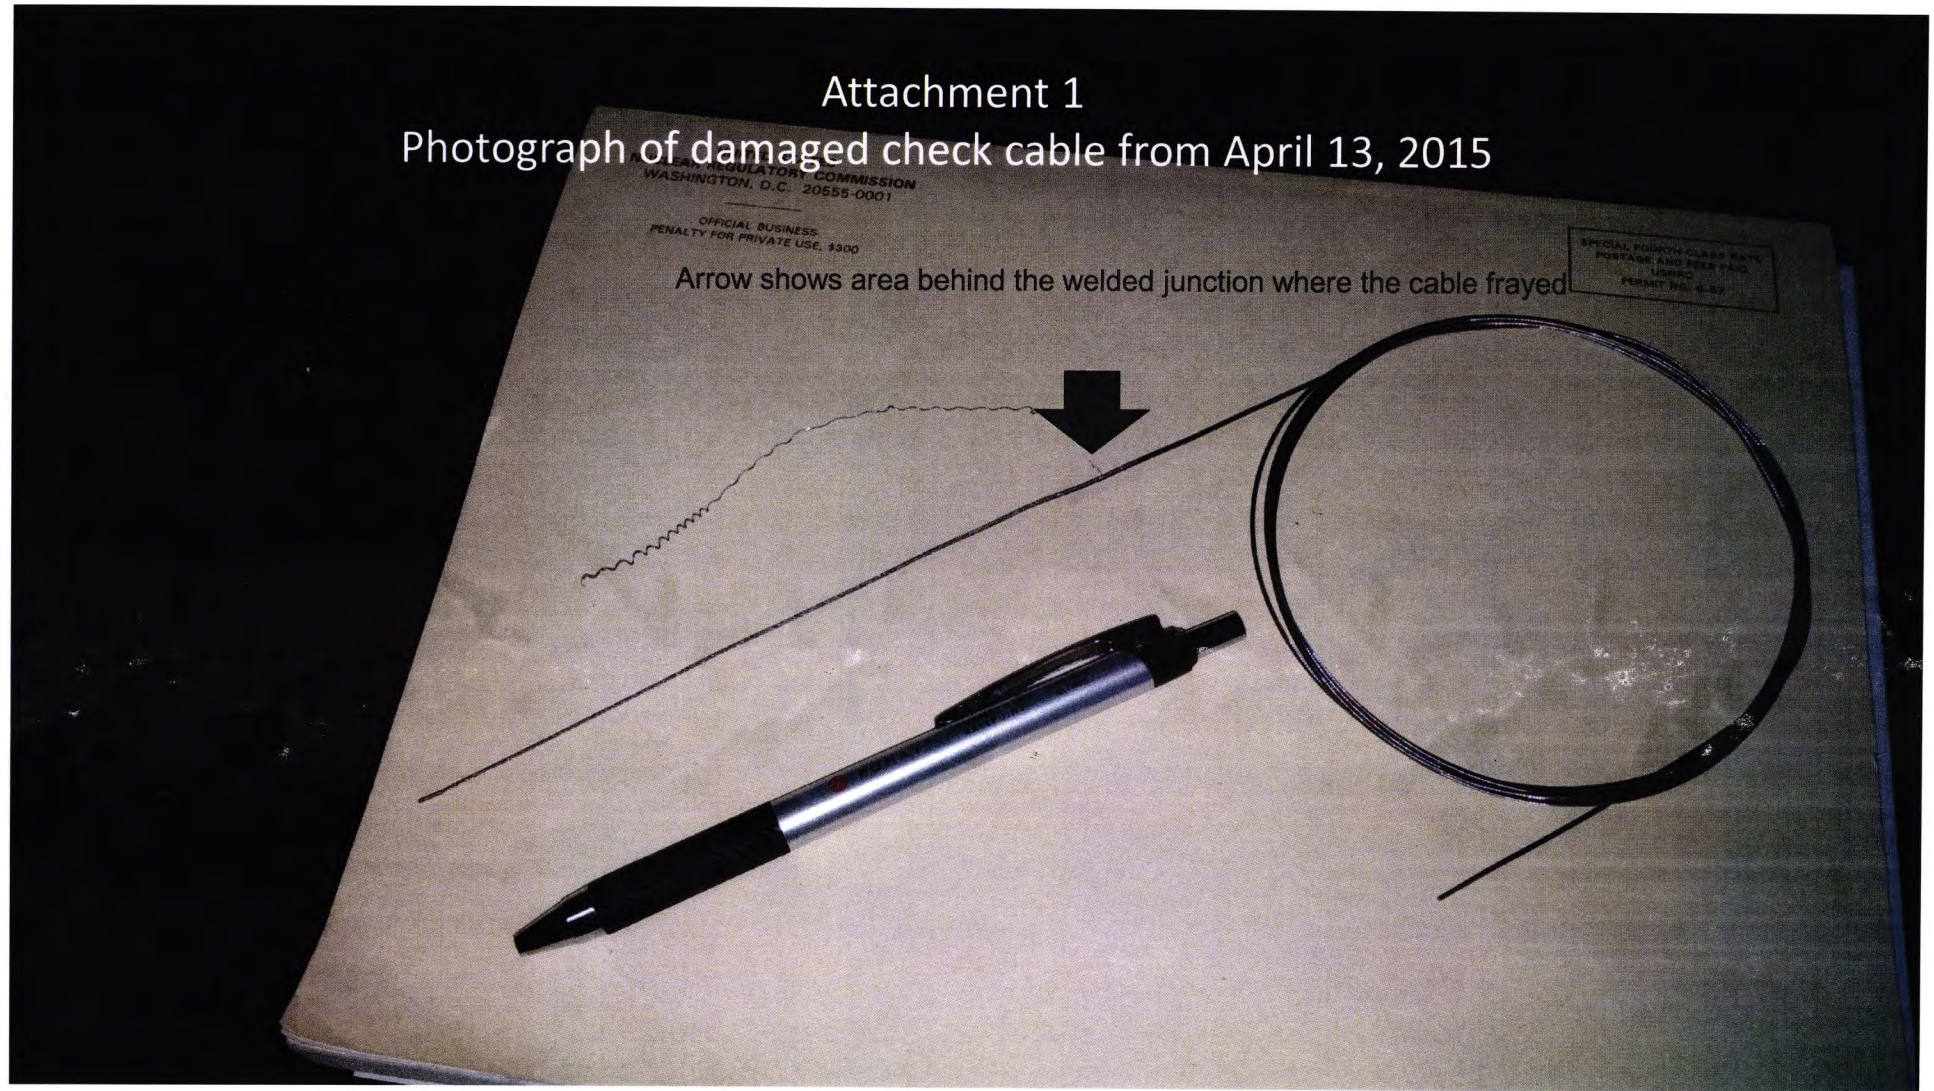
Attachment 1

The licensee contacted the vendor who dispatched a field service engineer to the hospital on April 14, 2015. Examination of the check cable found that it was frayed with one strand of wire unraveled from the braided cable and separated, breaking off and leaving a small tail of wire. The fray/break was located approximately 0.5 centimeters behind the welded junction (see Attachment 1). The field service engineer replaced the damaged check cable.

Photograph of damaged check cable from April 13, 2015

Arrow shows area behind the welded junction where the cable frayed

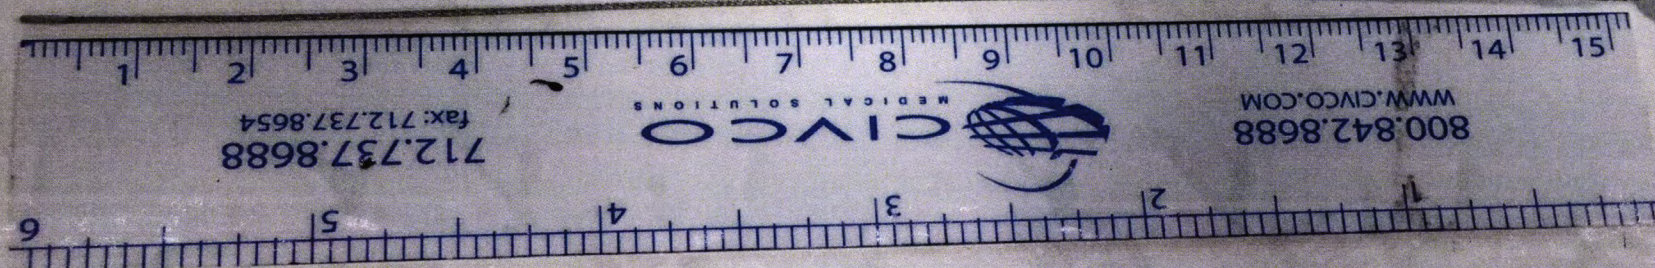
Attachment 2

During the reactive inspection, the licensee revealed that there was a prior instance of a damaged check cable. A field service engineer discovered damage to the check cable during a routine source exchange on November 7, 2014. The field service engineer identified damage to the check cable at a small area located approximately 0.5 centimeters behind the welded junction. Upon visual examination, the cable was characterized as “bulging” and frayed. The licensee provided a photograph of this damaged cable to the inspectors (see Attachment 2). The field service engineer replaced this damaged check cable.

Photograph of damaged check cable from November 7, 2014

Area showing bulging on the check cable just behind the welded junction

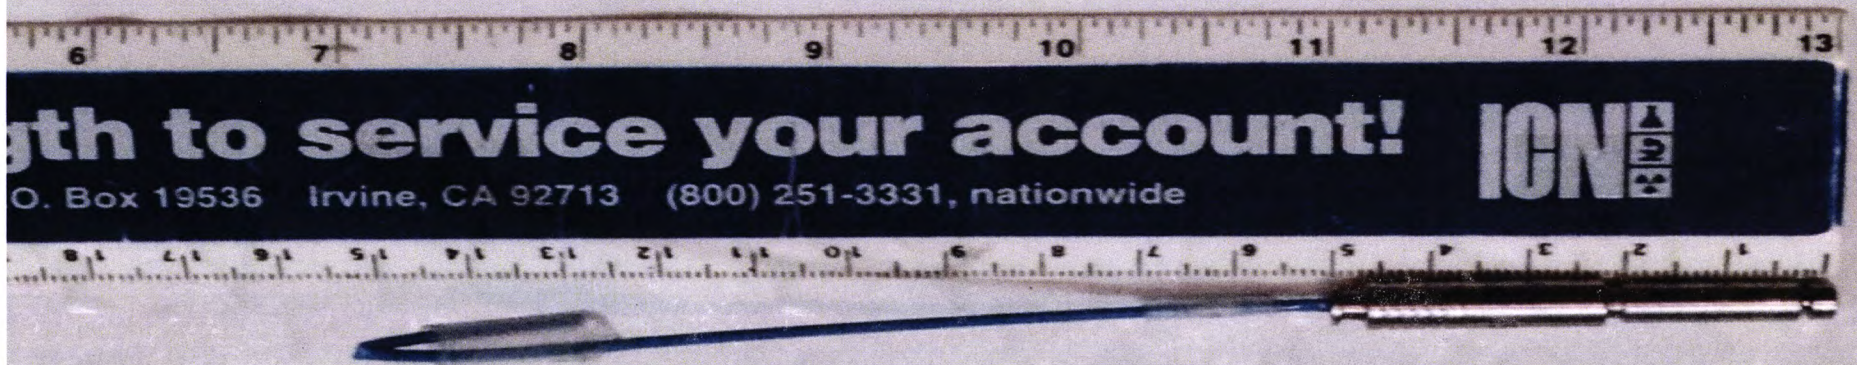
Attachment 4

The licensee provided a photograph of the jig used at the main hospital in the daily obstruction test (see Attachment 4). The licensee staff stated that this method of performing the daily obstruction test has been in place since their tenure. The licensee staff could not provide an explanation how this test originated or who designed this jig. The jig consisted of a lumen catheter fastened to a connector which seats in the HDR unit channel. The catheter is approximately 11 centimeters in length with the distal end bent backwards and taped. The results of this obstruction test are recorded in the HDR treatment computer.

Jig used to conduct daily "obstruction" test

During a teleconference on June 2, 2015, the Radiation Safety Officer informed the inspectors that the hospital elected to cease performing an obstruction test on its HDR units. The licensee stated that it would visually examine the check cable at biweekly intervals for any indications of damage.
