**From:** Advanced Isotopes <nukedoses@gmail.com>  
**Sent:** Monday, June 15, 2015 12:22 PM  
**To:** Katanic, Janine  
**Subject:** Re: Evaluation of Iodine Room at Advanced Isotopes  
**Attachments:** NRC Inspection Response Revised (1).doc; Current I-131 Room Diagram.jpg; Anemometer.pdf; Biodex Hood.pdf

June 15, 2015

We greatly appreciate the opportunity to address any potential items of concern found during your inspection of our pharmacy on May 18, 2015. I have attempted to address your concerns one by one below:

# **I-131 Room Hood** **Flow and Air Control**

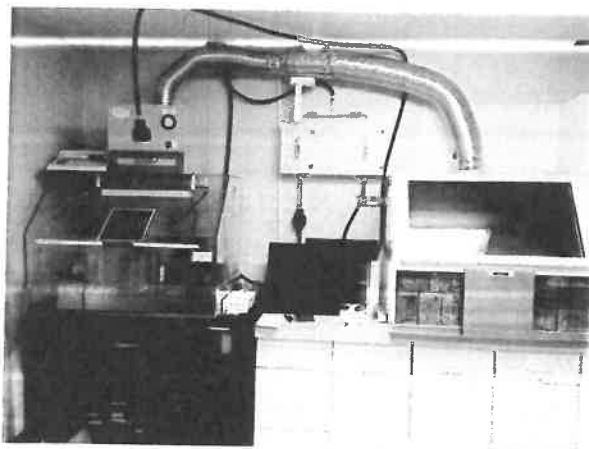
1. What is there on site currently is not what was submitted to NRC in the license application, so the facilities are not as described in the application.

There were modifications made by the previous RSO to allow for the incorporation of a dose calibrator into the I-131 hood, as well as a light fixture inside the hood. These modifications should have been reported, and the modifications were not made in a manner consistent with keeping exposures ALARA. When we asked our consultant to review the setup, he was unaware that this was not what was submitted to the NRC in the license application.

The current setup is diagrammed in the attachment labeled "Current I-131 Room Diagram." I have included a photo below for reference:

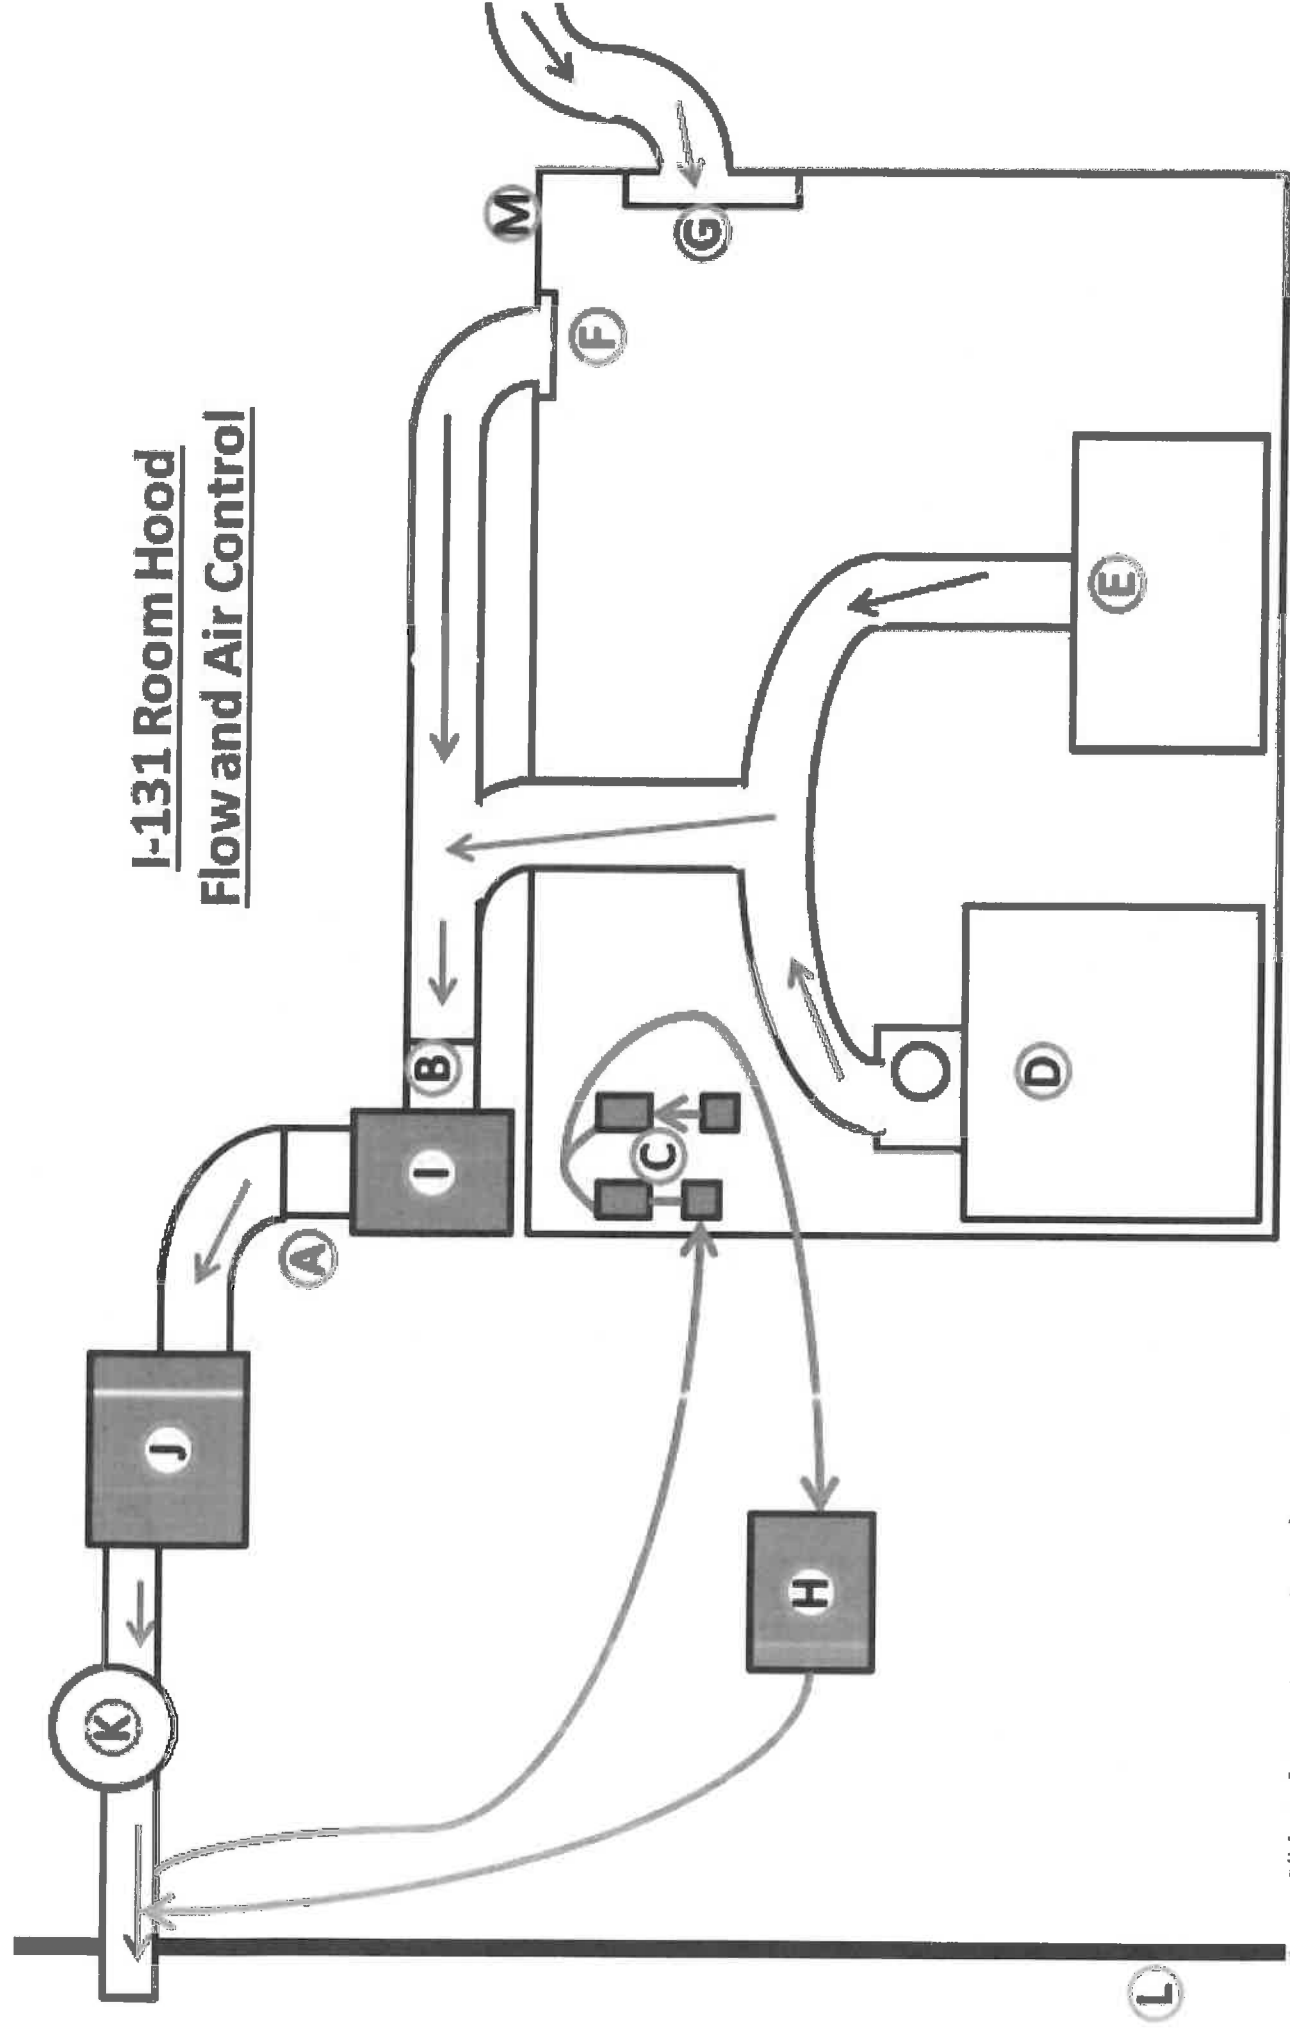
On page 2, it is noted that there is "a pipe with a diameter of 4 inches (area of pipe = 0.523 square foot)," However, I believe that a pipe with a 4 inch diameter is 0.087 square feet, not 0.523 square feet. Just at face value, it is not logical that a 4 inch

If we assume that the value is 0.087 ft<sup>2</sup>, for the outflow of air, if you redo the first calculation you get 107 cfm not 643 cfm. Then with the baffle removed/cleared you get 183 cfm not 1103.5 cfm. Therefore the total iodine out of room with hood fan off is 183 cfm.

If you want to reevaluate your calculations, you can. Additionally, I was wondering if A and B were correct on your drawing or if they are reversed. The text in your writeup would lead me to believe that either the drawing or the writeup perhaps are not correct or maybe I am misunderstanding the setup.

There are three points of entry into the air outflow from the I-131 room – all being vented through the charcoal barrel filter:

1. Air return opening (point “F” in the diagram) measuring 9” x 3.25” (0.203 ft<sup>2</sup>) that draws 340 linear ft of air/min out of the room:

All of these converge and pass through point “B” in the diagram, a pipe with a diameter of 4 inches (Area of pipe = 0.0872 ft<sup>2</sup>). On 3/2/15 a reading of 1230 linear feet/min, using Fisher Scientific Anemometer Model 1-241, serial #61603364 (calibration provided as an attachment to this document) was observed. The flow was calculated as follows:

A baffle within the charcoal filtration barrel that acted as a barrier to prevent the charcoal from blowing out was found to be obstructing outflow (at point “A”) and was cleared out on 5/29/15, and the airflow was adjusted to blow downward as it enters the charcoal to allow more surface area for contact on 6/13/15; an outflow reading taken at point “B” in the diagram on 6/14/15 was 2500 linear ft/min:

Therefore, the pump upstairs is currently drawing 218 cfm of air through the carbon filtration system.

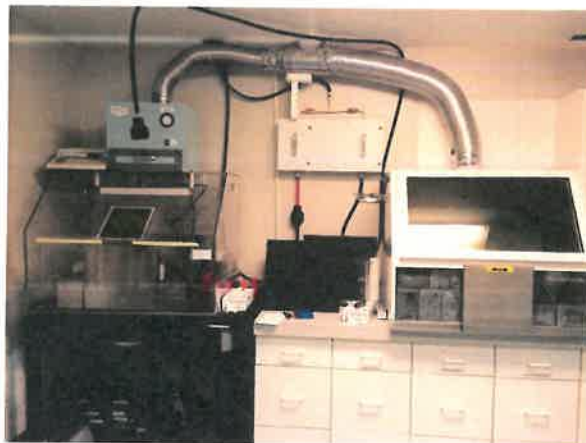
There were modifications made by the previous RSO to allow for the incorporation of a dose calibrator into the I-131 hood, as well as a light fixture inside the hood. These modifications should have been reported, and the modifications were not made in a manner consistent with keeping exposures ALARA. When we asked our consultant to review the setup, he was unaware that this was not what was submitted to the NRC in the license application.

The current setup is diagrammed in the attachment labeled "Current I-131 Room Diagram." I have included a photo below for reference:

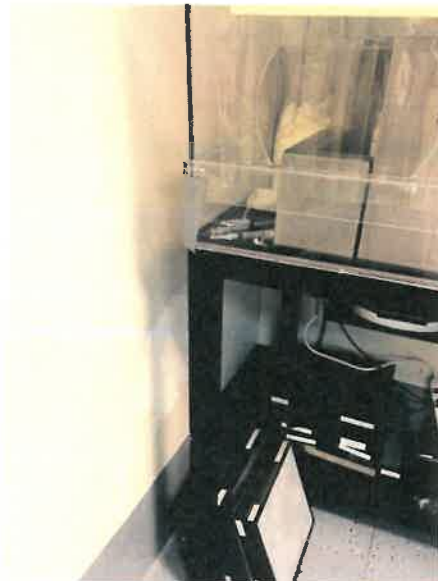
The outflow of air from the measured calculations appears to be almost 5X the inflow. However the inflows are very difficult to accurately measure because small cracks around doors, lights, electrical outlets, etc. allow air movement in but are not easily measurable. The anemometer could only assess a fraction of the airflow around the door (because of the relative size of the anemometer vs. the size of the cracks around the door) giving a lower estimate of what is truly occurring. I believe that negative pressure was not obvious during your visit because of the significant passive inflows through the hole in the wall from the old venting as well as from the HVAC providing air conditioning into that room. The hole next to the hood has since been patched and the inflow of air around the door is now more obvious, particularly when the air conditioning is turned off. See below for a photo of the patch:

Air in = leakage through hole in wall (patched on 5/23/15) + airflow in through HVAC system vent measuring 11.5" x 3.25" (measured at 800 linear ft/min on 5/29/15):

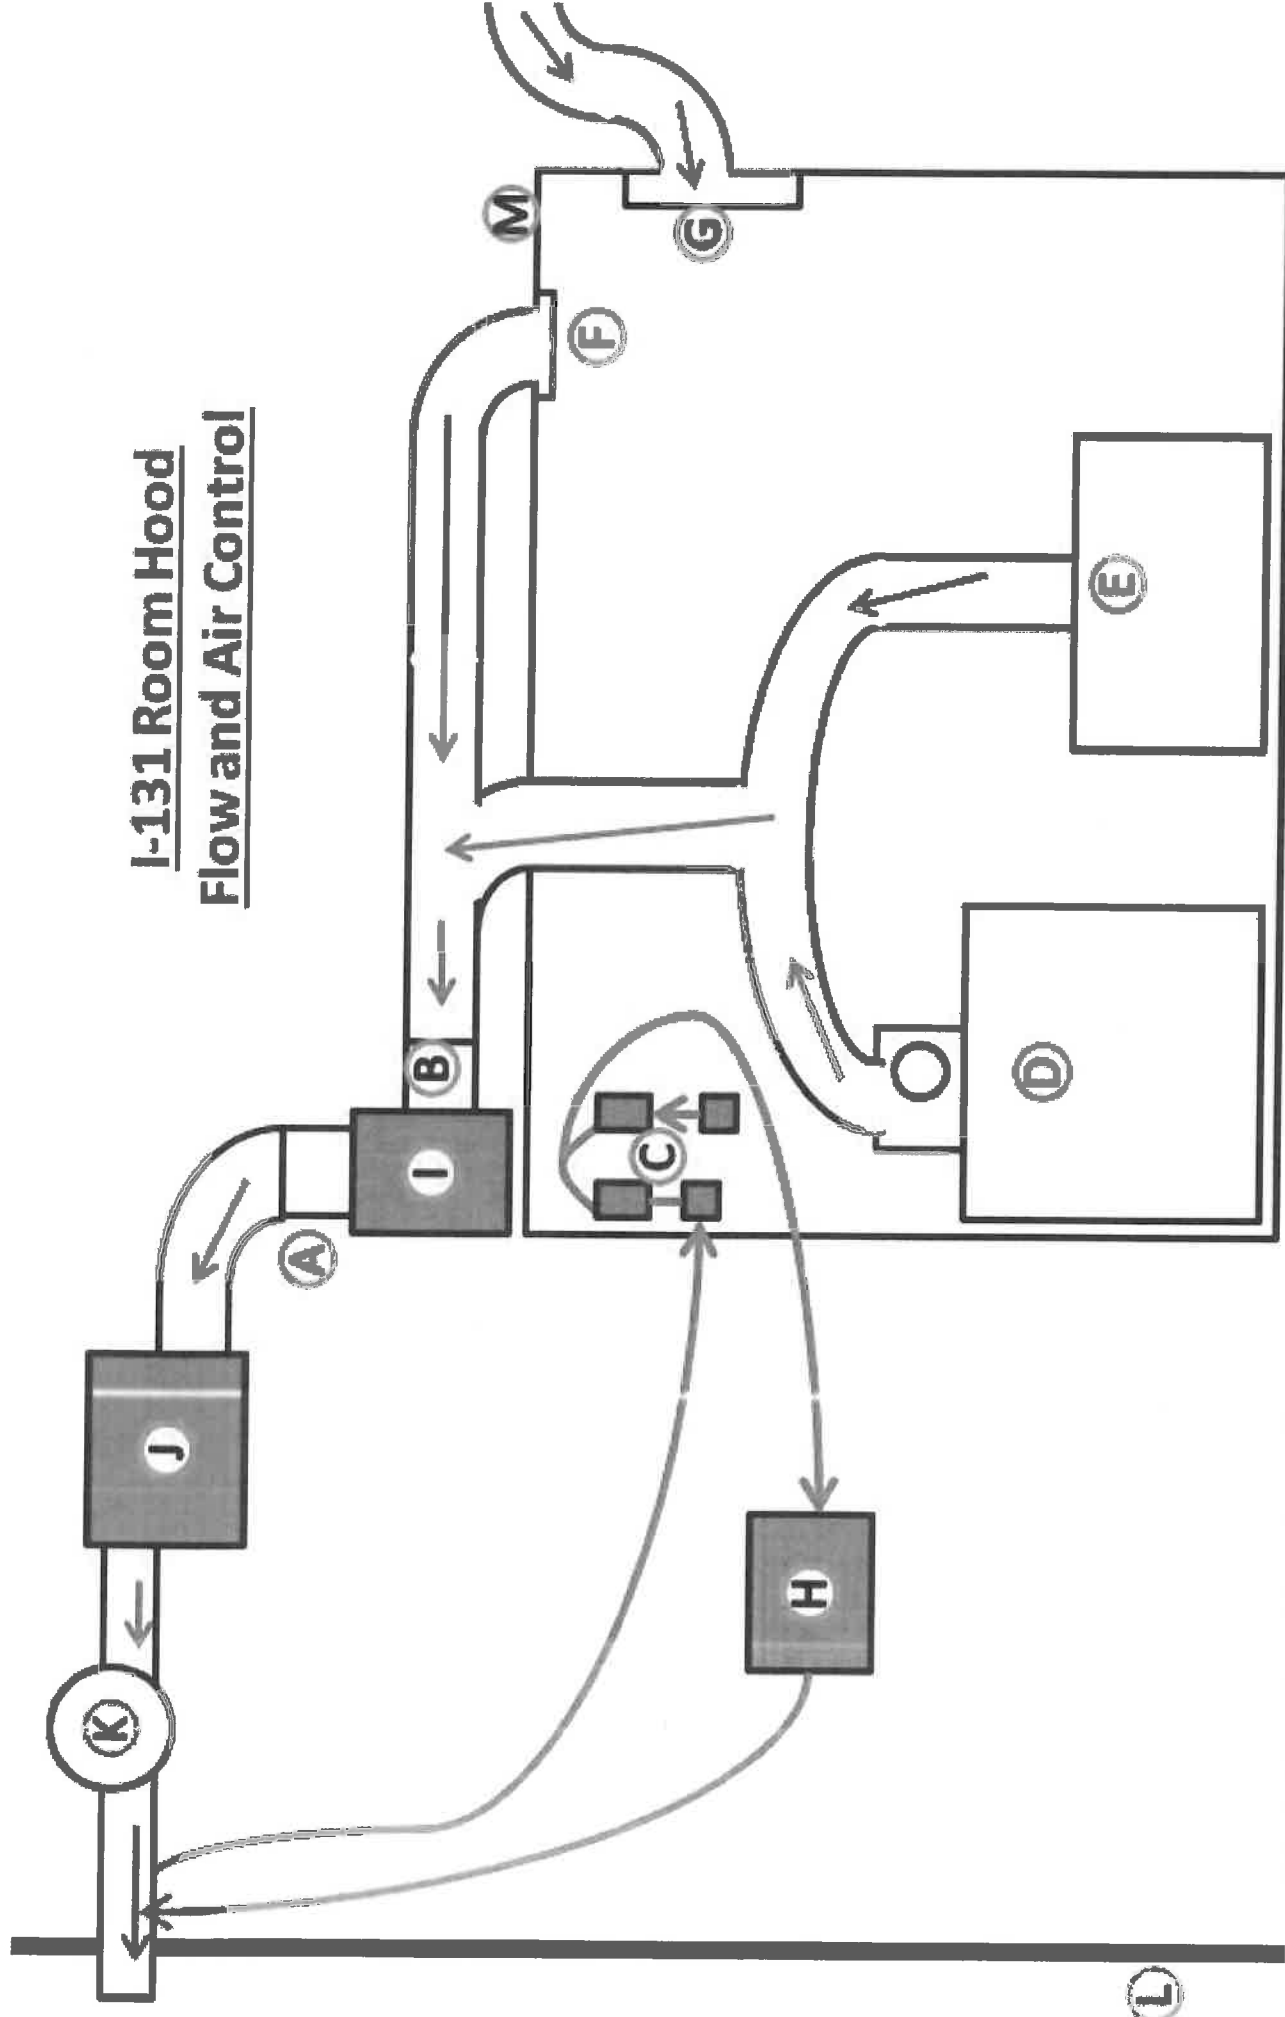
# I-131 Room Hood Flow and Air Control

All of these converge and pass through point "A" in the diagram, a pipe with a diameter of 4 inches (Area of pipe = 0.523 square foot). On 3/2/15 a reading of 1230 linear feet/min, using Fisher Scientific Anemometer Model 1-241, serial #61603364 (calibration provided as an attachment to this document) was observed. The flow was calculated as follows:

A baffle within the charcoal filtration barrel that acted as a barrier to prevent the charcoal from blowing out was found to be obstructing outflow (at point "B") and was cleared out on 5/29/15, and an outflow reading taken at point "A" in the diagram at that time was 2110 ft/min:
