Re: **Lost Creek ISR LLC, Permit 788, June 2015 Inspection**

# IN SITU MINE INSPECTION REPORT

<b>Permit Number:</b>	PT0788	<b>Permittee:</b>	LOST CREEK ISR LLC
<b>Inspection Date:</b>	6/29/2015	<b>Inspector(s):</b>	Brian Wood
<b>Report Date:</b>	7/9/2015	<b>Participant(s):</b>	Kurt Brown, Lost Creek ISR Mike Gaither, Lost Creek ISR
<b>Last Inspection:</b>	12/11/2014	<b>Current Bond:</b>	\$13,296,000
<b>Inspection Reason(s):</b>	Periodic	<b>Field Conditions:</b>	
		<b>Approval Date:</b>	10/21/2011

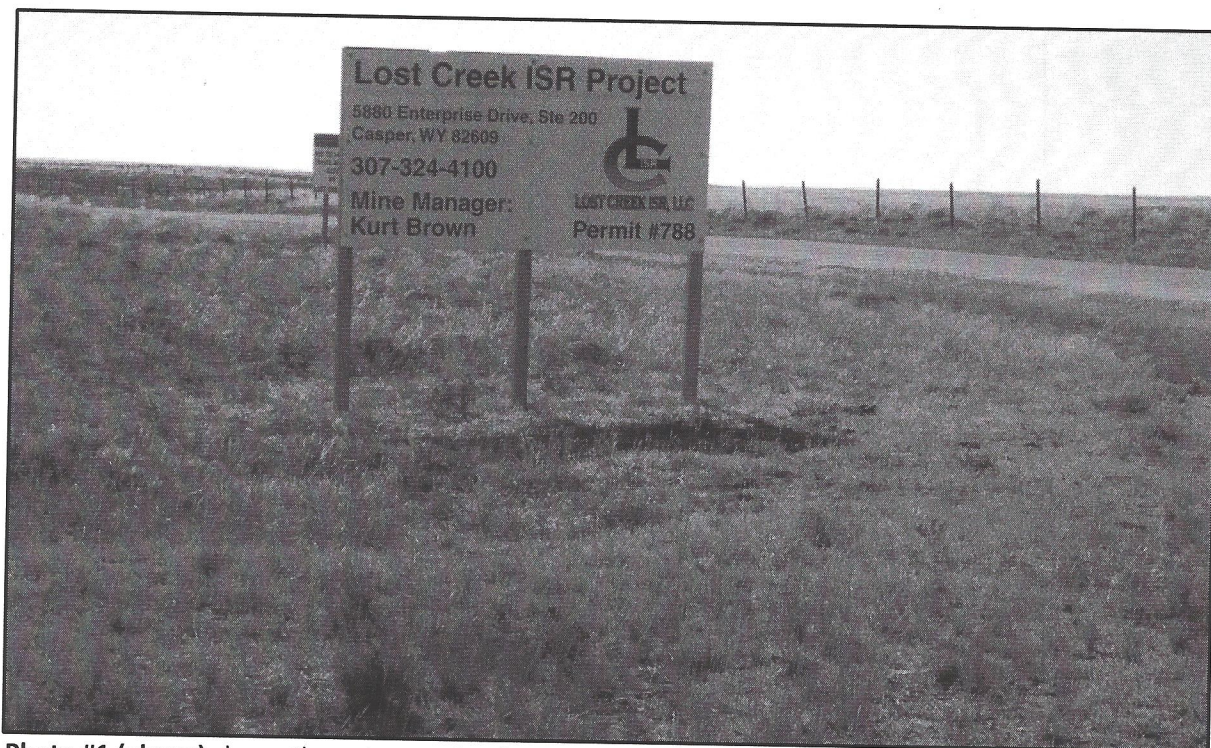
**Photo #1 (above)** shows the entrance sign from the Jeffrey City – Wamsutter Road. **Photo 2 (below)** looks east shows the wattles in place at the first drainage crossing. On the drive into the plant, several crossings were viewed and no issues were noted. There was a substantial increase in vegetation density with the road-side ditches.

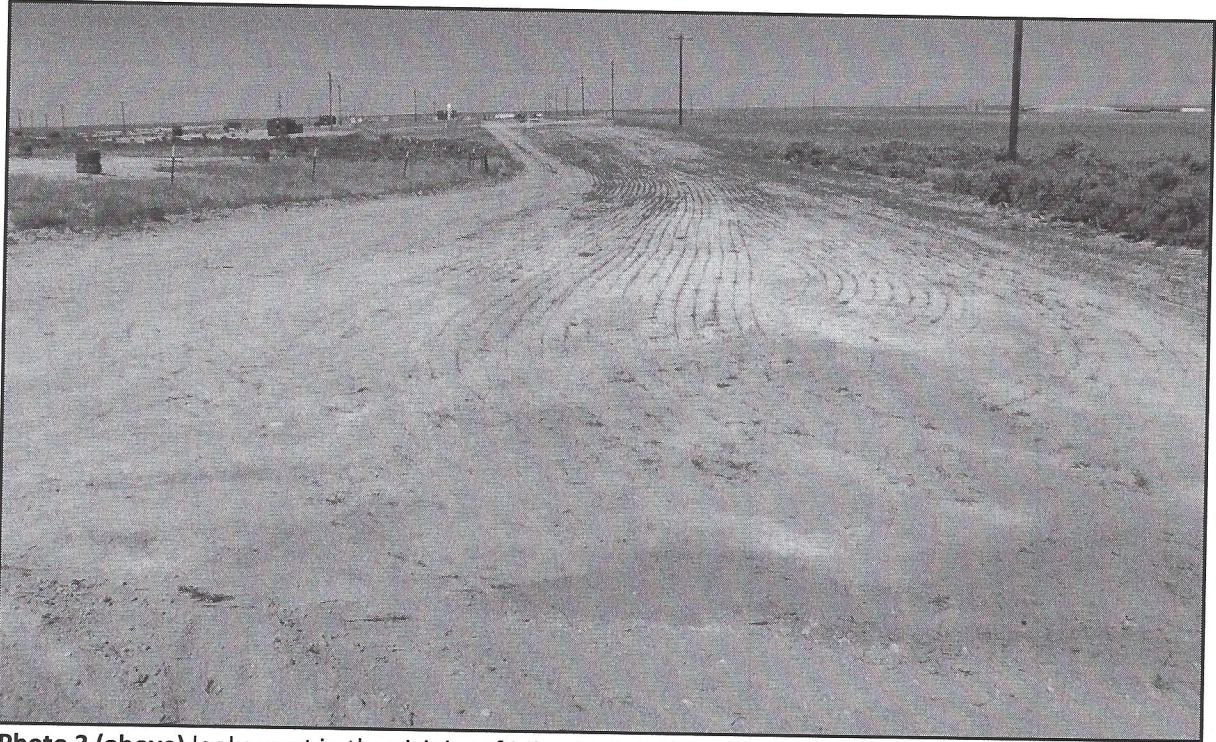
**Photo 3 (above)** looks west in the vicinity of Mine Unit #1 / Header House 9 and shows a portion of the trunk line route that was reclaimed earlier this year. **Photo 4 (below)** shows an area in Mine Unit #1 in the vicinity of Header Houses 9 and 10 that was left undisturbed during drilling. Topsoil preservation has been a substantial issue with the development of Mine Unit #1 and this effort is a step forward.

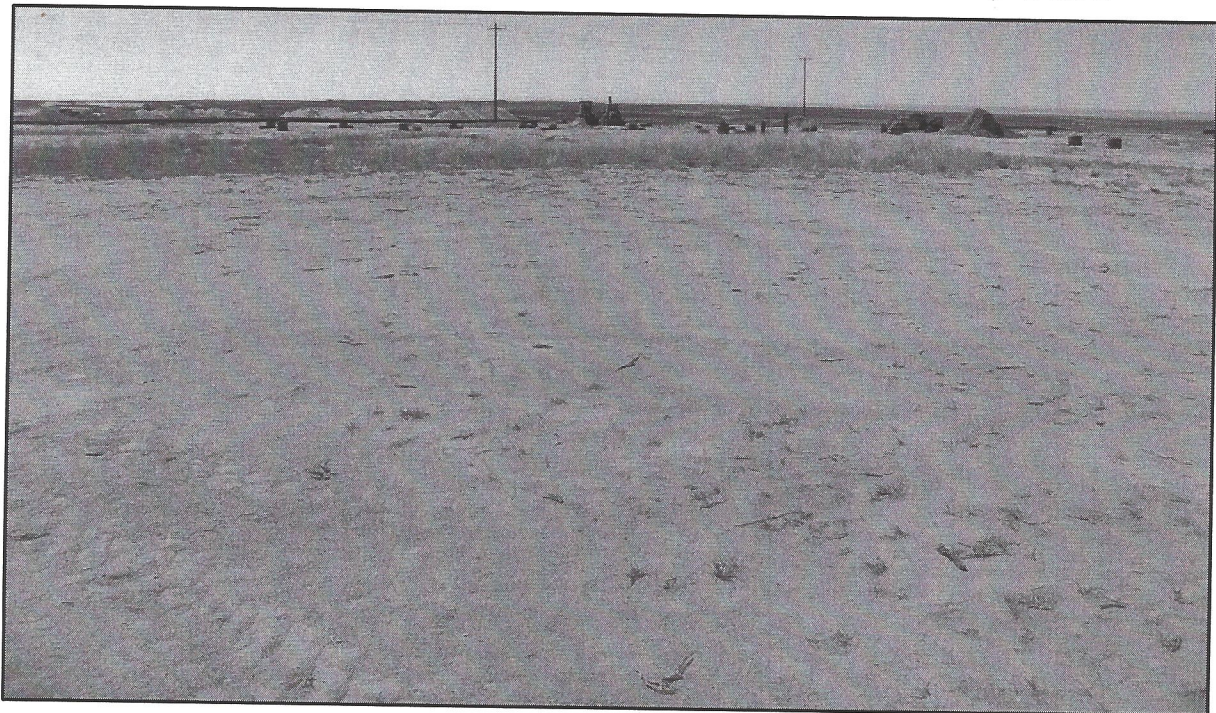
Inspection Topic	In Compliance
• Topsoil Stockpiles	Yes
All of the topsoil piles observed have been signed and were reasonably well vegetated.	
• Vegetation	Yes
Vegetation density in the vicinity of Header Houses 1, 3, and 4 is even greater than what observed late last fall. Photo 6 provides an example of the revegetation in this general area. Photo 3 illustrates trunk line corridor generally west of Header House 9 that was reclaimed and seeded earlier this Spring. As shown, the grass came up quicker than expected after seeding. In the vicinity of Header Houses 10 - 13, Lost Creek personnel have attempted to improve traffic patterns during well field construction. Photo 4 illustrates an area that was left undisturbed during construction.	
Well Field Development	N/A

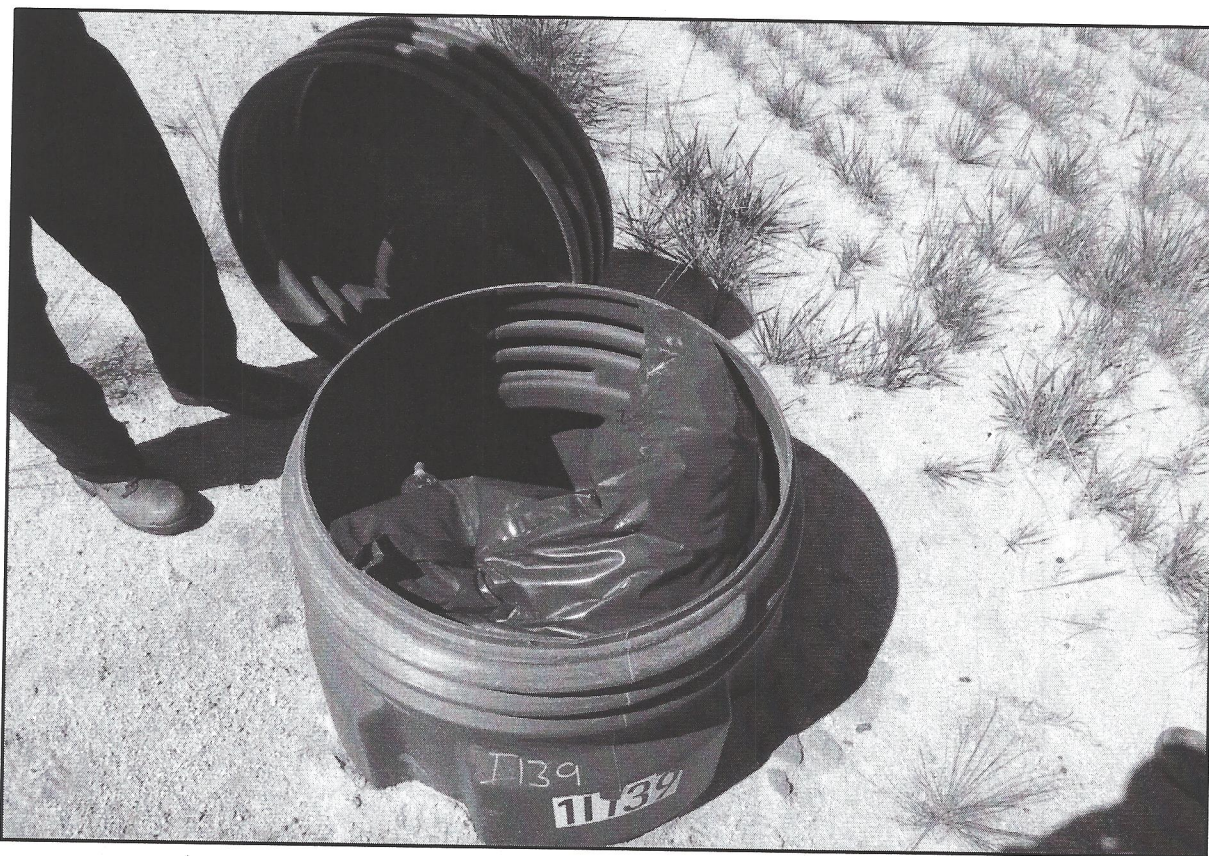
• Spills	Yes
Since the last inspection there have been six spill reports filed with one report covering two separate incidents. Some of the spills have been attributed to freezing vent valves. LCI developed procedures to help reduce failure potential. They also acquired insulating hoods to cover the entire assembly inside the well house. Photo 5 illustrates one of the hoods that has been removed for the warmer months and stored in the well house. The hood is essentially an insulated envelope.

**Photo 5 (above)** shows the jacket that is used around the piping inside the well house. After these were installed LCI did not have an issue with freezing. **Photo 6 (below)** shows the general status of the reclamation in the vicinity of Header Houses 1, 3, and 4. Grasses in many areas is quite dense after the volume of moisture received in May and early June.

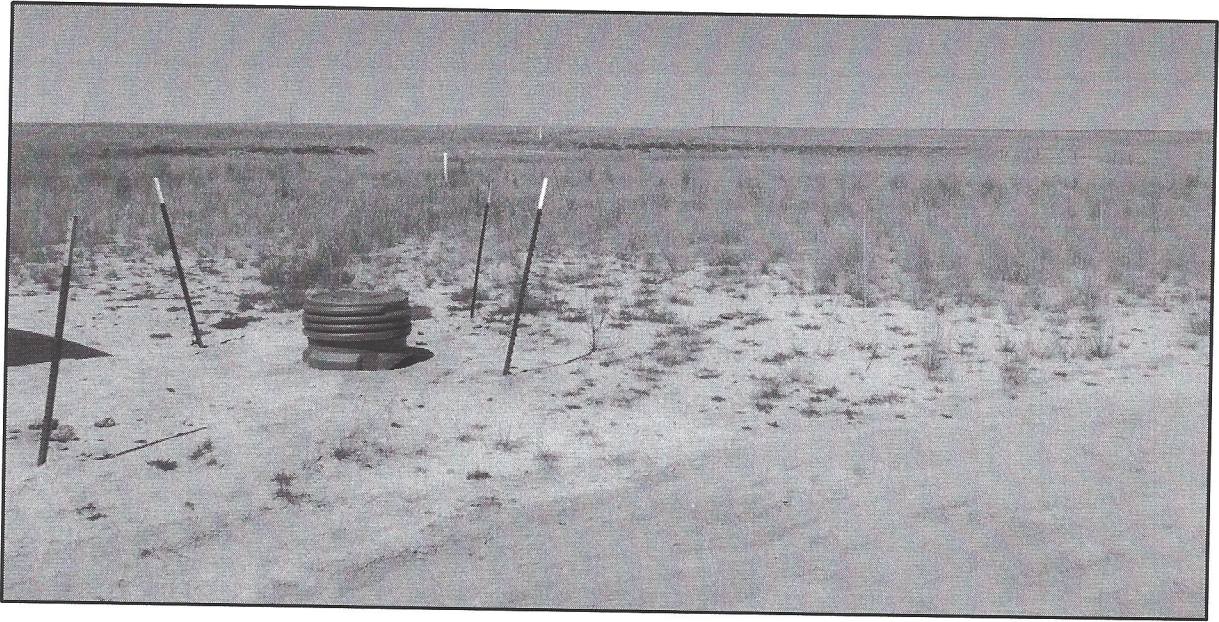
Inspection Topic	In Compliance
General	N/A
• Deep Disposal Wells	Yes
There are three deep disposal wells at the site. At the time of the inspection only DDW #3 was operating. Photo 7 illustrates a portion of the area that was reclaimed around DDW #1. The vegetation has done exceptionally well with the large amount of late Spring moisture. Photo 8 shows some of the delineator posts that have been sunk in the DDW #1 area to identify the extent of the travel corridor. The two ponds associated with the completion of DDW #3 still exist. The water in the northern most pond is of sufficient quality to be used in drilling. The plan is to use the water when drilling is initiated later this month in Mine Unit #2.

**Photo 7 (above)** shows some of the reclamation in the vicinity of Deep Disposal Well (DDW) #1. **Photo 8 (below)** shows the delineator posts that have been set out at the DDW #1 site to define the limits of the traffic area and keep people off the reclamation. These same posts are now set out in the reclaimed areas within Well Field #1.

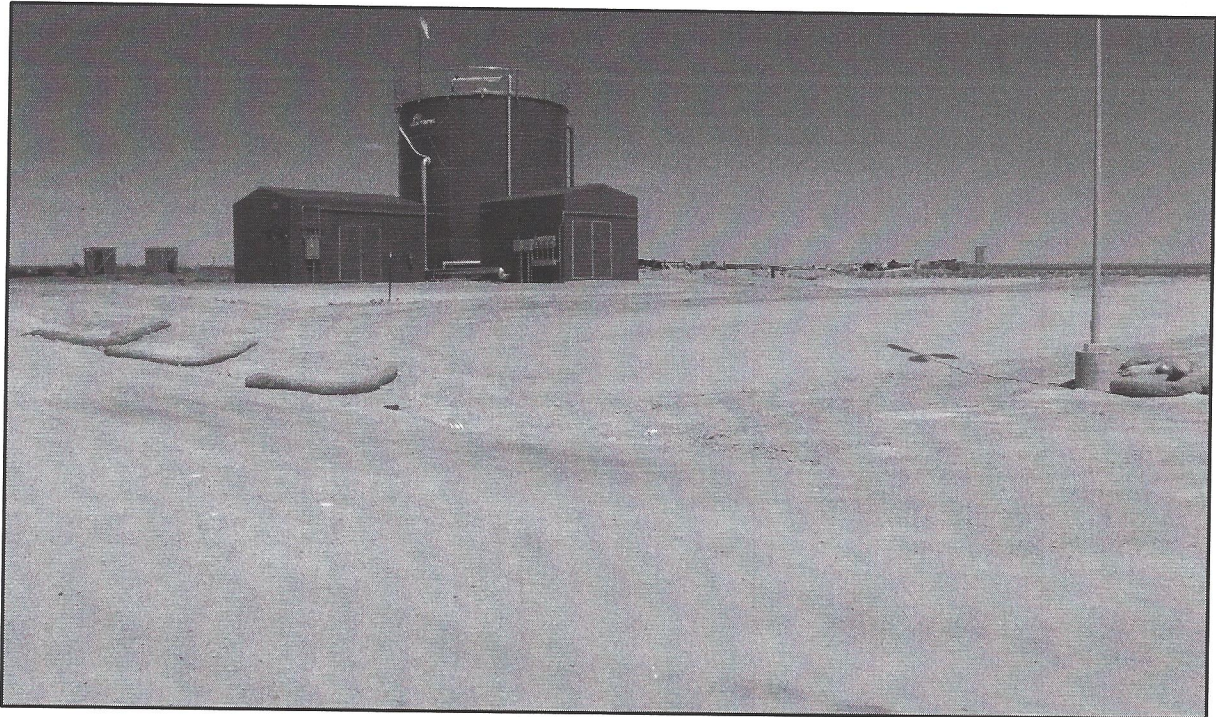
**Photo 9 (above)** shows the erosion control measures that have been installed in the vicinity of the fire water storage tank. **Photo 10 (below)** shows the status of the revegetation effort / reclamation south of the hydrochloric acid storage tanks. Erosion and sedimentation has been an issue in this area before, but the expanse of revegetation this year seems to have addressed any prior issues.
