Re: Docket No. 70-925; License No. SNM-928  
Road and Spillway Repair

Road to the Western Alluvial Area

### Spillway of Reservoir #3

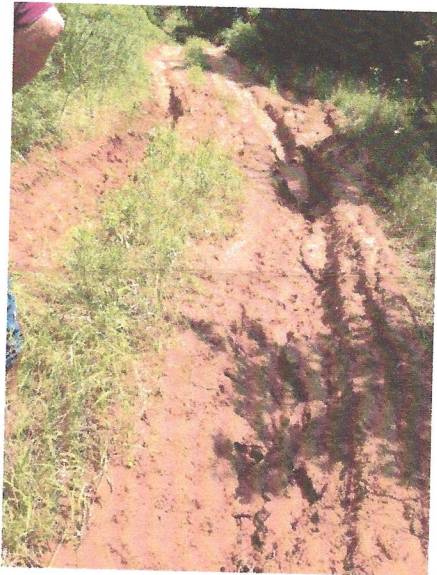
The rainfall received in May eroded gullies in the tracks, in places nearly two feet deep (see photo below). The road is now difficult for a four-wheel-drive vehicle to negotiate. A total of approximately 1,100 feet of this road requires rehabilitation. This would involve grading the roadway, installing culverts in two locations to divert runoff across and under the roadway instead of over the roadway, and placement of gravel. As much as is feasible, the roadway should be crowned to divert runoff to the side of the road instead of down along the road.

For road repair, Caruthers measured 1,100 feet of washed out road – nearly a quarter of a mile. Caruthers estimated a need for 425 tons of limestone rock, which can be delivered to the location for \$43/ton. The truck hauling the rock can't get down the hill to place the rock, so a backhoe is needed to place the rock. A dozer will be used both to grade the road with a crown and to dig bar ditches where needed, as well as to grade the rock. A compactor will be used to compact the rock. Equipment rates include the operator, so there are no labor costs. A culvert (tin horn) will be placed at one location where a terrace forces runoff to cross the road. This runoff washed out the gravel that had been placed on the road for the 2014 design investigation. The total cost to repair the road is estimated at \$24,775.00.

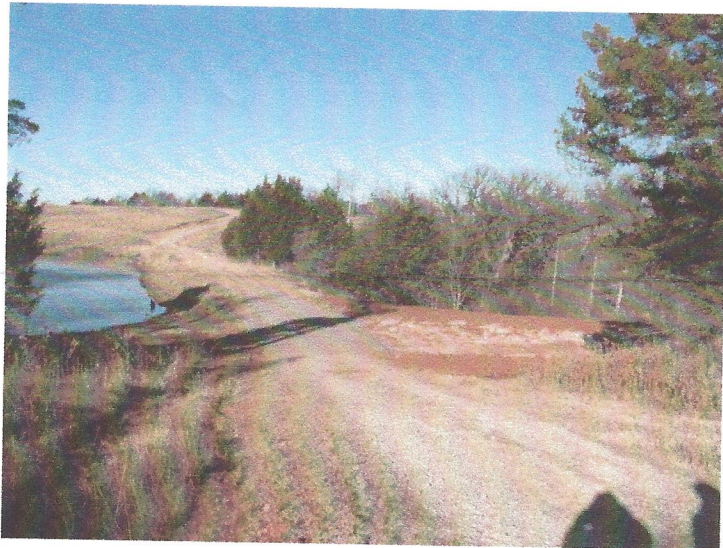
In the picture below, the spillway is the graveled area just west of the tree's shadow (the picture was taken looking east). In the process of performing this work, surge rock was placed in the spillway and covered with additional gravel, the gray rock in the photo. This raised the elevation of the spillway to at least a foot above the previous spillway elevation.

The higher spillway was not a problem during the relatively dry years of 2011 through 2014. 2011 through 2014 were so dry that the pool elevation dropped below 957' AMSL. The heavy rains of April and May 2015 filled the pond to the point that there was over a foot of water flowing over the spillway, resulting in less than one foot of freeboard in some locations. The spillway downstream from the dam experienced significant erosion, and much of the soil between and beneath the concrete slabs washed away.

Work needs to be performed to return the spillway to its design elevation of 960 feet. The roadway will need to carry traffic both to construct and to operate the groundwater remediation system in Burial Area #1. The roadway crossing the spillway needs to be improved so traffic doesn't create ruts in the spillway. Environmental Property Management (EPM) proposes to install two culverts in the dam at an elevation of 960' AMSL, place surge rock (6" rock) around and over the culverts, and place gravel on top of the surge rock to provide a road surface that is nearly the same elevation as the dam.

The second sheet provides Caruthers' bid for the dam spillway. A pair of trenches will be dug, and two 40-foot long by 30" diameter culverts will extend from the pond to the spillway downstream from the pond. In all, an area approximately 50' by 50' will be regraded and graveled. At the upstream end, the bottom of the culverts will be at approximately 960' AMSL. After placing the culverts, approximately 300 tons of 6" surge rock will be placed around and over the culverts, and approximately 300 tons of 1 ½" limestone rock will be placed over the culverts and extending to the roadway. The total cost to repair the spillway is estimated at \$44,650.00.
