Clinton Power Station  
8401 Power Road  
Clinton, IL 61727

Subject: Requested Information from June 25, 2015 Regulatory Conference

Subject: **Clinton 1C SX Pump Bearing Hardfacing Evaluations  
(Supplemental Memo to Report CPS-86766))**

Subject: Clinton Power Station 1SX01PC Pump September 2014 Bearing Failure –  
Calculation Summary Report

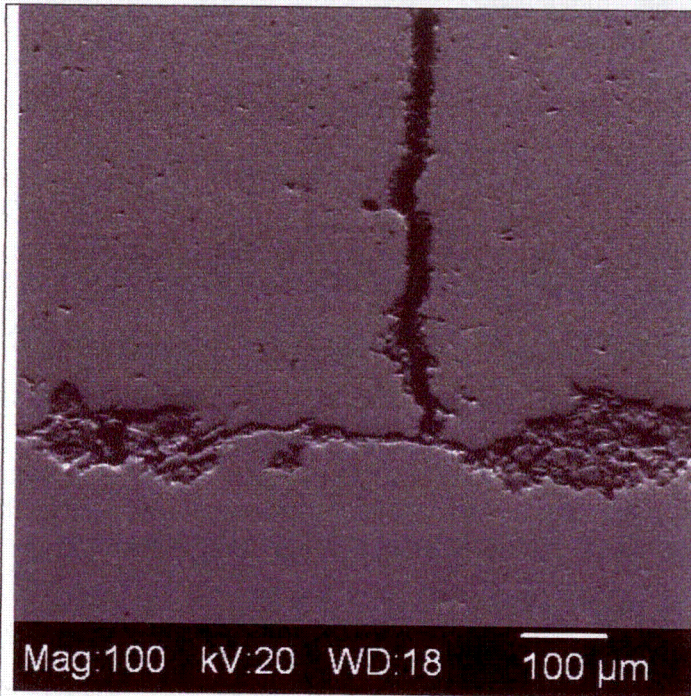
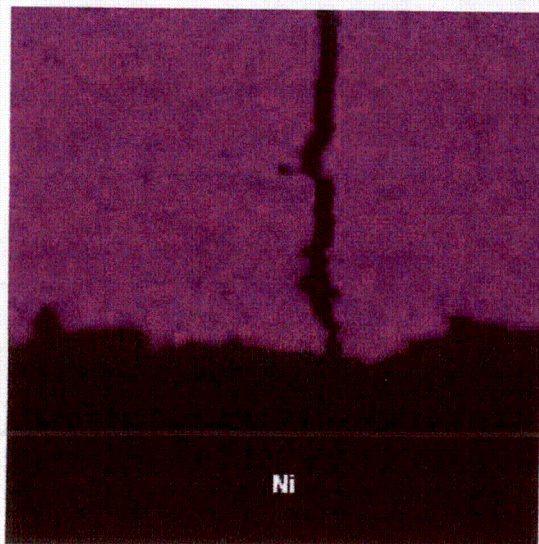
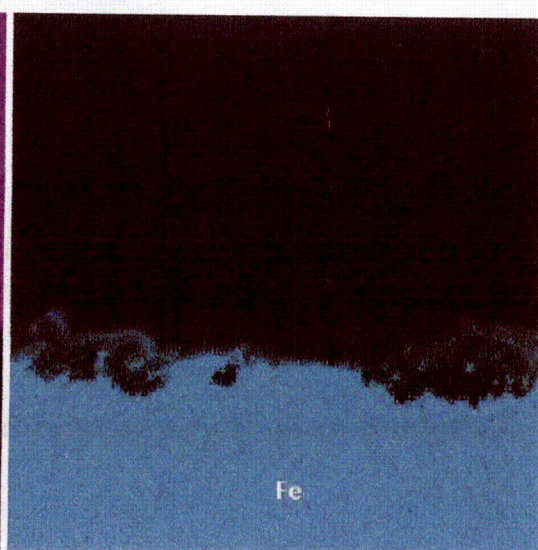
**Figure A - SEM-EDS Evaluations of Sleeve F Interface**

PowerLabs did not find evidence that the hardfacing was welded to the sleeves. Every hardfacing/base metal interface showed a distinct boundary between the sleeve and the coating with no evidence of dilution from welding as shown in Figure A below. Additional metallurgical photos of the interface regions were provided in the following photos of PowerLabs Report CPS-86766.

Figure A – The scanning electron photograph to the left shows the interface of the cracked hardfacing (upper areas) in Sleeve F with the base metal (lower area). The sample was evaluated using SEM-EDS techniques and the individual elemental distributions for nickel and iron are shown in the photo below. Note there was no evidence of a welding induced dilution layer, which would have contained significant levels of both nickel and iron.
