Subject: 10 CFR 71.95 Report on the 8-120B Cask

**Failure to Observe Certificate of Compliance Conditions
for the 8-120B Vent Port Pre-Shipment Leak Test**

June 24, 2015

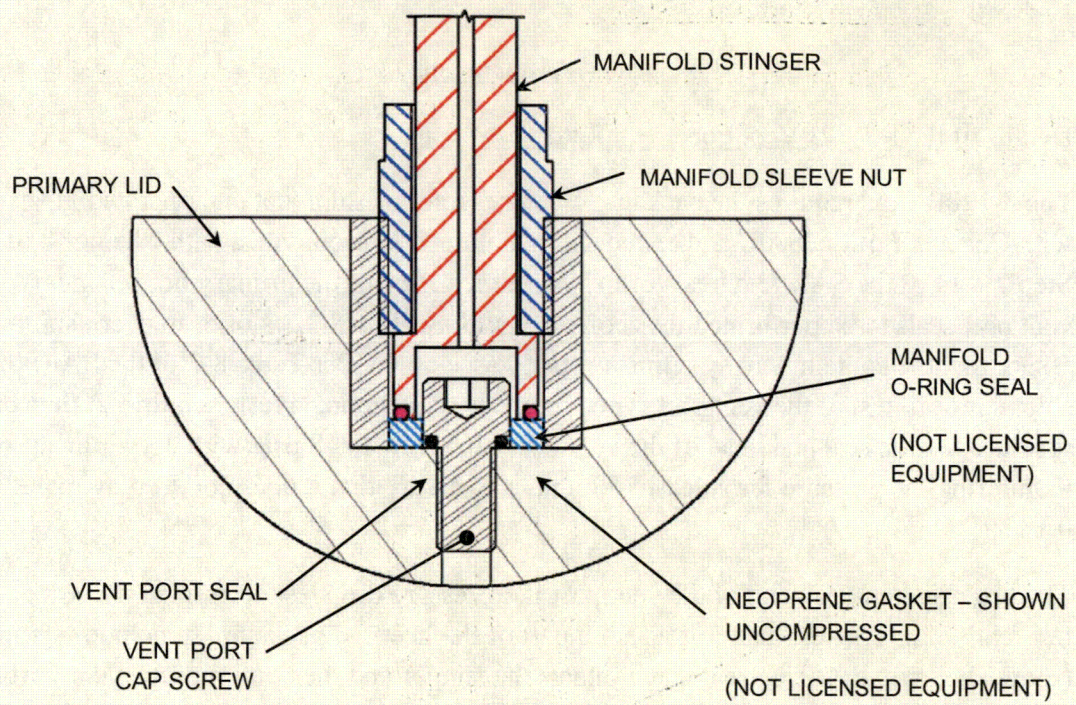
The neoprene gasket can constrict on the head of the vent port plug cap screw when it is compressed by the bottom end of the test manifold stinger, which could reduce the sensitivity of the pre-shipment leak test. Consequently, the vent port pre-shipment leak tests performed using the neoprene gasket may not have provided the required test sensitivity of 1×10^{-3} ref-cm³/sec.

On Monday June 1, 2015, an 8-120B cask user identified a concern that the neoprene gasket could potentially affect the integrity of the vent port seal pre-shipment leak test. Later that week EnergySolutions performed a bench test that confirmed that the neoprene gasket can constrict on the head of the vent port plug cap screw when it is compressed by the manifold, resulting in a reduction of the test sensitivity.

The pre-shipment leak test of the vent port is a pressure drop test performed using a dedicated test manifold. The test manifold is not a part of the licensed package. It includes a stinger (shown below), an O-ring seal that contacts the stinger and the bottom of the vent port hole, and a sleeve nut to compress the O-ring seal. The test manifold was designed so that it surrounds the vent port cap screw, leaving a small gap between itself and the vent port cap screw. The 8-120B cask fleet began to ship with a new lid design in September 2013, and operations staff noted more frequent difficulty getting the manifold to seal. It became desirable to find a better way to seal the bottom of the manifold in order to minimize operator exposure. They found that adding a neoprene gasket (also not part of the licensed package) under the base of the stinger as shown below helped reduce testing time and exposure.

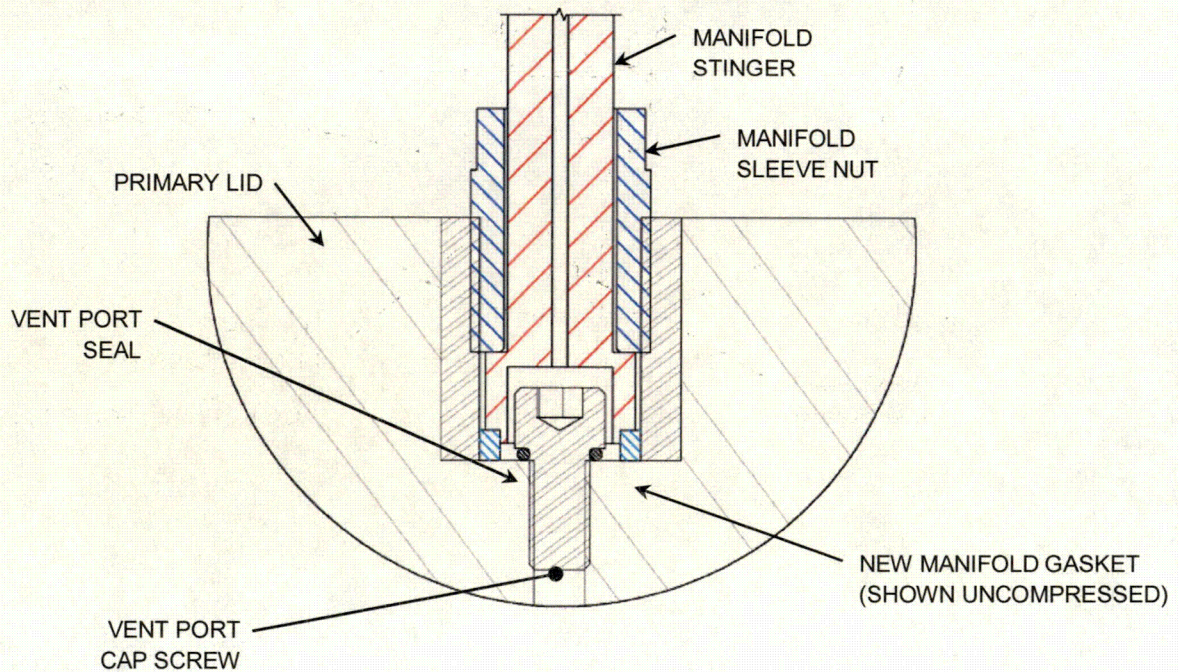
Corrective Action – Modified Test Seal

The new manifold gasket design, shown below, replaces the manifold O-ring seal and neoprene gasket previously used with a neoprene gasket that fits within the notch at the base of the manifold stinger.

- EnergySolutions notified all 8-120B cask users with upcoming shipments to require use of a new procedure, in conjunction with the new manifold gasket design, for pre-shipment leak testing of the vent port seal on all future shipments.
- EnergySolutions designed and tested new manifold gasket design that does not constrict onto the head of the vent port plus screw when compressed, and therefore it does not reduce the test sensitivity. The new gaskets have been distributed to all upcoming shipment users. The new manifold gasket design is shown in Attachment 1.

The EnergySolutions drawing for the 8-120B air drop manifold have been revised to include the new gasket seal, and the air pressure drop test procedure TR-TP-002 has been revised to incorporate the new pre-shipment leak test procedure for the vent port. Use of the new procedure and the new manifold gasket will assure that the pre-shipment leak test satisfies the required test sensitivity and that the manifold gasket is removed from the test port after completing the pre-shipment leak test.
