LR-N15-0147

Hope Creek Generating Station  
Renewed Facility Operating License No. NPF-57  
NRC Docket No. 50-354

Subject: License Renewal Commitment Implementation

**Hope Creek Generating Station License Renewal Commitment Implementation  
90-Day Report for Refueling Outage 19**

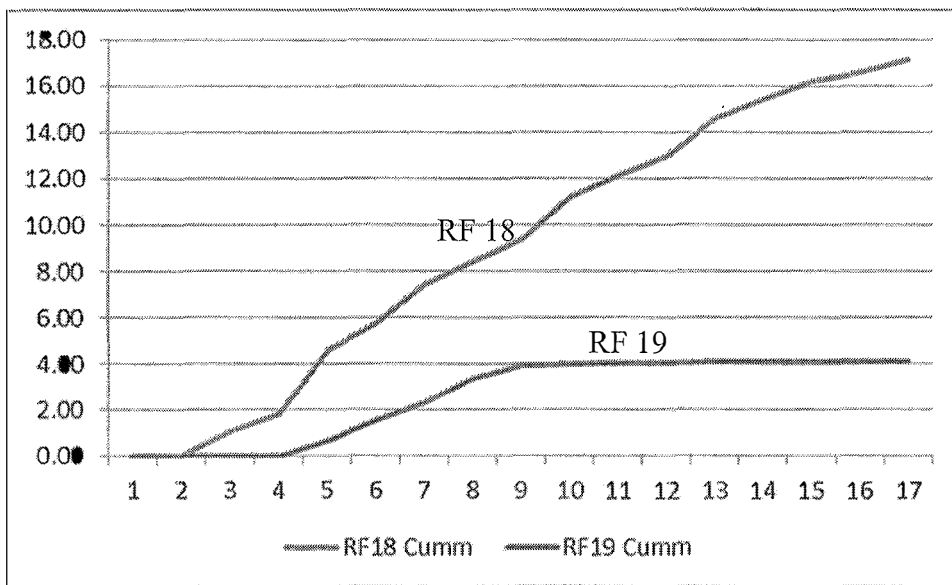
to diminish over the next several days. The last leakage was recorded on April 25, 2015 from the penetration J19 at a rate of approximately 1 drop per minute. It is likely that the leakage observed April 22 through 25, 2015 was residual leakage. Note that the cavity remained flooded through April 30, 2015. The chart below represents a comparison of the RF19 leakage to that of the RF18 leakage where the X-axis represents days following flood up and the Y-axis represents cumulative gallons leaked.

Note that the time from flood up to first observation of leakage during RF19 was four days versus two days during RF18. In addition, the leakage during RF19 lasted only five days versus fourteen days during RF18. The RF19 total leakage was less than 25% of that collected during RF18. The characteristic deltas between the observed leakage from RF18 to RF19 will be taken into consideration when developing leak investigation efforts for RF20.

From the monitoring conducted during RF19 it can be concluded that the source of the leakage has not degraded from RF18 to RF19. No leakage was observed from any other air gap penetration sleeves and there was no sign of leakage from the end of the other three drywell air gap drains (at 80, 160 and 340 degree azimuths) or from the excavated tunnels at 290, 155 and 115 degree azimuths. The Reactor Cavity to Drywell Seal Rupture Drain Alarm (HC.OP-AR.ZZ-0024, Alarm point D3837) did not actuate. All leakage stopped before draining of the reactor cavity.
