IE Bulletin 77-05

ELECTRICAL CONNECTOR ASSEMBLIES

TRIP REPORT  
by  
W. R. Rutherford

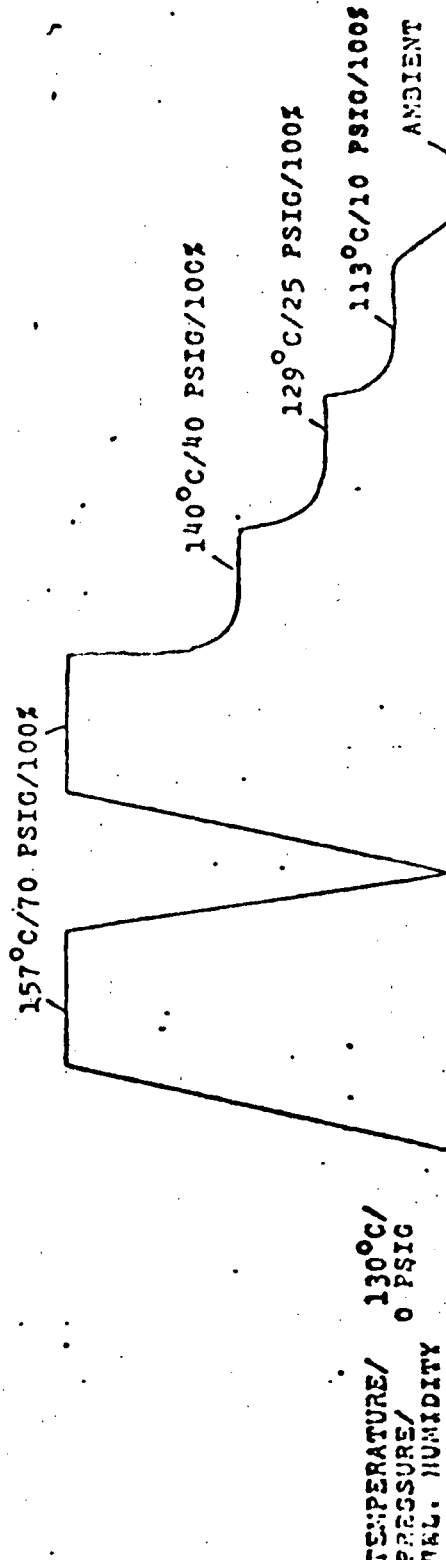
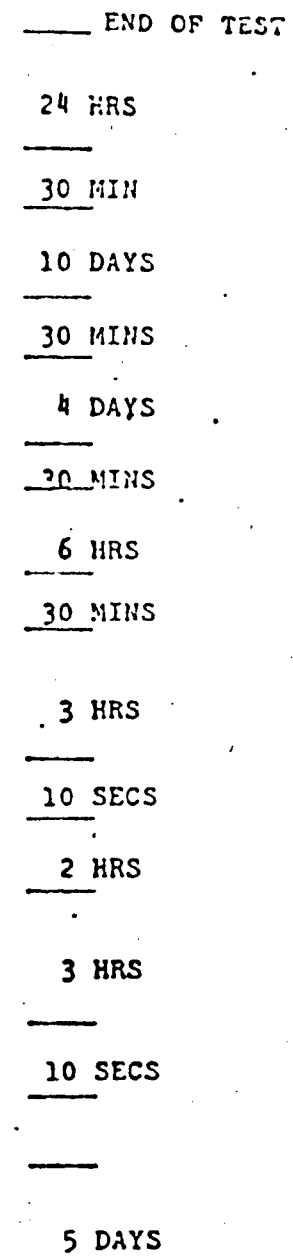
Figure 2

The three tests performed by Sandia were composed of two sequential and one simultaneous exposure to LOCA environments. In each case the equipment was exposed to radiation and thermal aging prior to operating under the simulated LOCA conditions. Figures 1 and 2 describe the test profiles for sequential and simultaneous tests respectively (Sandia tests were designed to study synergistic effects). Each of the tests satisfy the intent of IEEE 323-1974. The assemblies were electrically loaded to 20 amperes and 600 volts at the start of the tests. Insulation resistance and capacitance measurements were recorded during the tests to indicate damage.
