RESEARCH REACTOR CENTER

SUBJECT: Written communication as required by University of Missouri Research
Reactor Technical Specification 6.1.h(2) regarding a deviation from
Technical Specifications 3.2.a

Licensee Event Report No. 15-02 – June 29, 2015
University of Missouri Research Reactor

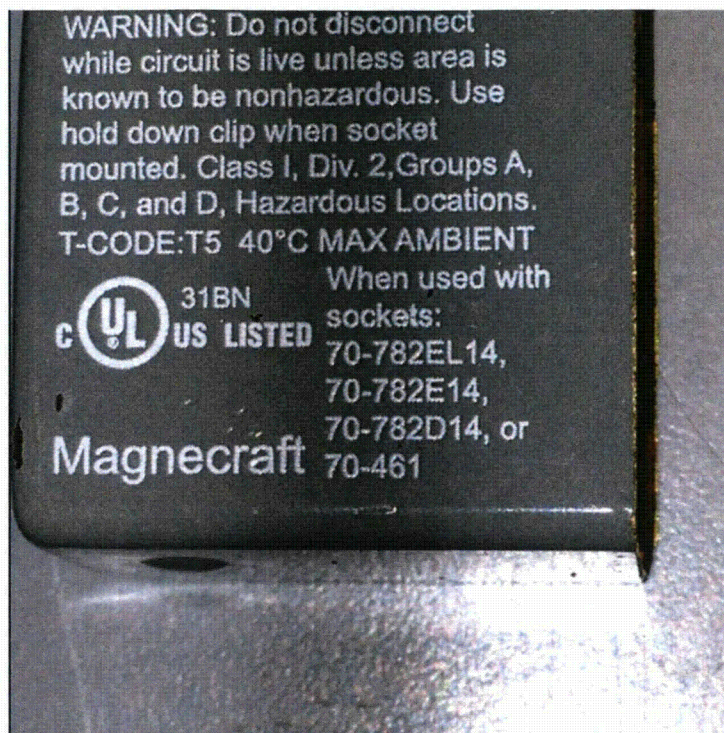
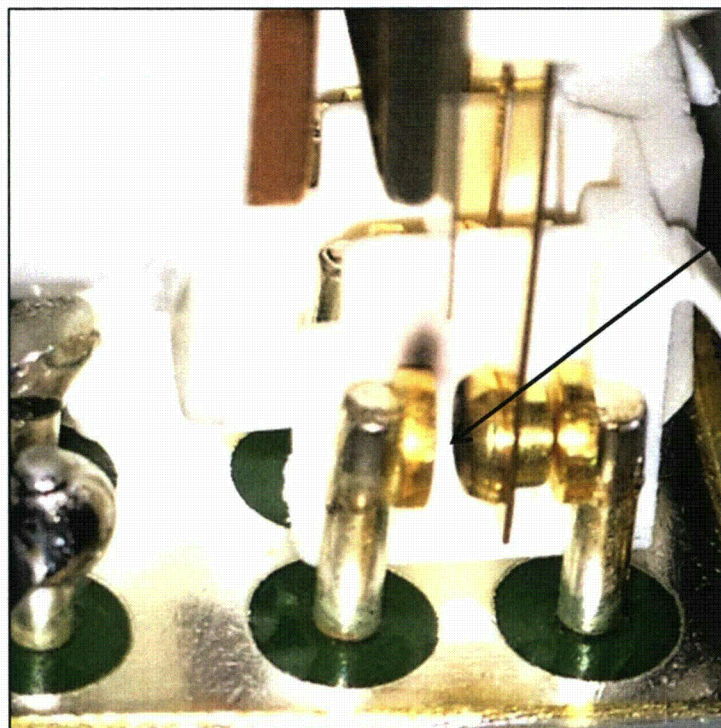
ATTACHMENT 1

After the reactor was secured, the CRDM was removed for inspection. Troubleshooting efforts revealed an intermittent failure of CRDM ‘A’ motor relay K1. Relay contacts 6 and 10 would intermittently not make sufficient contact to allow current flow with the relay coil energized; thus preventing the motor inward direction windings from being energized.

Troubleshooting efforts identified the failure of CRDM motor inward relay K1. The relay was bench tested to identify the single component intermittent failure of contacts 6 and 10. A visual inspection of the relay internals also revealed some discoloration on contacts 8 and 12, which can be associated with a high resistance connection (Attachment 1). This type of relay, Magnecraft 782HXDXH21-120A, has been used at MURR for many years and has proven very reliable in the past. However, a similar event occurred on April 23, 2014 (see LER 14-02, letter dated May 16, 2014). As a result of that event, all Magnecraft relays of that lot number were removed from service and a new lot of relays were installed. At that time the relay manufacturer (Schneider Electric) was contacted and MURR was assured that the failure was an isolated instance and not an identified deficiency. Because this June 29th occurrence is a similar repeat failure, the Magnecraft relay has been replaced with an equivalent relay from a different manufacturer (Allen Bradley) (Attachment 2). In addition to replacing the failed relay, all Magnecraft relays have been removed from the remaining CRDMs and replaced with Allen Bradley relays.

Magnecraft 782H Hermetic Ice Cube Relay

Control Rod Drive Mechanism Motor Relay K1

MURR electronic maintenance procedure EMP-12, "Drive Mechanism," was completed on CRDM 'A.' Additional post maintenance testing included bench testing to ensure correct operation of the CRDM relay contacts, monitoring CRDM run current and speed over the full length of travel, and performing multiple cycles of the CRDM motor relay to ensure proper operation.
