Part 21 (PAR)

## PART 21 - ACTUATOR SHAFT DID NOT MEET DIMENSIONAL REQUIREMENTS

**ENGINEERING EVALUATION**  
**10CFR21 File No. 89**

**SUBJECT:** Actuator Shaft supplied for 6-900 Exercisable Swing Check Valve, Drawing No. 3489-3 manufactured by Anchor/Darling Valve Co. and installed at Energy Northwest (ENW) - Columbia Station.

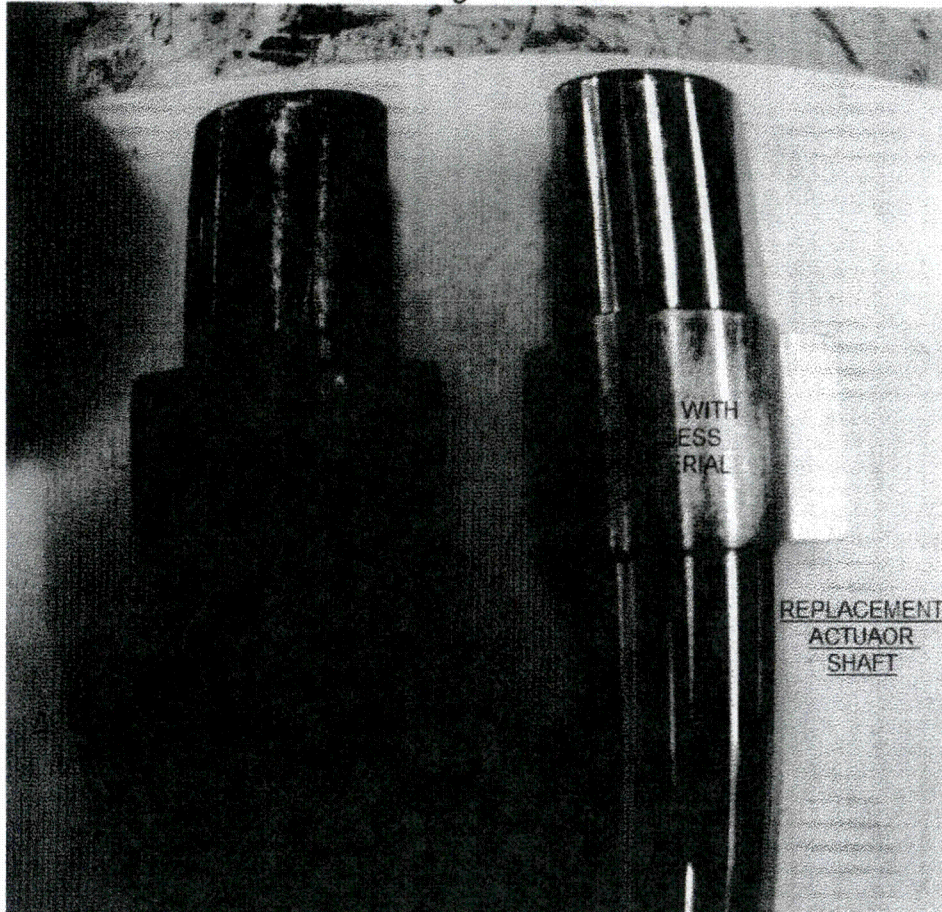
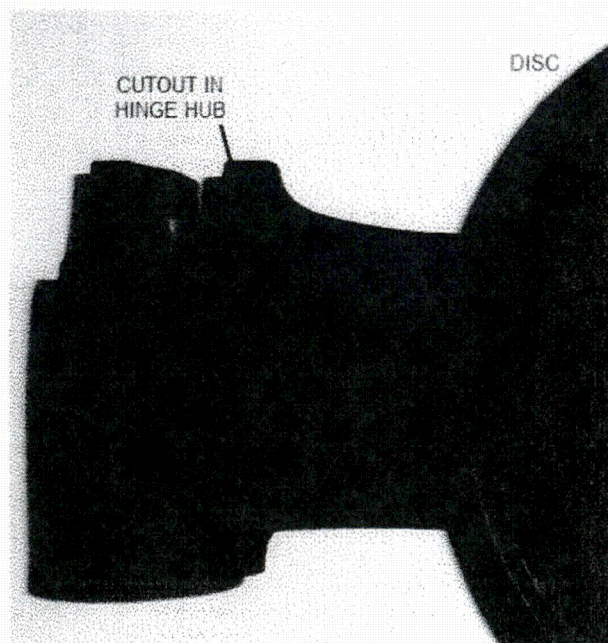
Figure 1  
ENW Photos of Removed and Replacement Actuator Shafts  
and Hinge with Disc

**PROBLEM:** ENW - Columbia reported the replacement actuator shaft was different than the one removed and could not be installed. After consultation with Flowserve it was determined the actuator shaft did not meet the dimensional requirements of the manufacturing drawing. The shaft includes an off-set lug that engages the hinge and allows testing or exercising the valve disc. The shaft diameter opposite the lug must be equal to or less than the basic diameter adjacent to the lug in order to allow free disc swing. See figures 1 photos and 2 drawing.

**ROOT CAUSE:** The actuator shaft was machined by a Flowserve subvendor which incorrectly interpreted the machining drawing and produced the shaft with a large, out of tolerance radius around the lug. The drawing was not clear to the subvendor. Flowserve inspection did not discover the discrepancy during subsequent dimensional inspection.

An excessively large diameter at the lug will not allow installation of a replacement actuator shaft. A shaft with a diameter opposite the lug that is greater than design but still small enough to allow installation could retard or prevent free disc swing and adversely affect check valve function.

**PROPOSED ACTION:** Flowserve will revise actuator shaft drawing to clearly define the radius/diameter at the lug. Flowserve will notify the customers in table 1 of the attached evaluation of the defect and will request that the actuator shafts be returned to Flowserve for evaluation and/or replacement at no charge.

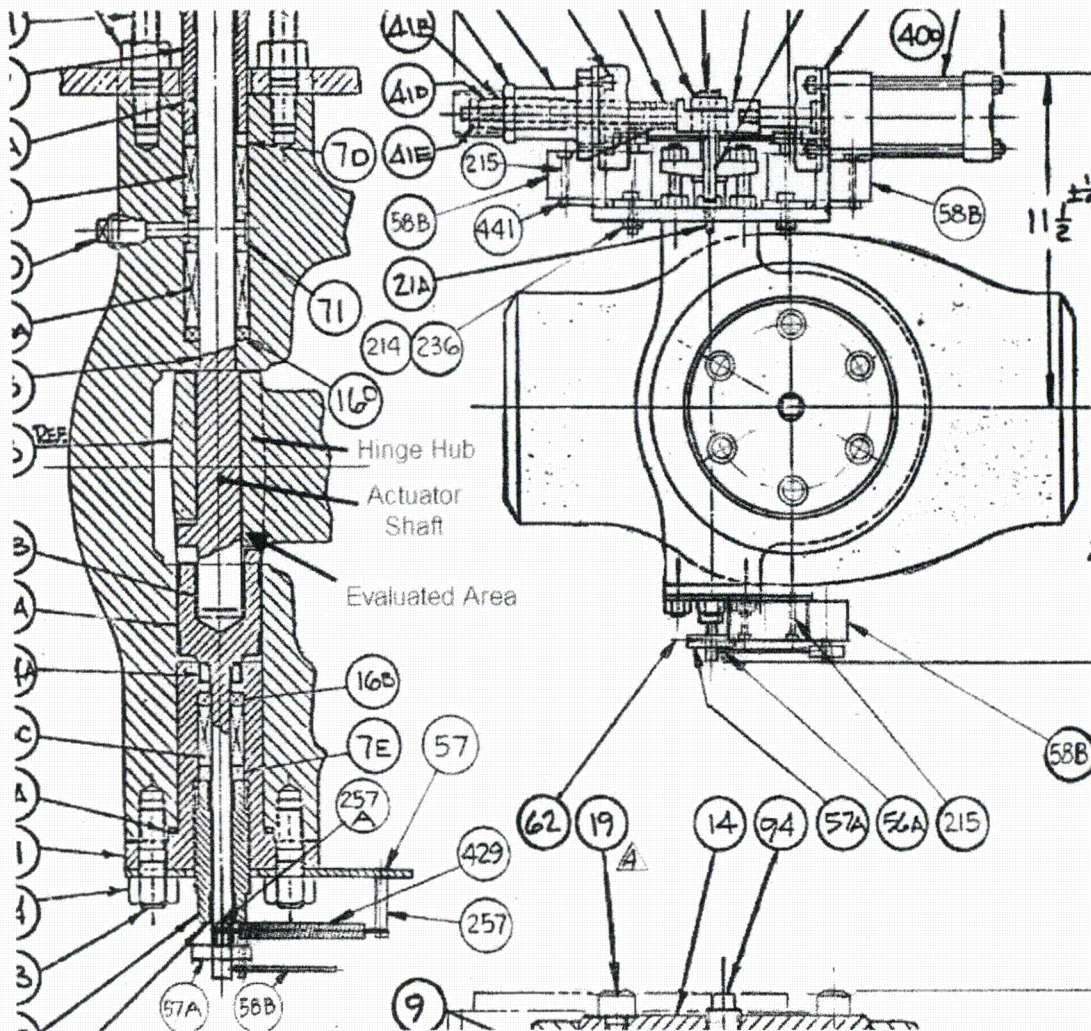
Figure 2  
 Drawing Showing Installed Actuator Shaft and Evaluated Area

"POTENTIAL EFFECT: An excessively large diameter at the lug will not allow installation of a replacement actuator shaft. A shaft with a diameter opposite the lug that is greater than design but still small enough to allow installation could retard or prevent free disc swing and adversely affect check valve function.

"PROPOSED ACTION: Flowserve will revise actuator shaft drawing to clearly define the radius/diameter at the lug. Flowserve will notify the customers of the attached evaluation of the defect and will request that the actuator shafts be returned to Flowserve for evaluation and/or replacement at no charge.
