Docket Nos. 50-269
50-270
and 50-287

IE Bulletin 77-05

ELECTRICAL CONNECTOR ASSEMBLIES

Trip Report by W. R. Rutherford
Electrical Connector Assemblies

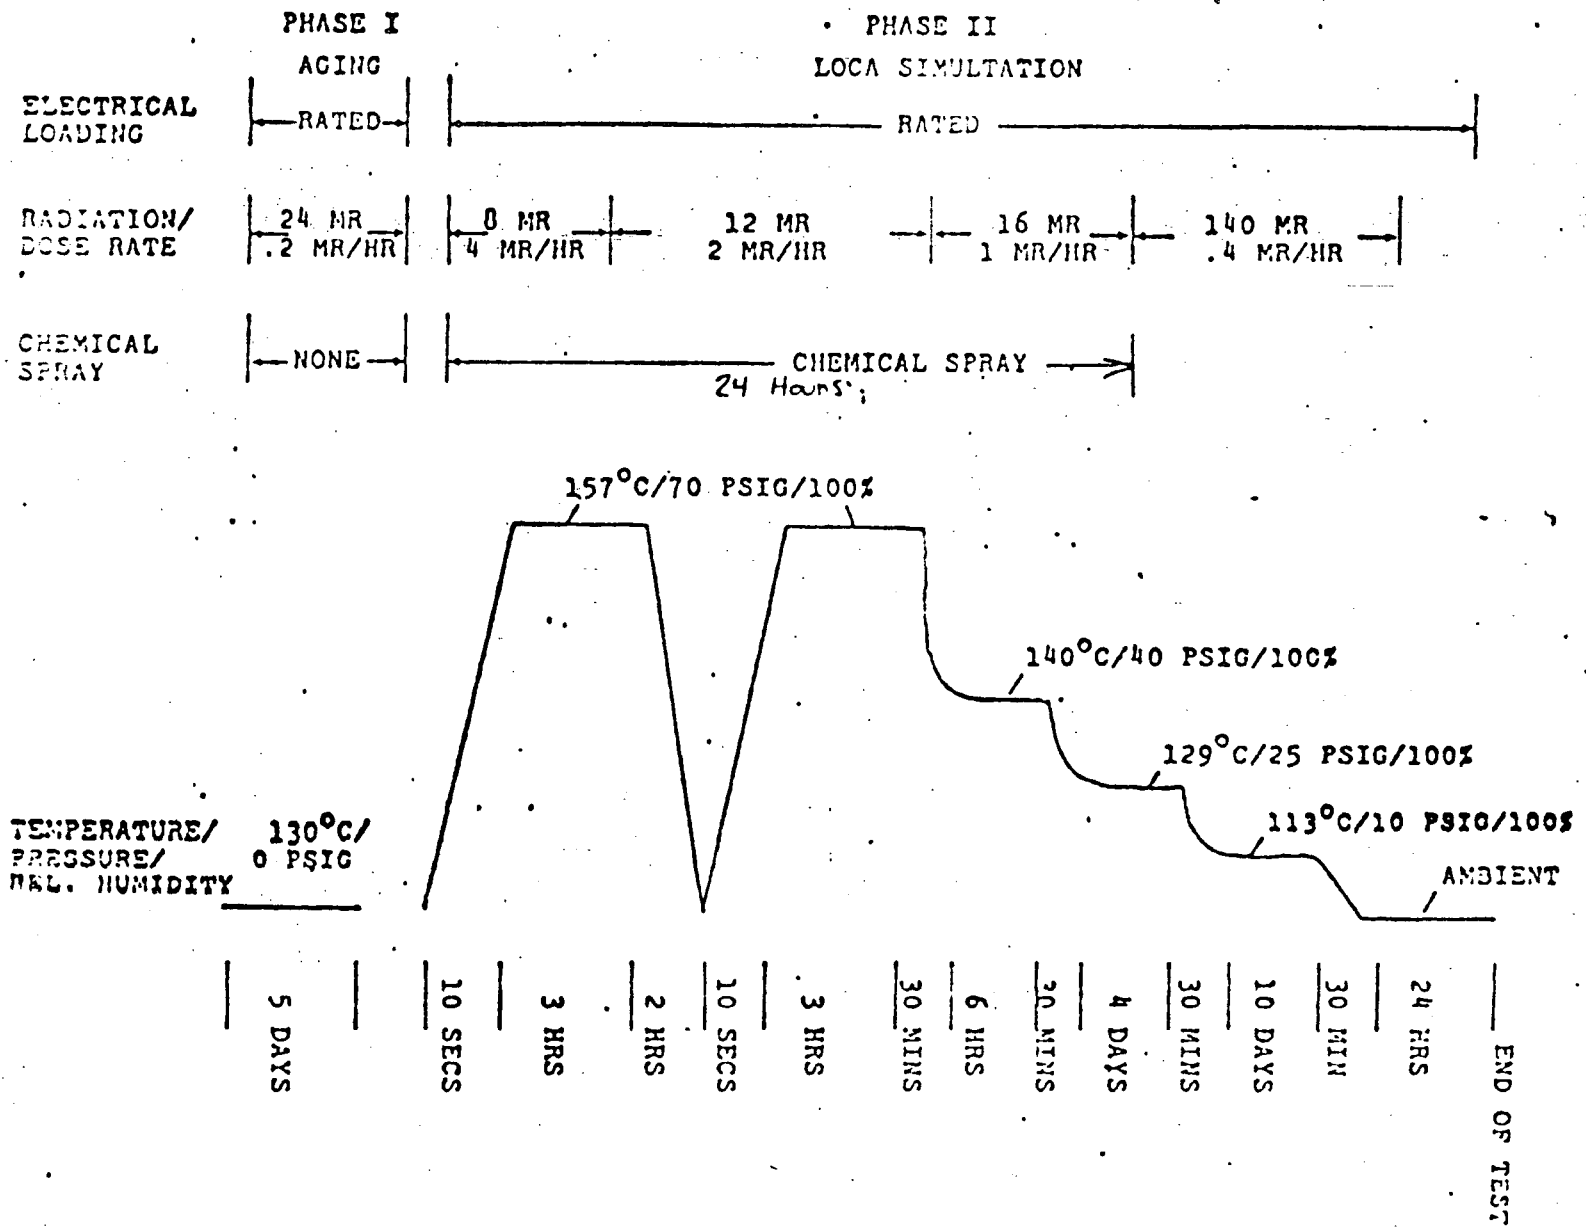
Figure 2

The three tests performed by Sandia were composed of two sequential and one simultaneous exposure to LOCA environments. In each case the equipment was exposed to radiation and thermal aging prior to operating under the simulated LOCA conditions. Figures 1 and 2 describe the test profiles for sequential and simultaneous tests respectively (Sandia tests were designed to study synergistic effects). Each of the tests satisfy the intent of IEEE 323-1974. The assemblies were electrically loaded to 20 amperes and 600 volts at the start of the tests. Insulation resistance and capacitance measurements were recorded during the tests to indicate damage.
