102-07089-MLL/DJH
July 29, 2015

Subject: **Palo Verde Nuclear Generating Station (PVNGS) Unit 3**
Docket No. STN 50-530 / License No. NPF 74
Licensee Event Report 2015-003-00

Damaged High Pressure Safety Injection Pump Motor Journal Bearing

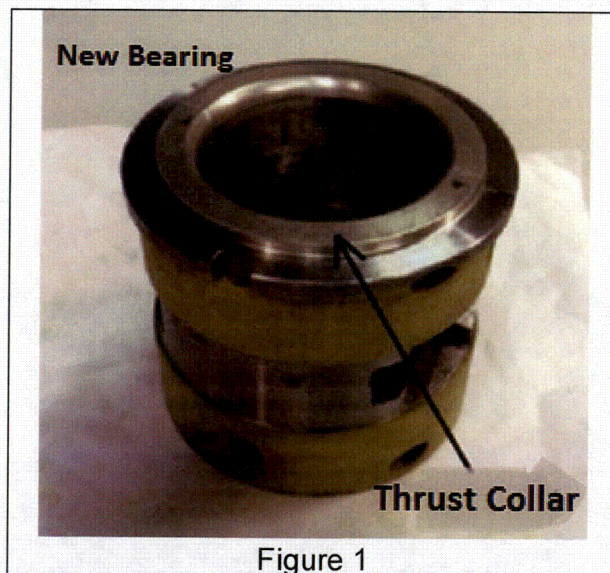
Figure 1

The HPSI pumps are manufactured by Ingersoll-Rand and are driven by Westinghouse model 1000HP/5810H FRAME/3557 RPM motors. The HPSI pump motor outboard journal bearing is a Westinghouse, model 267C790G01, slinger ring oiled, split sleeve journal bearing with an integrated thrust collar that is approximately 0.25 inches thick and made entirely of babbit material (Figure 1). The thrust collar works in conjunction with a shoulder milled into the shaft, to limit axial shaft movement (Figure 2).

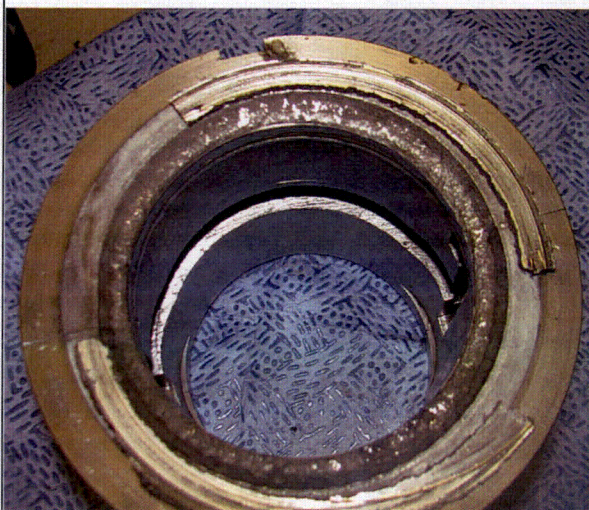
Damaged Bearing (loose pieces of recovered babbitt placed for illustration)

Inspections and measurements revealed improper adjustment of the pump to motor coupling and displacement of the motor shaft toward the outboard motor journal bearing. This displacement resulted in contact between the milled shaft shoulder and the bearing thrust collar which caused babbitt material to be abraded from the thrust collar (Figure 2). Actions were implemented to replace the journal bearing and properly align the shaft and pump to motor coupling.

The investigation determined improper reassembly of the train A HPSI pump motor during planned refueling outage maintenance resulted in axial displacement of the motor shaft and damage to the thrust collar on the outboard HPSI pump motor journal bearing.

Immediate corrective actions included replacement of the damaged HPSI pump motor outboard journal bearing, proper reassembly of the pump and motor, and completion of post-maintenance testing. Following maintenance, the train A HPSI pump was returned to service and declared operable.
