**Subject: 10 CFR 71.95 Report on the 8-120B Cask**

## **Failure to Observe Certificate of Compliance Conditions for the 8-120B Vent Port Pre-Shipment Leak Test**

### Details of the 8-120B Vent Port Leak Rate Test Setup

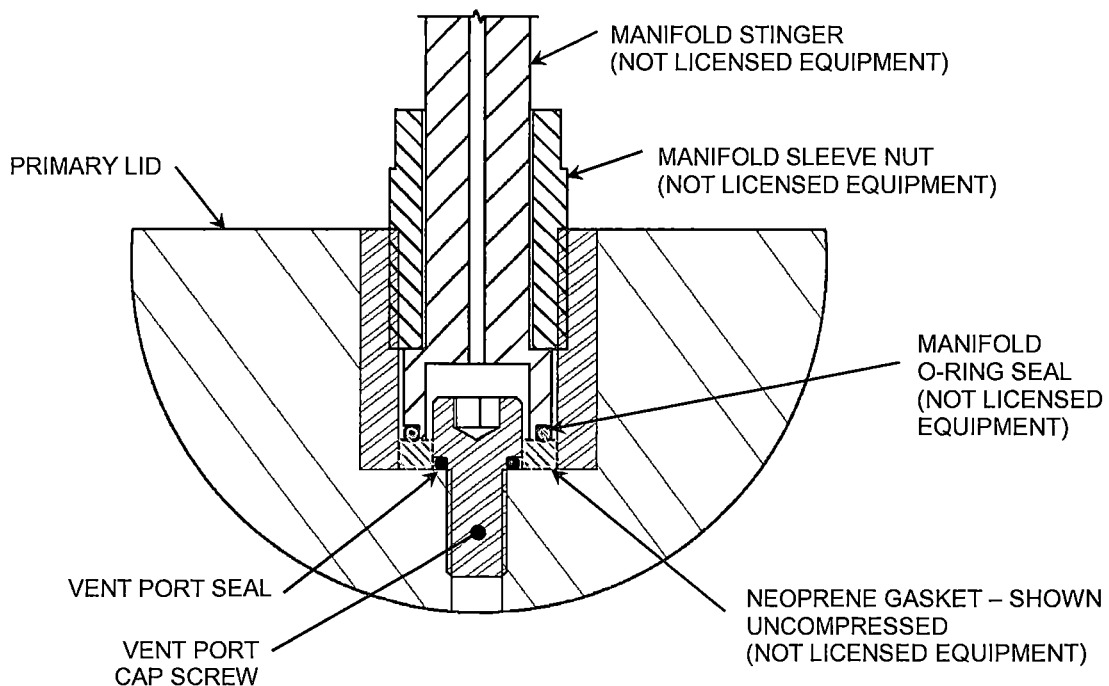
The neoprene gasket can constrict on the head of the vent port plug cap screw when it is compressed by the bottom end of the test manifold stinger, which could reduce the sensitivity of the pre-shipment leak test. Consequently, the vent port pre-shipment leak tests performed using the neoprene gasket may not have provided the required test sensitivity of  $1 \times 10^{-3}$  ref-cm<sup>3</sup>/sec.

The pre-shipment leak test of the vent port is a pressure drop test performed using a dedicated test manifold. The test manifold is not a part of the licensed package. It includes a stinger (shown below), an O-ring seal that contacts the stinger and the bottom of the vent port hole, and a sleeve nut to compress the O-ring seal. The test manifold was designed so that it surrounds the vent port cap screw, leaving a small gap between itself and the vent port cap screw. The 8-120B cask fleet began to ship with a new lid design in September 2013, and operations staff noted more frequent difficulty getting the manifold to seal. It became desirable to find a better way to seal the bottom of the manifold in order to minimize operator exposure. They found that adding a neoprene gasket (also not part of the licensed package) under the base of the stinger as shown below helped reduce testing time and exposure.
