FRAMATOME  
TECHNOLOGIES

## ENGINEERING INFORMATION RECORD

Document Identifier 51 - 5000239 - 00Title INTERIM BWOOG REPORT ON HPI/MU NOZZLE CRACKING

The purpose of this interim report is to collect information relative to the cracking found in the high pressure injection/makeup nozzle at Oconee Unit 2 in April, 1997. This report represents the first phase of a program to determine the root cause behind the cracking. This interim report does not attempt to determine the root cause behind the cracking. This report provides partial response to the Request for Information transmitted by the NRC on 5/27/97 (Attachment 1).

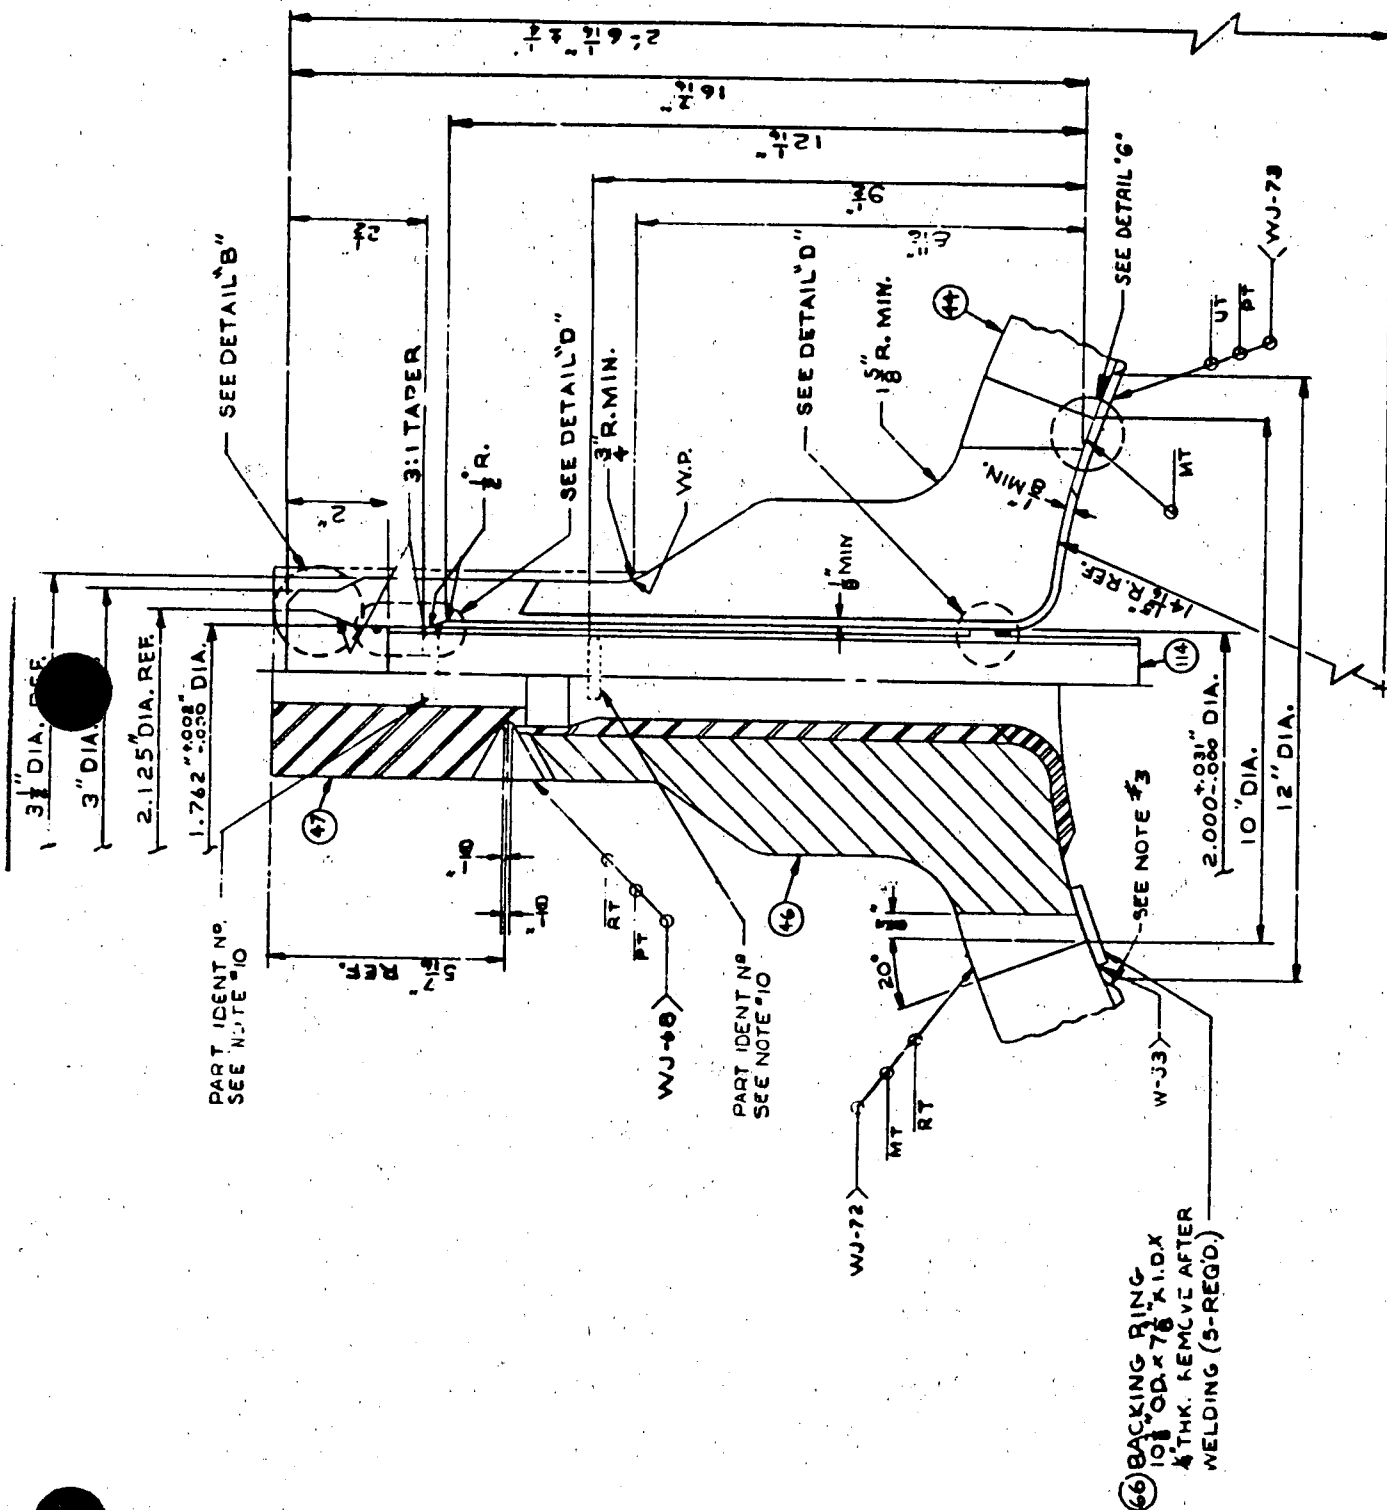
**Figure 3-1 Original Standard Design HPI/MU Nozzle  
(Excerpted from reference 29)**

1. Carbon steel nozzle body with stainless steel cladding
2. NiCrFe weld between nozzle body and safe end
3. Stainless steel safe end
4. Stainless steel weld between safe end and attached pipe or valve

5. Stainless steel thermal sleeve attached to safe end by contact roll at outboard (upstream end of the nozzle) end with 0.5 inch wide collar around the circumference containing a .010 to .015 inch diametral clearance to the nozzle body cladding at the inboard end (downstream end of the nozzle) (reference 1). The contact expansion length at the outboard end is approximately 2 inches long and wall thinning was not specified.

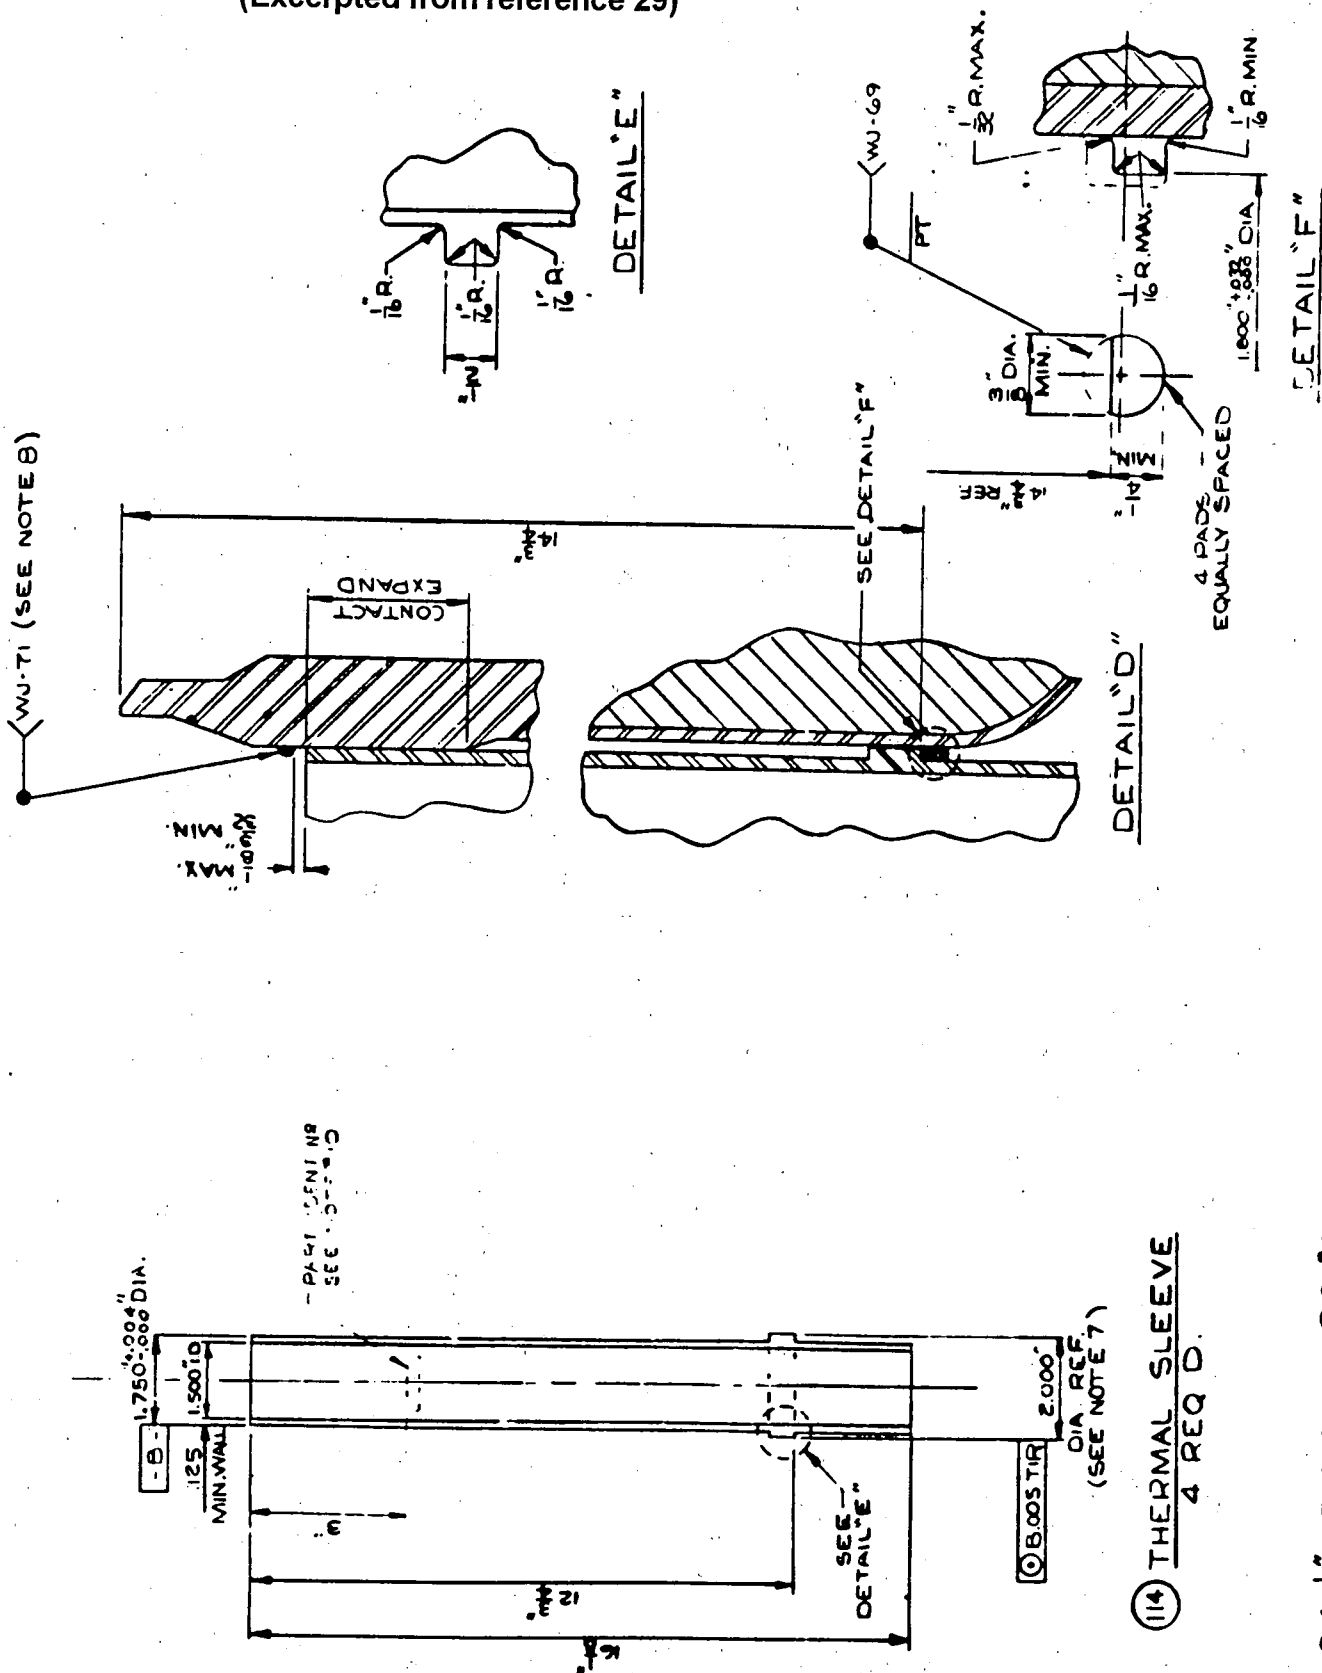
Figure 3-2 Original Standard Design HPI/MU Nozzle Thermal Sleeve Details  
(Excerpted from reference 29)

0.4-1" WELD BEADS @ 90° TO BE ATTACHED AFTER PADS (PER DETAIL "F") AND THERMAL SLEEVE ARE IN PLACE.

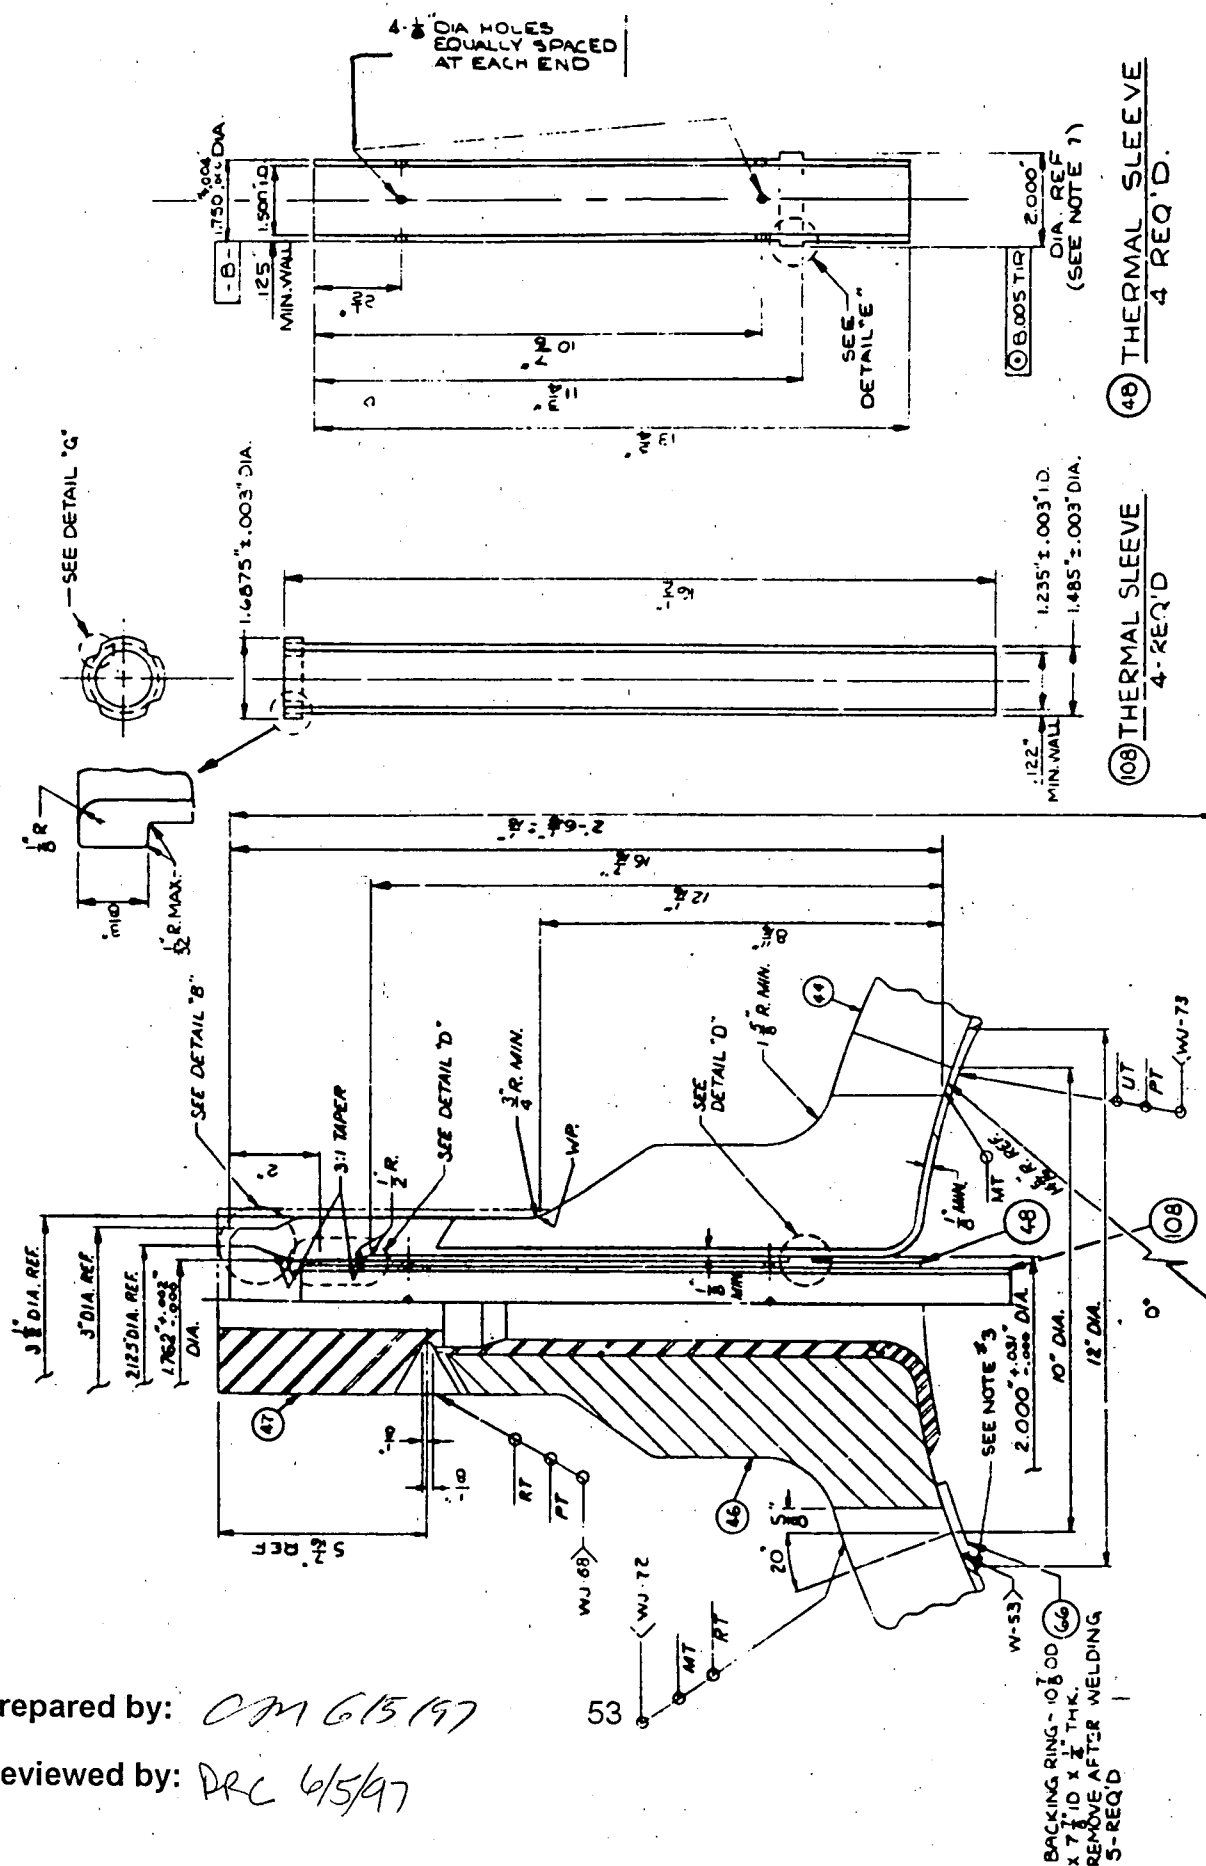
**Figure 3-3 Ocone Unit 1 Double Thermal Sleeve HPI/MU Nozzle  
(Excerpted from reference 30)**

1. Carbon steel nozzle body with stainless steel cladding
2. NiCrFe weld between nozzle body and safe end
3. Stainless steel safe end
4. Stainless steel weld between safe end and attached pipe
5. Double stainless steel thermal sleeve - Original thermal sleeve is attached to safe end by contact roll at outboard end with 0.5 inch wide collar around the circumference containing a .010 to .015 inch diametral clearance to the nozzle body

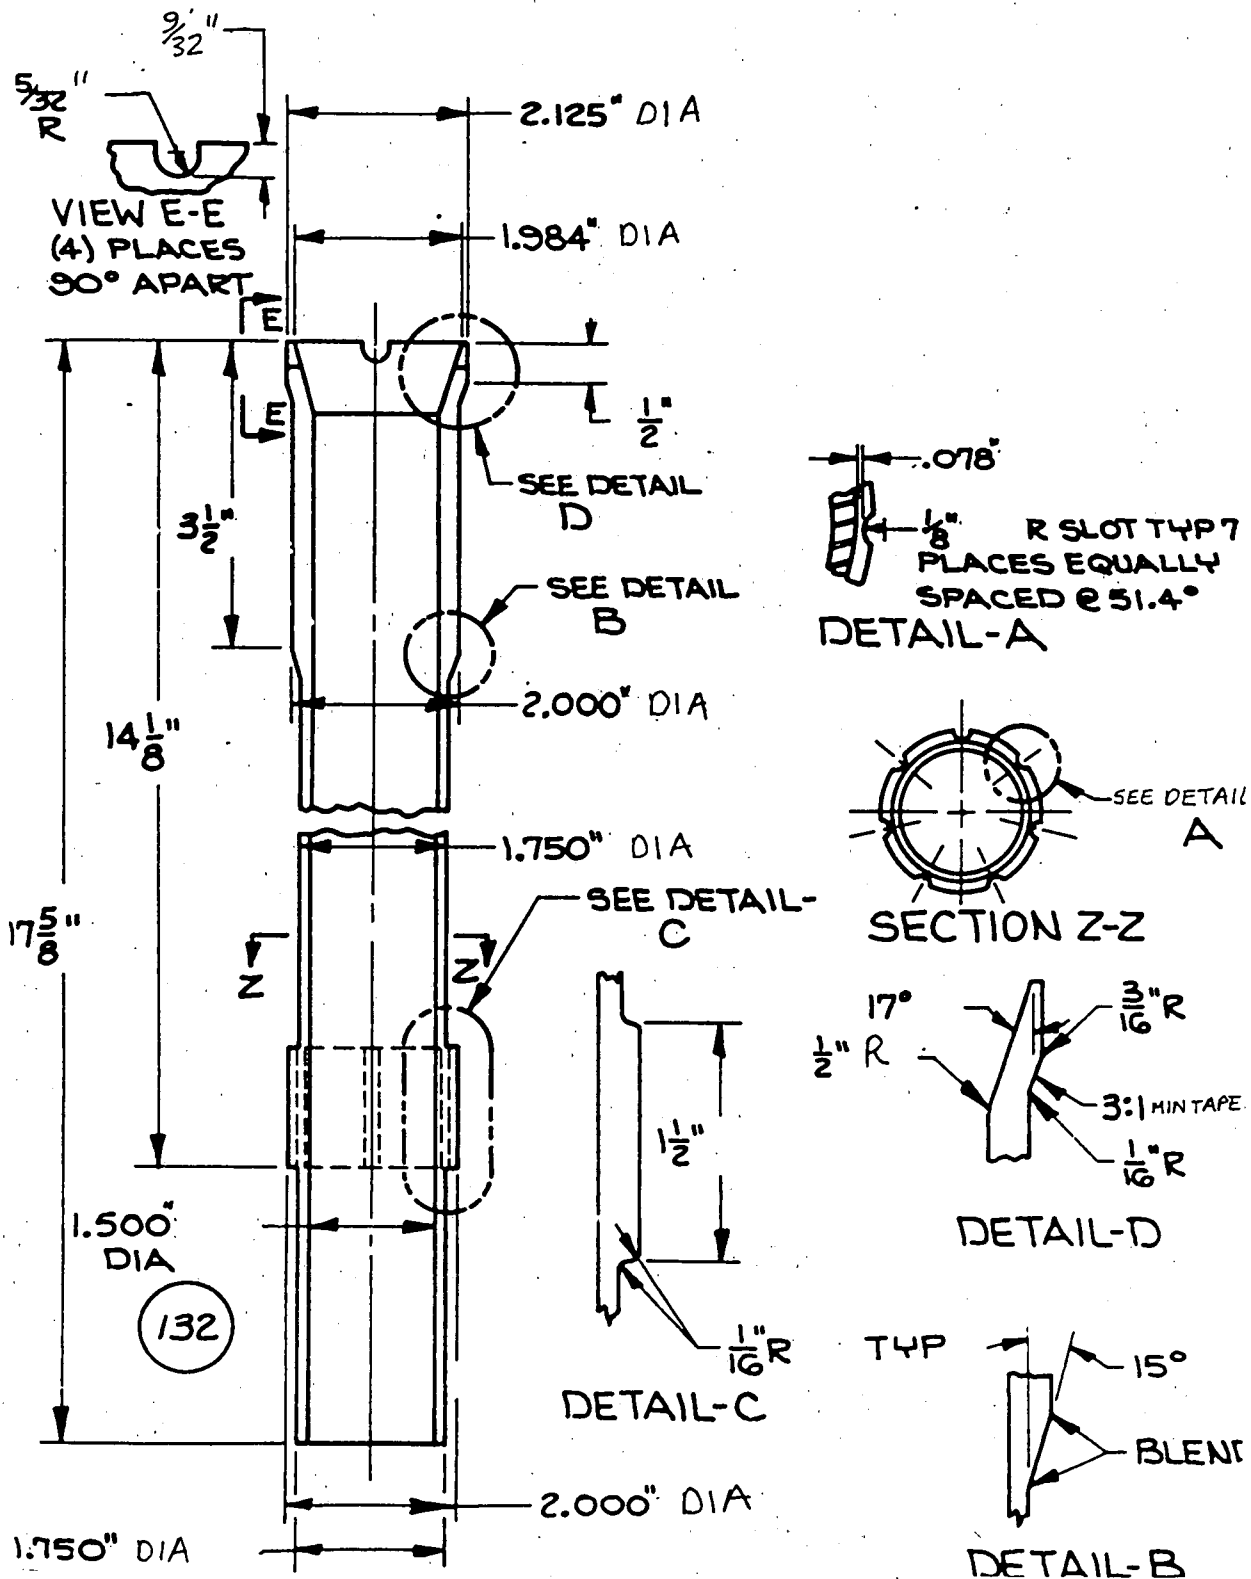
Figure 3-5 Improved HPI/MU Nozzle Design Thermal Sleeve  
(Excerpted from reference 31)

1. Stainless steel thermal sleeve attached to safe end by hard roll at outboard end with a 1.5 inch wide collar around the circumference contact expanded against the nozzle body cladding at the inboard end. The hard roll expansion length at the outboard end is approximately 2.72 inches long and recommended wall thinning is 5% (reference 1). The outboard end also contains a bell shaped region that provides additional stability.
2. The thermal sleeve is slotted to receive four weld beads upstream of the hard roll expansion region. The intent of these weld beads is to provide axial restraint to prevent displacement of the thermal sleeve.

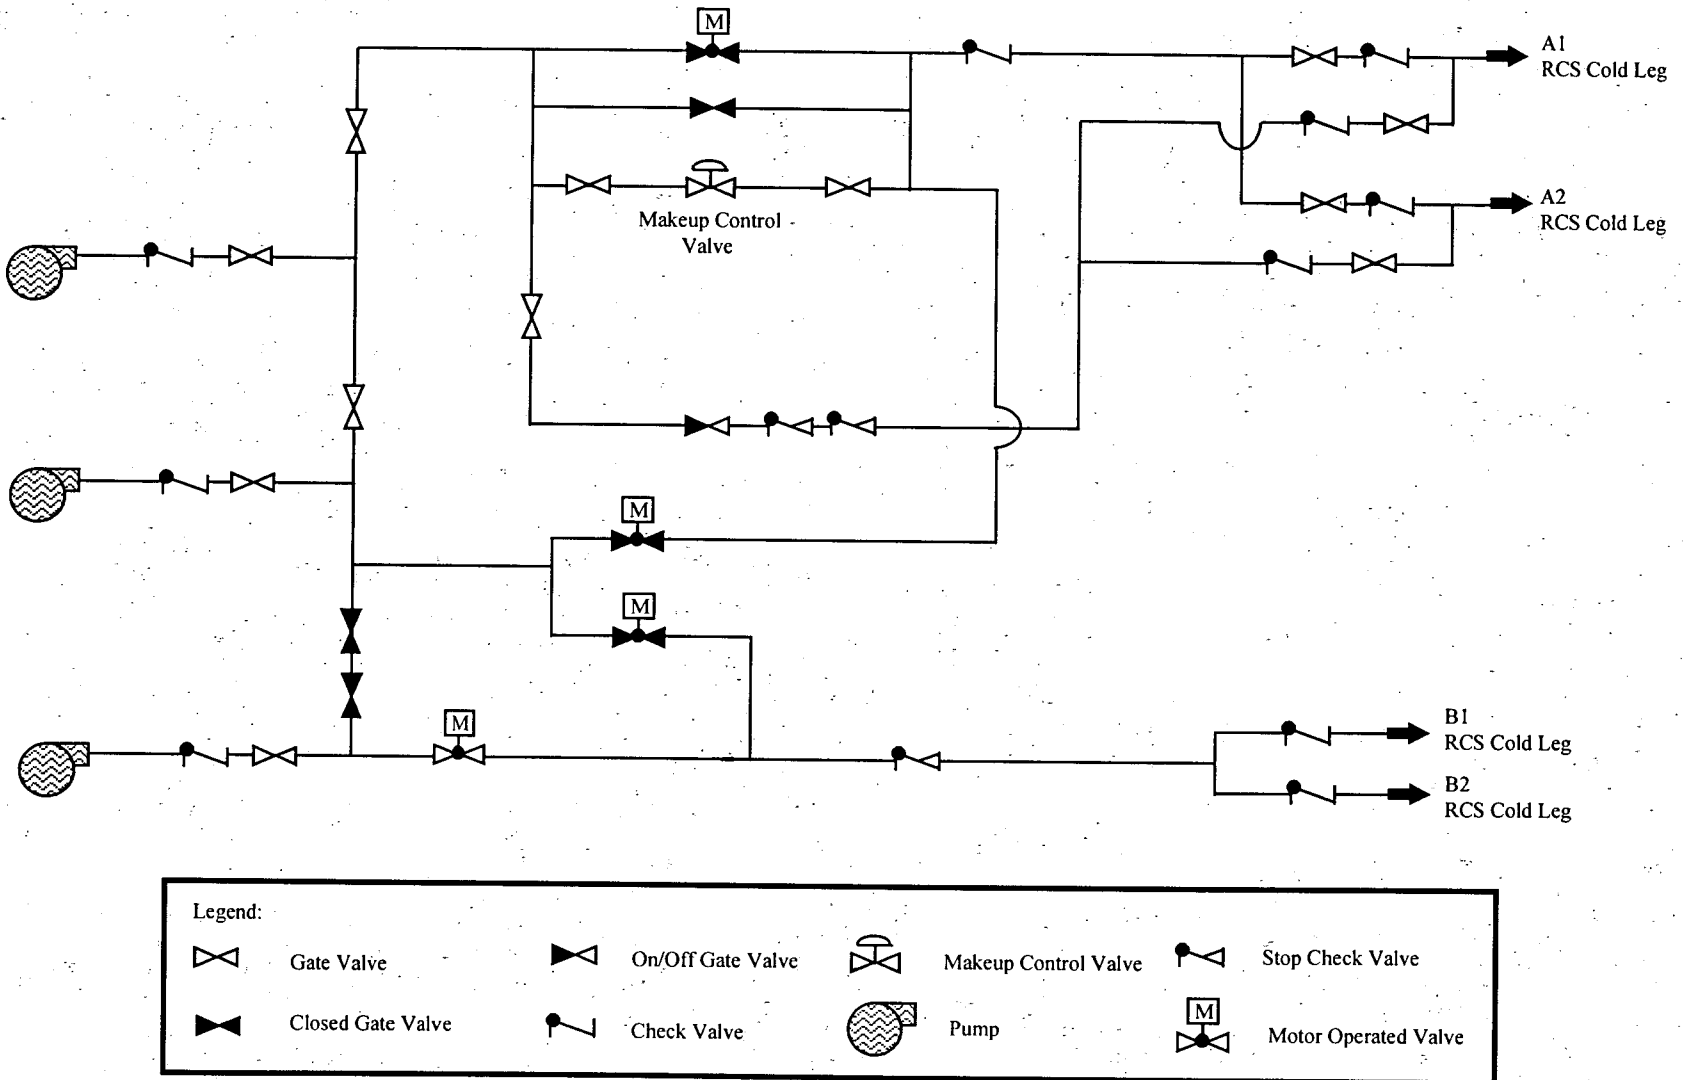
Figure 6-1 Ocone 1, 2, &amp; 3 HPI/MU System Schematic

Figure 6-1 shows that the loop B1 and B2 HPI-only nozzles are "cross-connected" as are the loop A1 and A2 HPI/MU nozzles. This means that backflow from the loop B1 HPI-only nozzle to the loop B2 HPI-only nozzle is possible if one of the two check valves separating the two nozzle leaks. The reverse situation is also possible. The same situation is possible for the loop A1 and A2 HPI/MU nozzles. The bypass lines which enter the HPI/MU lines just upstream of the loop A1 and A2 HPI/MU nozzles are also "cross-connected". With this configuration, bypass flow can be diverted to the line with the highest differential pressure which can occur during single RC pump operation.

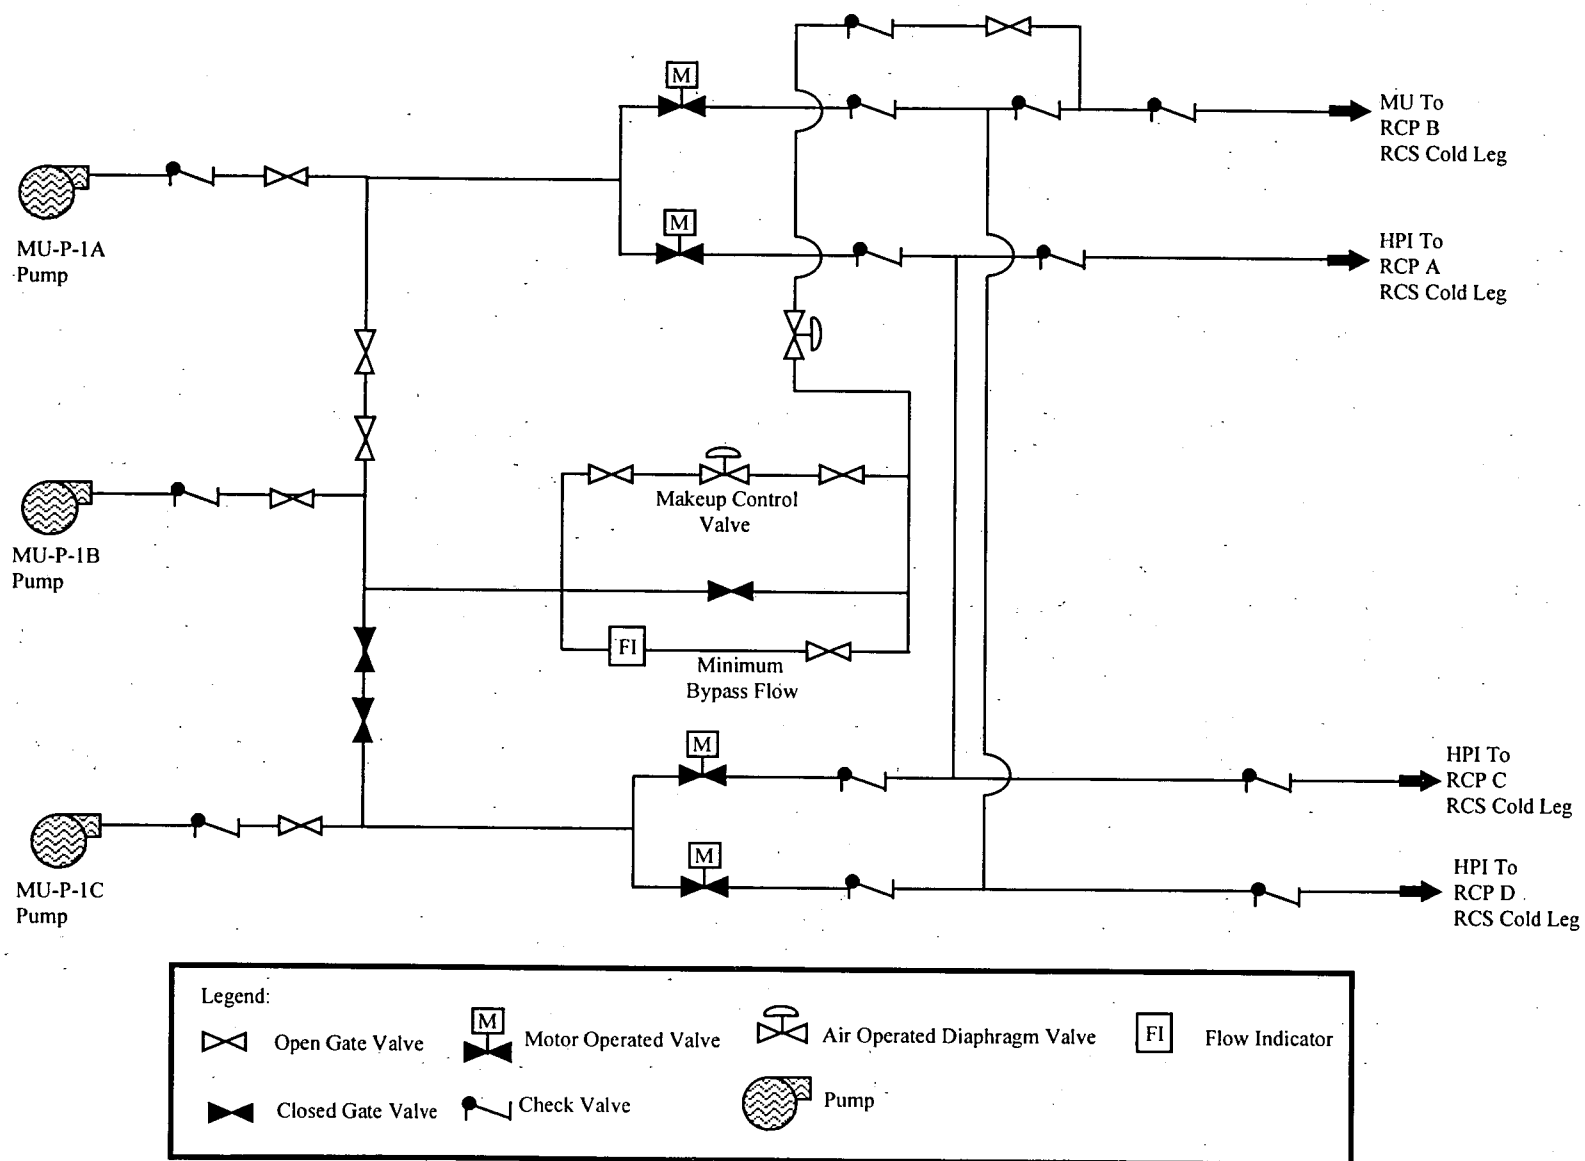
Figure 6-2 TMI 1 HPI/MU System Schematic

Figure 6-2 shows that the loop A and C HPI-only nozzles are "cross-connected" as are the loop D HPI-only and loop B HPI/MU nozzles. This means that backflow from the loop A HPI-only nozzle to the loop C HPI-only nozzle is possible if one of the two check valves separating the two nozzle leaks. The reverse situation is also possible. The same situation is possible for the loop D HPI-only and loop B HPI/MU nozzles except that there is an extra check valve upstream of the loop B HPI/MU nozzle.
