OSC-6547 Performed CGA

The purpose of this calculation is to determine if the portions of the Unit-2 "B" LPI piping and components exceeded design parameter(s) resulting from pressurization during heat up. This calculation is performed to resolve PIP 2-097-1553.

**METALLURGICAL EXAMINATION  
OF  
OCONEE-2A2 MPI COMPONENTS**

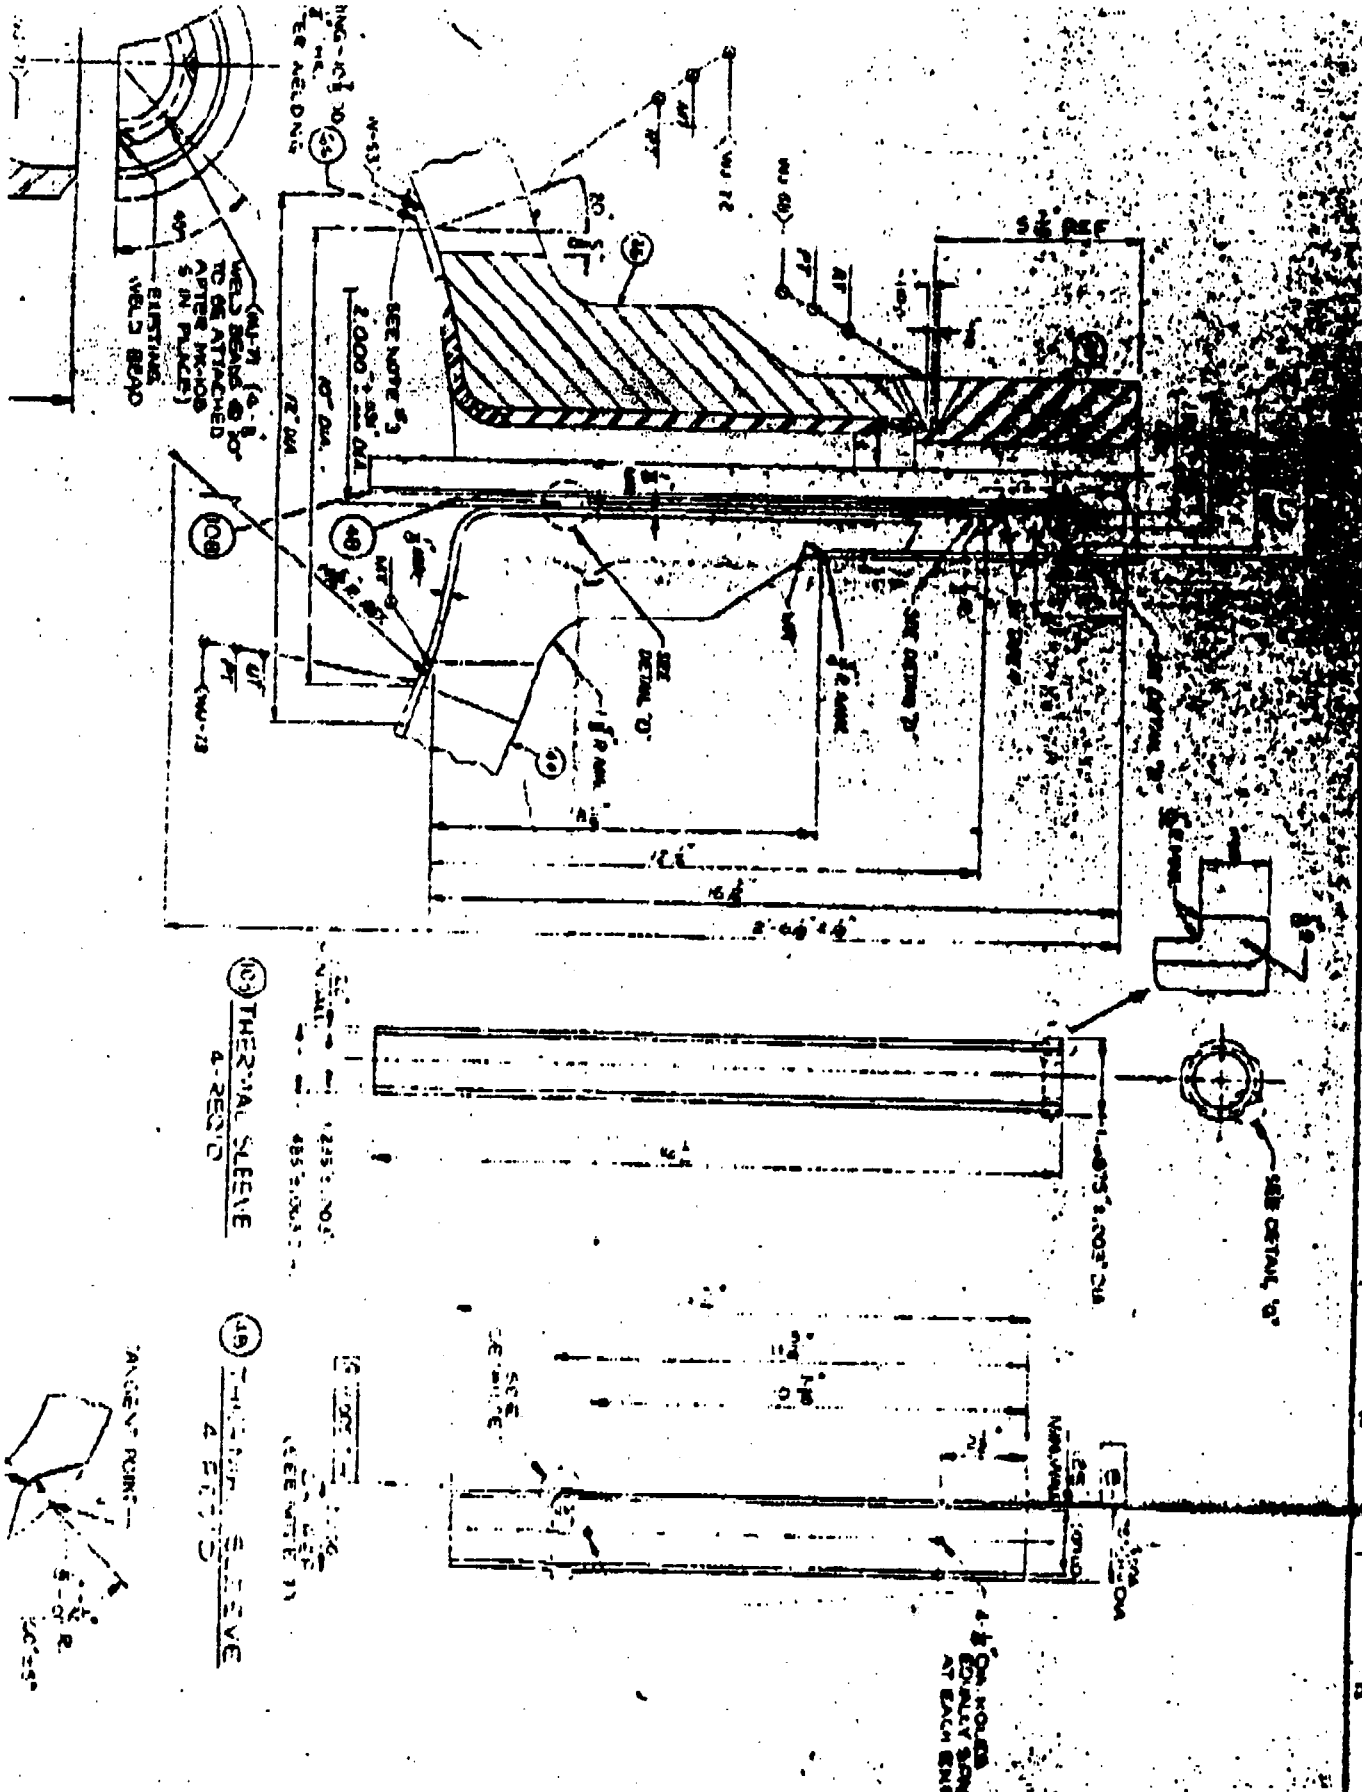
(10) THERMAL SLEEVE

- **Material loss on thermal sleeve** - there was obvious material loss along the RCS downstream side of the thermal sleeve, consisting of an irregular-shaped pattern approximately 4-1/4 inches long through a maximum 150° arc; long, axial cracks were associated with the material loss area, extending from the outlet end of thermal sleeve through the collar region and ending approximately mid-length on the sleeve (i.e., about 7-1/2 inches from inlet end); the longest crack appeared to have propagated in the axial direction from the outlet end toward the inlet end and exhibited signs of blunting at the tip.

- **Wear damage on the thermal sleeve & safe-end** - Significant wear was noted along the RCS downstream side of the sleeve extending from its deepest (~0.048 inch) and widest (~150°) point about one inch downstream of the collar, tapering out to the

nominal OD surface about 5 inches in back of the collar; a deep circumferential wear groove was observed adjacent to the collar on the downstream side (i.e., correlating to location of downstream weld pads); at its deepest point, this groove extended nearly through the wall of the sleeve; circumferentially oriented cracks were also observed in these thinned regions adjacent to the collar; significant wear was observed at the rolled end of the thermal sleeve to approximately 2-1/4 inches from the inlet end; the deepest portion was approximately 0.040 inches on the RCS downstream side.

3. The wear damage, material loss and long axial cracking observed near the outlet end of the thermal sleeve is more likely the result of flow induced vibration (FIV) from RCS cross-flow excitation, although initiation of the long axial cracks may have been due to localized thermal fatigue in this region. Wear in the rolled region is also consistent with FIV.
