LEUPA

Type B(U) Package to Contain Fissile Substances

**TESTS CARRIED OUT ON SPECIMENS
OF THE DESIGN OF TYPE B(U)
PACKAGE TO TRANSPORT
RADIOACTIVE MATERIAL
FINAL REPORT**

INAP

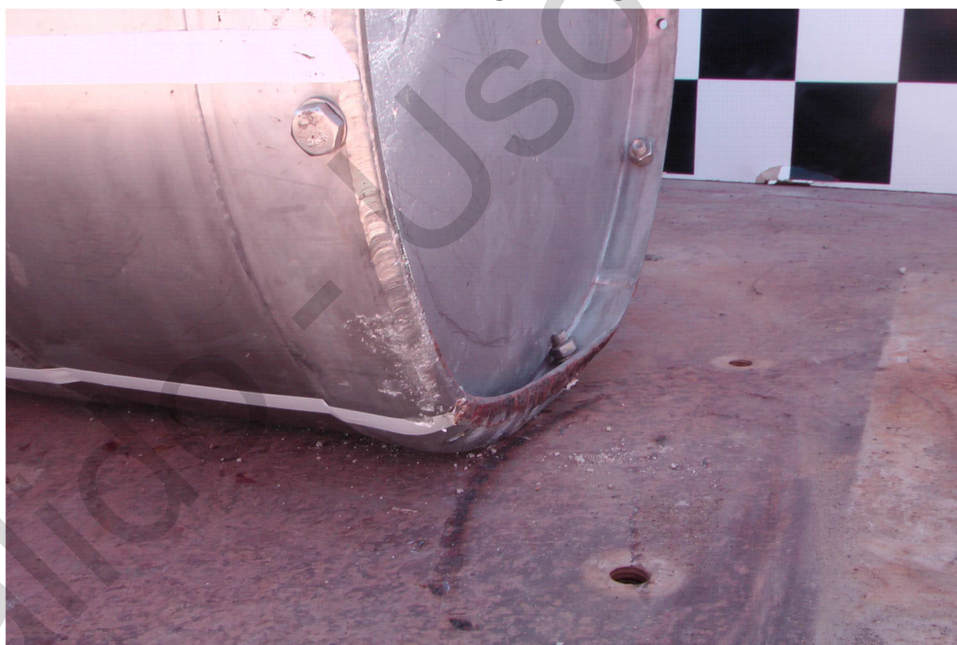
Picture 8: Package damage (free drop test)

7. The specimen was released, hitting into target, it produced the flattening of the inferior ferrule at the bottom of the container (see Picture 8:).

1. Visual inspection showed a flattening of the inferior ferrule at the bottom of the specimen of around 290 mm in length and the falling of two (2) bolts in the same place.
2. No insulating thermal material was released.
3. There were no further damages in other parts of the specimen.
4. After certifying and evaluating the suffered damages by the specimen LEUPA 01, the test was considered satisfactory, and the specimen was released for the following test.

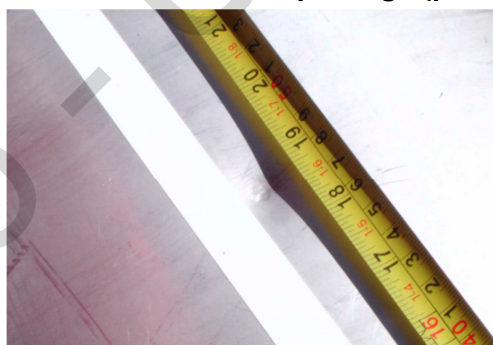
Picture 10: Mark in the package (penetration test)

3. The 1 m drop height was verified by means of a witness specially prepared, and with a tape measure.
4. The bar which crashed into the specimen was freed, it left a small mark (see Picture 10:).

1. In visual inspection it could be seen that the 6 kg bar left on the specimen a small mark of around 14 mm diameter and 3 mm in depth.
2. The drop of the bar produced no further damage in the specimen structure.
3. The drop of the bar did not make any release in the insulating material.
4. The damage on the specimen was minimum.
5. After certifying and evaluating the damages suffered by the LEUPA specimen 01, the test was considered satisfactory; it was then released for accident condition tests.

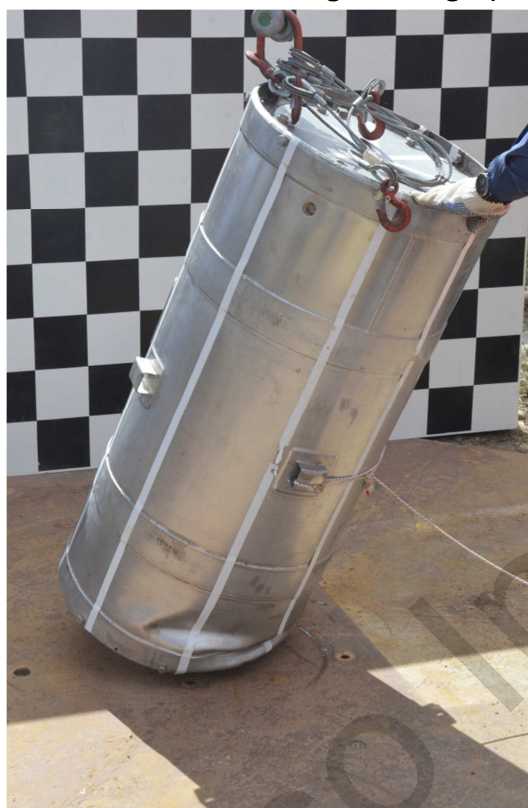
Picture 12: Package damage (drop I)

1. In the inspection following the test, a deformation on the inferior part of the bottom, where the impact was produced, could be seen.
2. This deformation produced a cave-in of around 75 mm at the bottom of the specimen LEUPA 01.
3. It could also be seen that two (2) bolts were cut off from the bottom and another one at the upper part due to the rebounding of the specimen.
4. During inspection it was verified that all the welds of the specimen were intact, we can therefore infer that the cut-off bolts do not imply an important damage.
5. After certifying and evaluating the damages suffered by the LEUPA specimen 01, the test was considered satisfactory; it was then released for the following test.

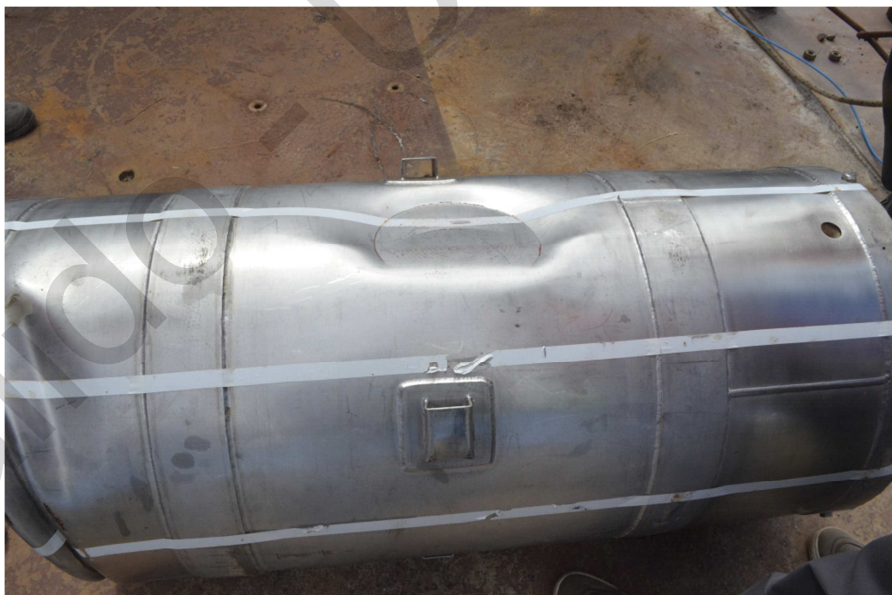
Picture 14: Package damage (drop II)

3. After verifying the drop height, the specimen was dropped, hitting on the cylindrical penetrator which produced a dent on its central area (see Picture 14:).

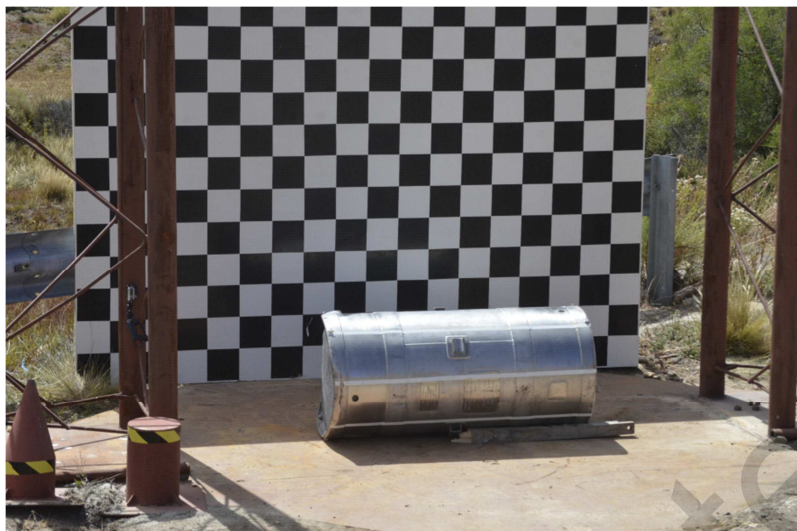
Picture 15: Package after drop

1. Once the test was finished, there was a visual inspection of the specimen, the damage was verified and evaluated.
2. The impact made a circular mark of around 220 mm and a depth of 30 mm (see PHOTO 15).

3. No insulating material was released.
4. After certifying and evaluating the damages suffered by the specimen LEUPA 01, the test was considered satisfactory, and the specimen was released for the next test.

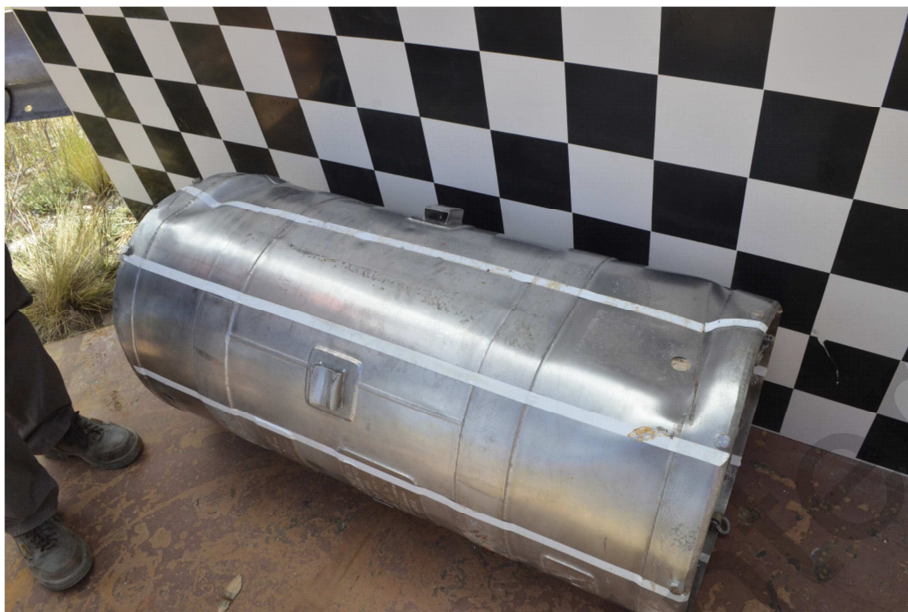
Picture 17: Package damage (drop III)

3. The 529 kg plate was fixed by means of an automatic release hook and it was lifted up to the 9 m height described in Specification No. 0908-LE02-3BSIN-002 and required as to Standard AR 10.16.1 – Rev. 2 (see Picture 16:).
4. Once the drop height was verified, the plate was dropped landing on the specimen producing a flattening of the surface (see Picture 17:).

1. After the drop was finished, a visual inspection of the damages produced, verified a slight flattening at the impact area.
2. There was also a small release of insulating material through the pressure release holes.
3. After certifying and evaluating the damages suffered by the specimen LEUPA 01, the test was considered satisfactory, and the specimen was released for the next test.

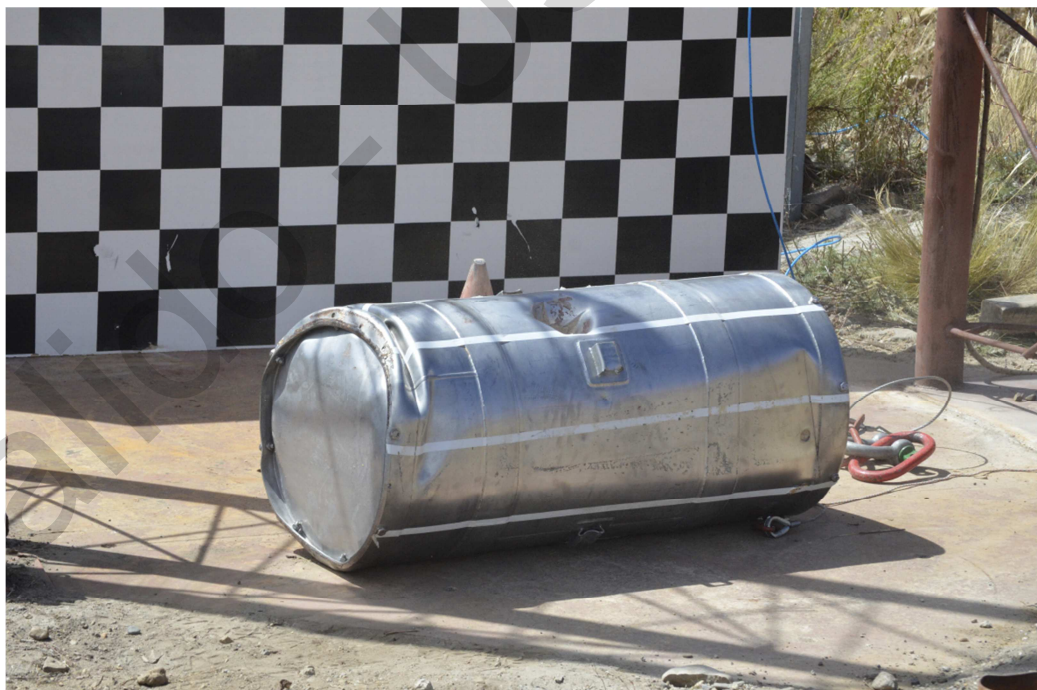
Picture 19: Package damage (drilling – tearing test)

1. Once the test was finished, a visual inspection of the specimen was carried out which verified and evaluated the damages produced during test.
2. The impact made a conical hole of around 140 mm in diameter and 180 mm in depth.

3. There was release of insulating material in the impact area.
4. No damages were seen in the inner structure of the package.
5. After the test a situational analysis was performed, and the continuity of tests was evaluated.
6. After certifying and evaluating the damages suffered by the specimen LEUPA 01, the test was considered satisfactory, and the specimen was released for the next test.

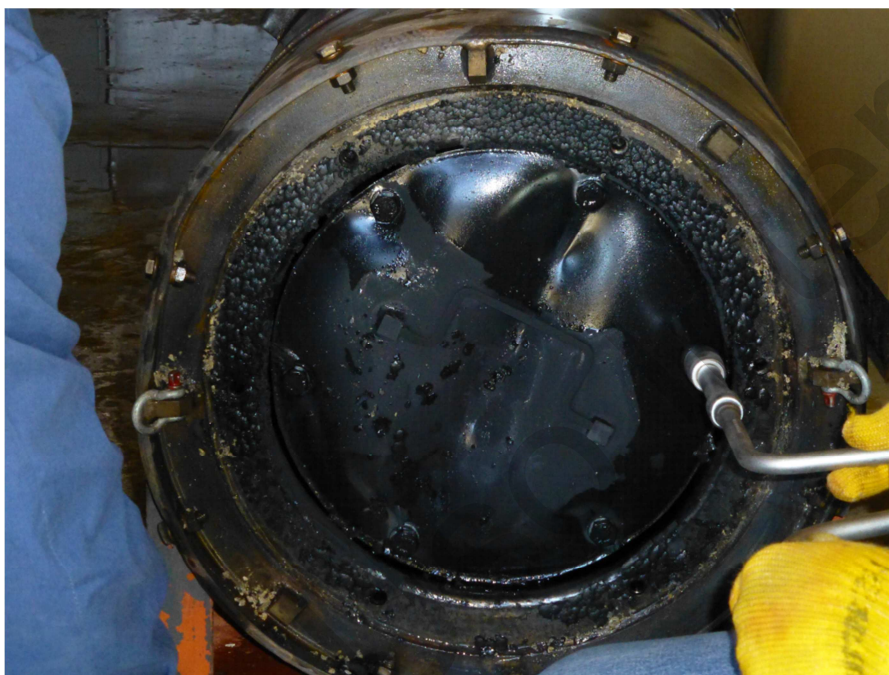
Picture 25: Intermediate cover after tests

5. The joint was burnt; it had not lost its form and was adhered to the container flange.
6. The intermediate cover was deformed, and some parts were slightly swollen.
7. It could be seen that the second compartment was wet, but the flange of the container of the inner cans was in perfect conditions (see Picture 26:).

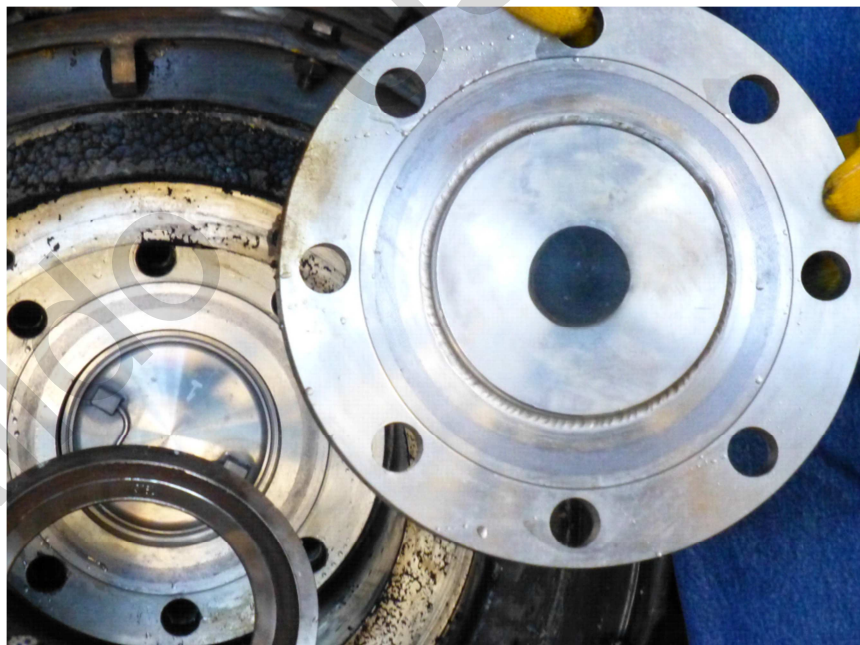
Picture 27: Primary containment flange after tests

8. The bolts of the flange were removed, and it could be seen that they had kept the same torque (approx. 60/70 Nm).
9. When the flange was removed, it could clearly be observed that its state was perfect, as well as the gasket, and the inner cans.

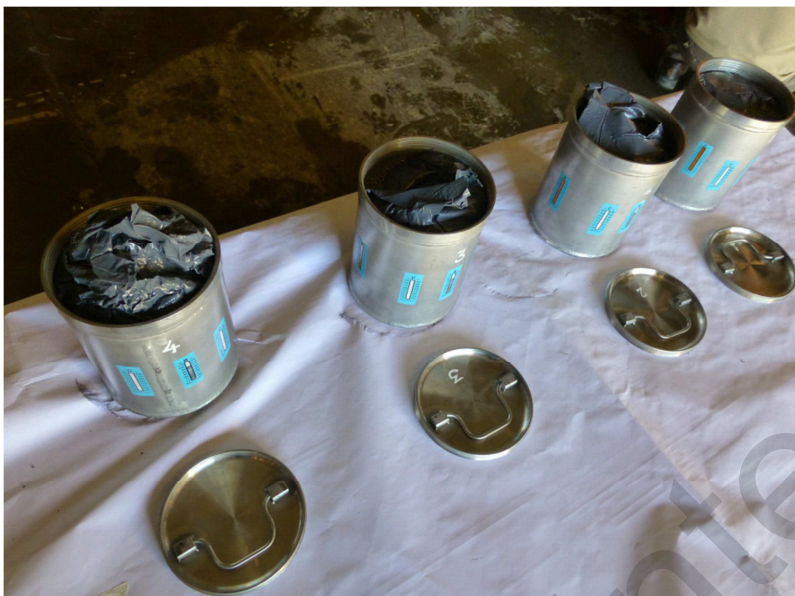
Picture 28: Inner cans after tests

10. The four (4) inner cans were taken out and their perfect state was verified.
11. The temperature in their outer surfaces was between 90 °C and 110 °C (see Picture 28:).
