**From:** Waters, Roger M. [rwater1@entergy.com]  
**Sent:** Monday, July 22, 2013 10:53 AM  
**To:** Green, Kimberly  
**Subject:** the InfoGram on the Clevis Insert Cap Screws  
**Attachments:** AR2010-1804\_10-Year\_Reactor\_Vessel\_In-Service\_Inspection.pdf

IG-10-1

## **REACTOR INTERNALS LOWER RADIAL SUPPORT CLEVIS INSERT CAP SCREW DEGRADATION**

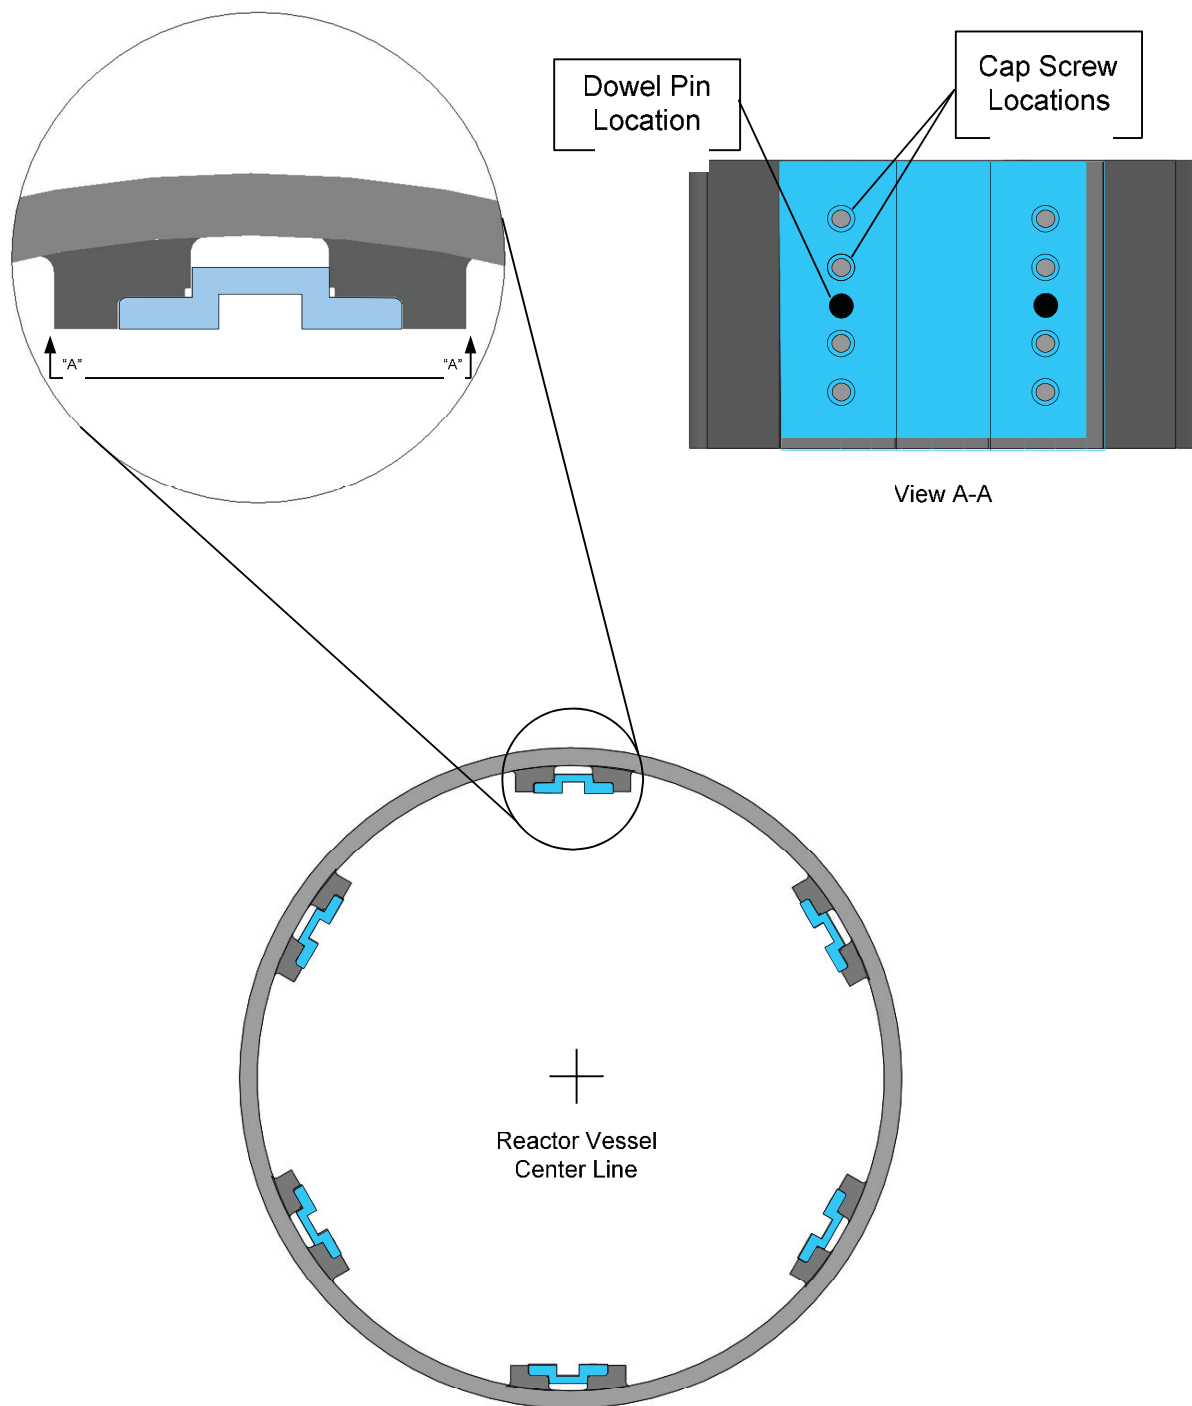
Figure 1. Radial Support Clevis Insert, Cap Screw and Dowel Pin Locations

During the March 2010 10-year in-service inspection (ISI) of the reactor vessel at D. C. Cook Nuclear Plant Unit 1, an anomaly was observed in the lower radial support clevis inserts. Figure 1 provides an overview of the radial support clevis insert configuration. At D. C. Cook Unit 1, each clevis insert features eight cap screws and two dowel pins which provide for retention of the insert. At a total of seven (of 48) cap screw locations, there was visual evidence that the cap screw head had detached from the shank. On one of the clevis dowel pins, the lock welds on the pin had broken and the pin was slightly rotated and displaced deeper into the insert. Reviews of video images from the previous 10-year ISI vessel inspection showed no indications of wear, fractures, or other anomalies with the clevis insert cap screws or dowel pins at any location.

Westinghouse is currently evaluating degradation mechanisms that could have contributed to the observed degradation. While not confirmed, the known susceptibility of Inconel X-750 to stress corrosion cracking and low temperature crack propagation is expected to be a contributor to the observed degradation.

Westinghouse also performed a detailed structural evaluation of the as-found condition of the clevis inserts. The analysis demonstrated the ability of the structure to function as required to meet criteria for one additional fuel cycle with no immediate physical modifications required. Westinghouse recommended that an inspection be performed at the next refueling outage and that appropriate actions be taken then for permanent repairs.
