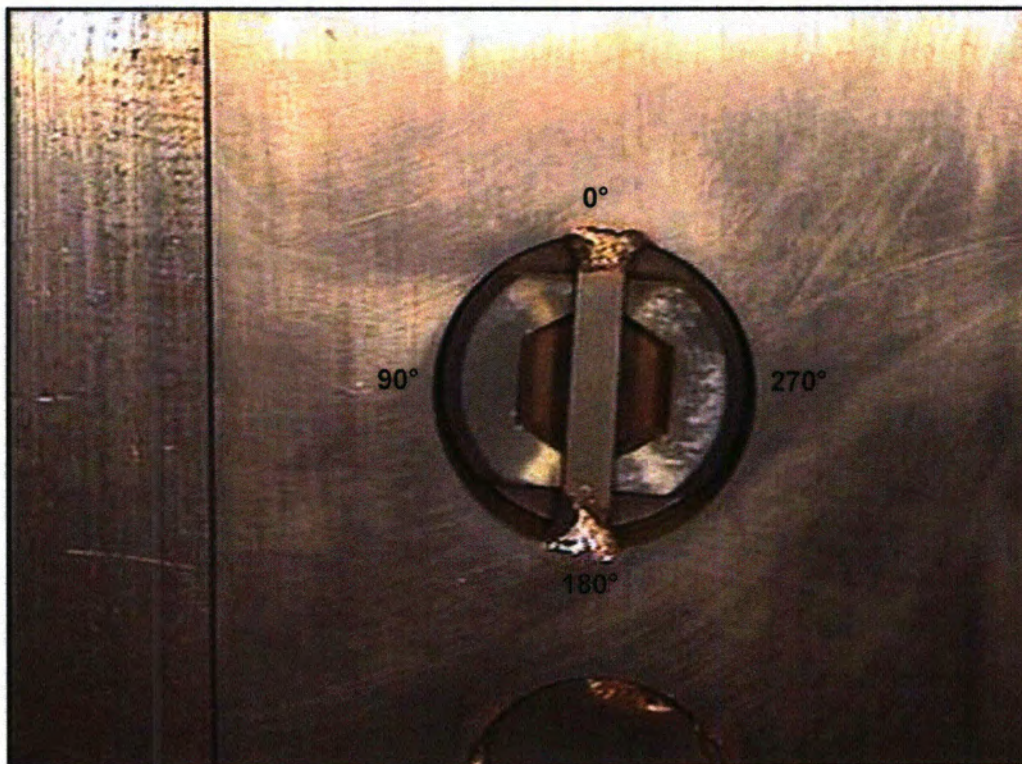
Figure 3: Bolt 120°-2, annotated with laboratory rotational orientations.

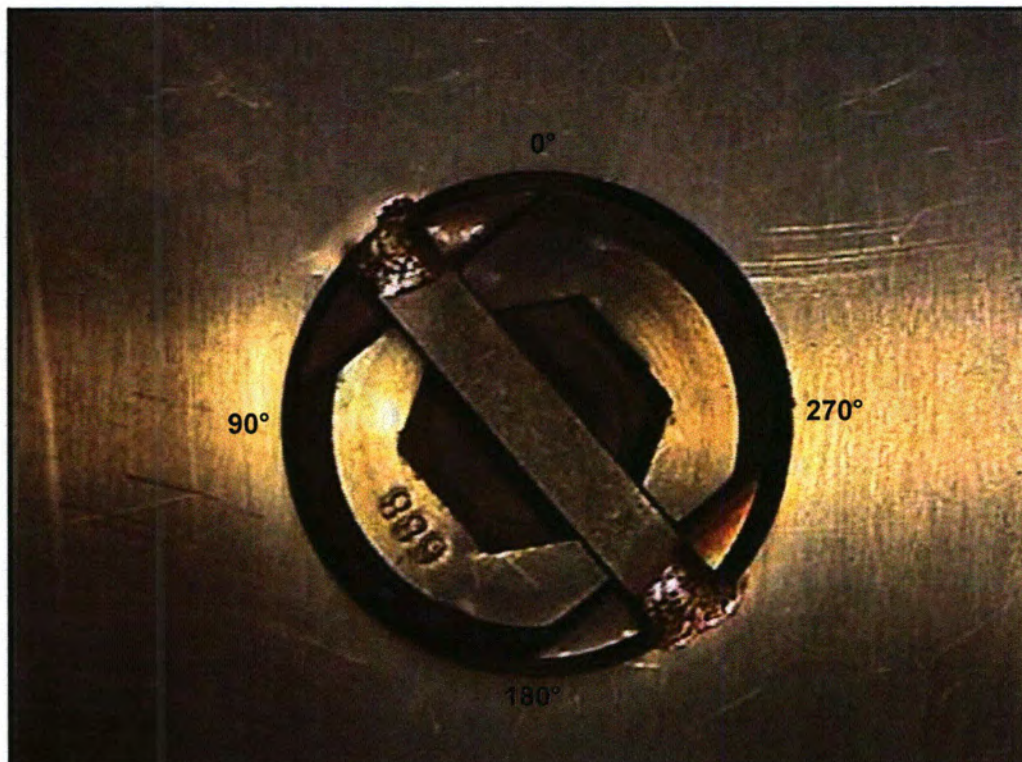
Figure 4: Bolt 120°-6, annotated with laboratory rotational orientations.

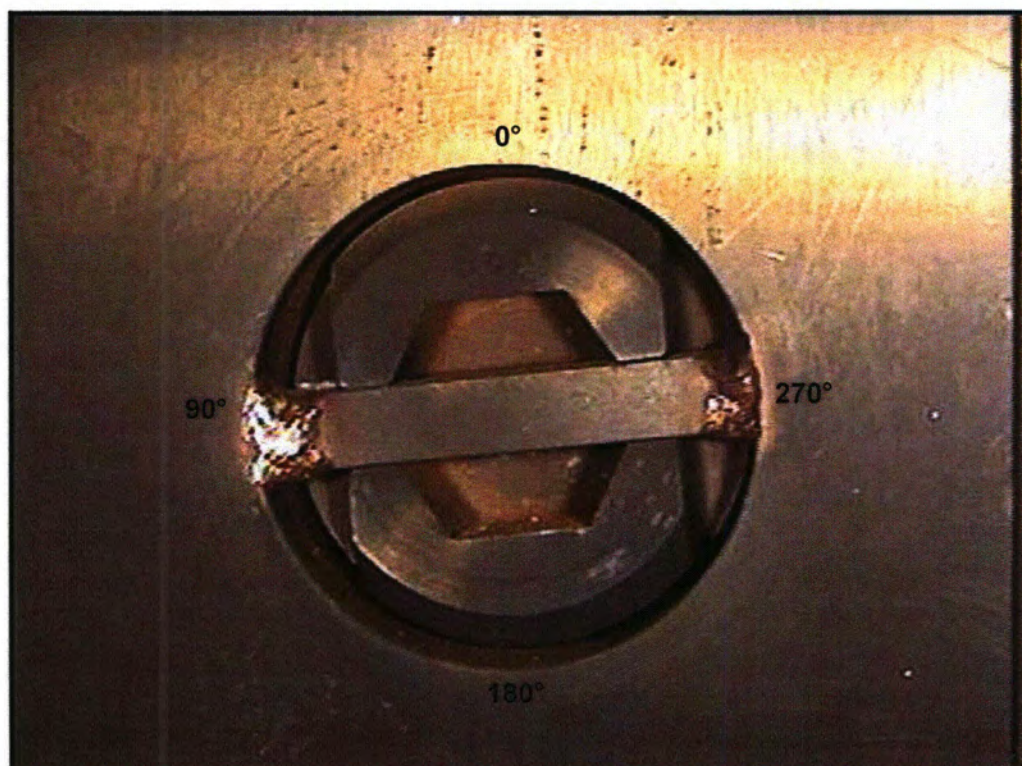
Figure 5: Bolt 240°-7, annotated with laboratory rotational orientations.

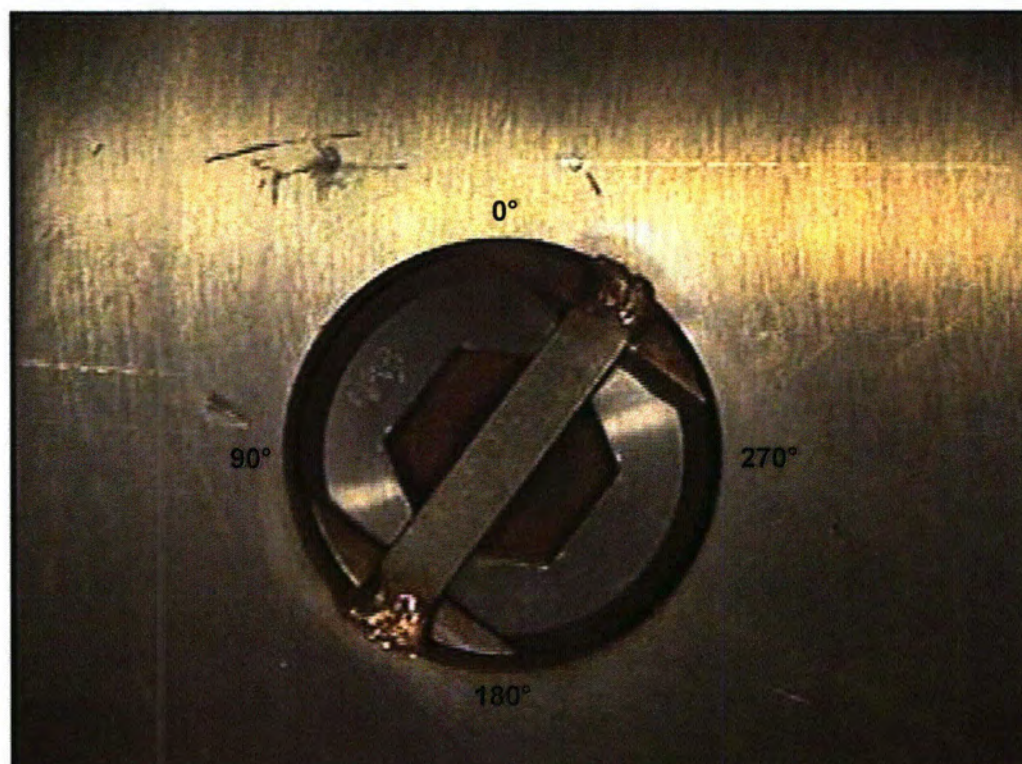
Figure 6: Bolt 300°-1, annotated with laboratory rotational orientations.

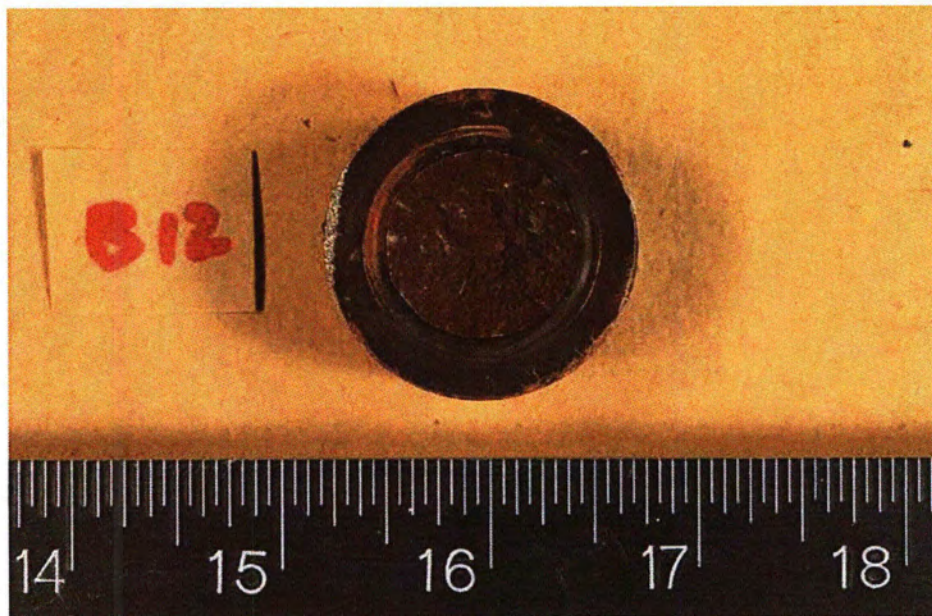
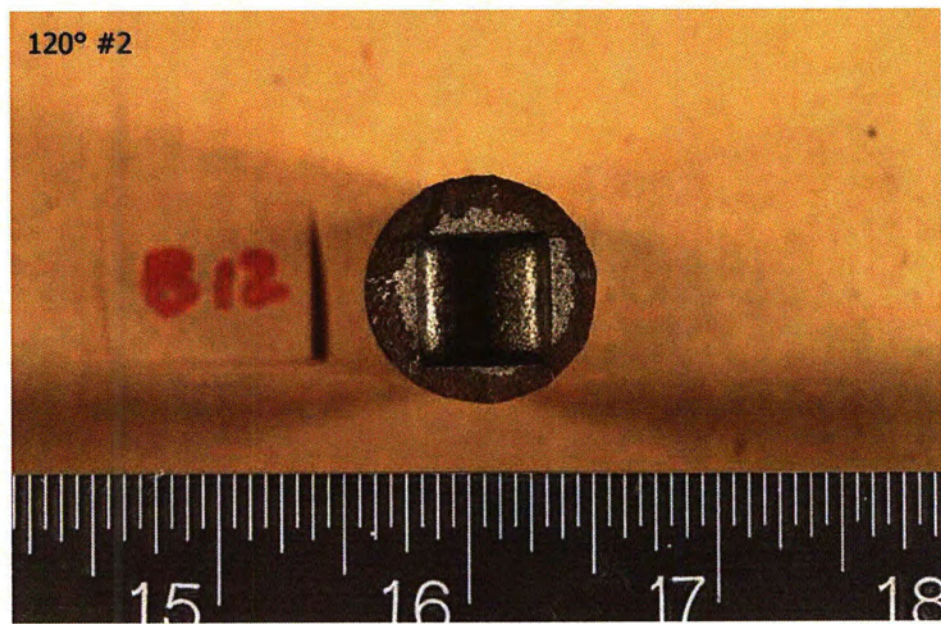
High magnification SEM examinations performed on the open cracks indicated the fracture surface was essentially 100% intergranular fracture. One small area near the center of bolt 120°-2 was mixed mode fracture consisting of transgranular cleavage and ductile microvoid coalescence. Cross section metallographic examinations confirmed the branched intergranular nature of the cracking in all four bolts examined.

Figure 16: Receipt macro photographs for bolt 120°-2.

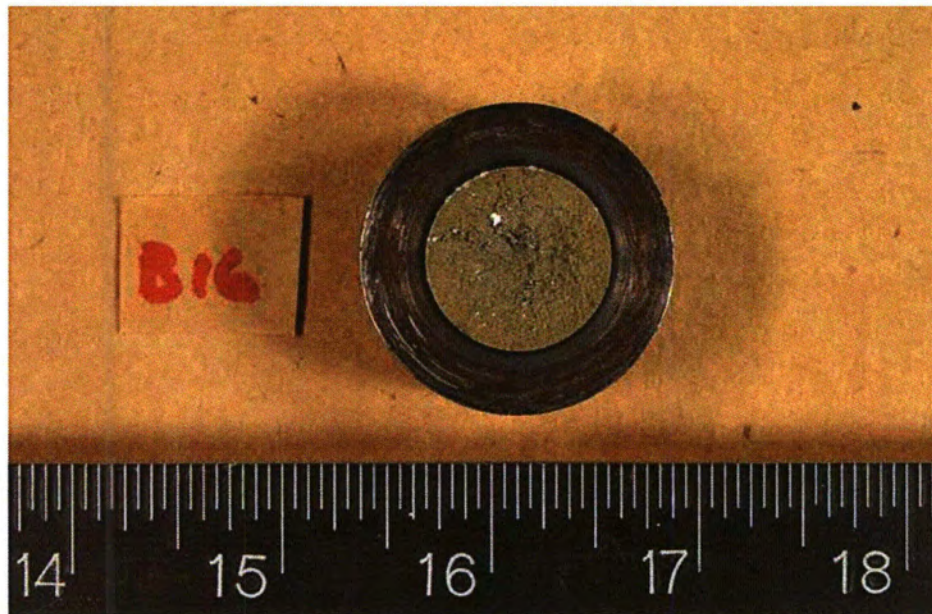
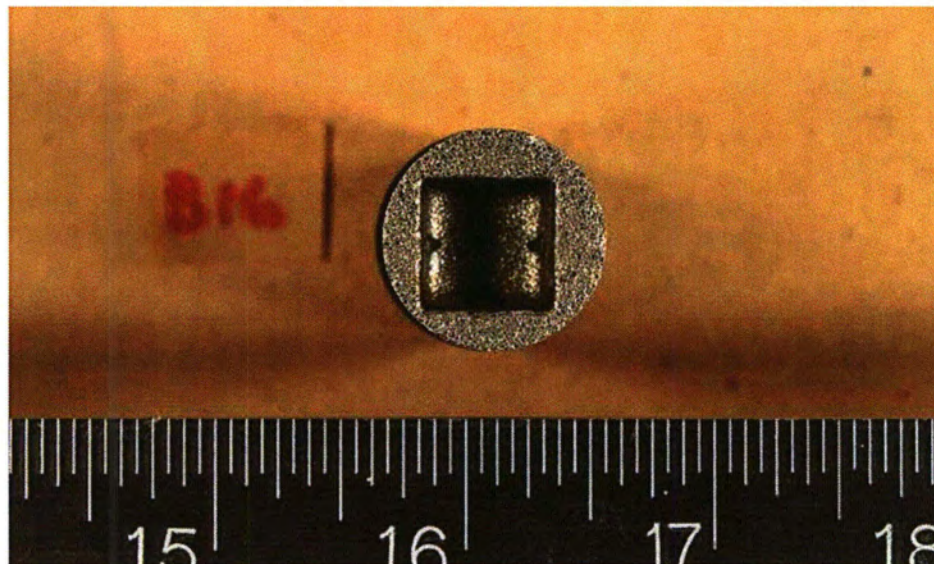
Figure 20: Receipt macro photographs for bolt 120°-6.

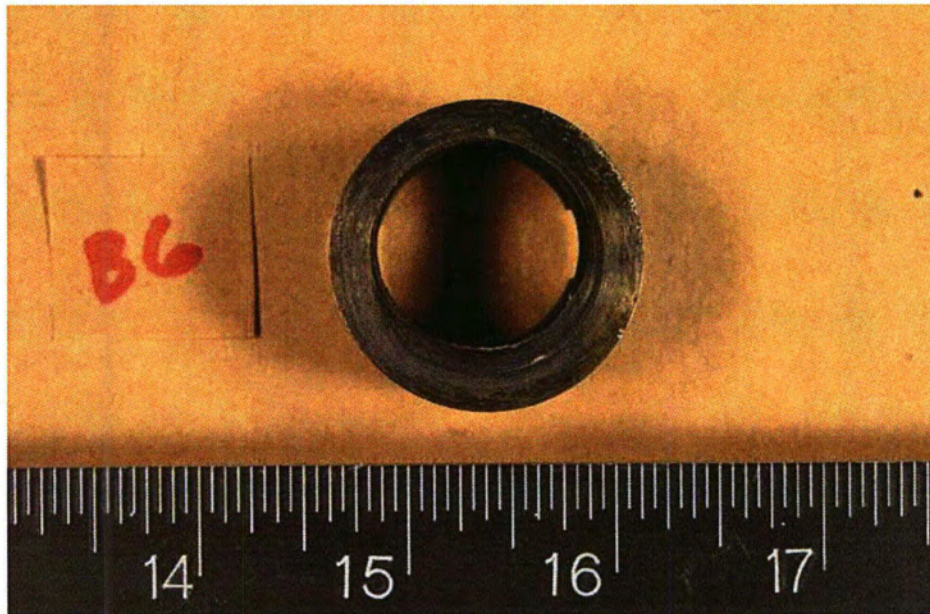
Figure 21: Receipt macro photograph for bolt 120°-7. The shank was not shipped to the laboratory.

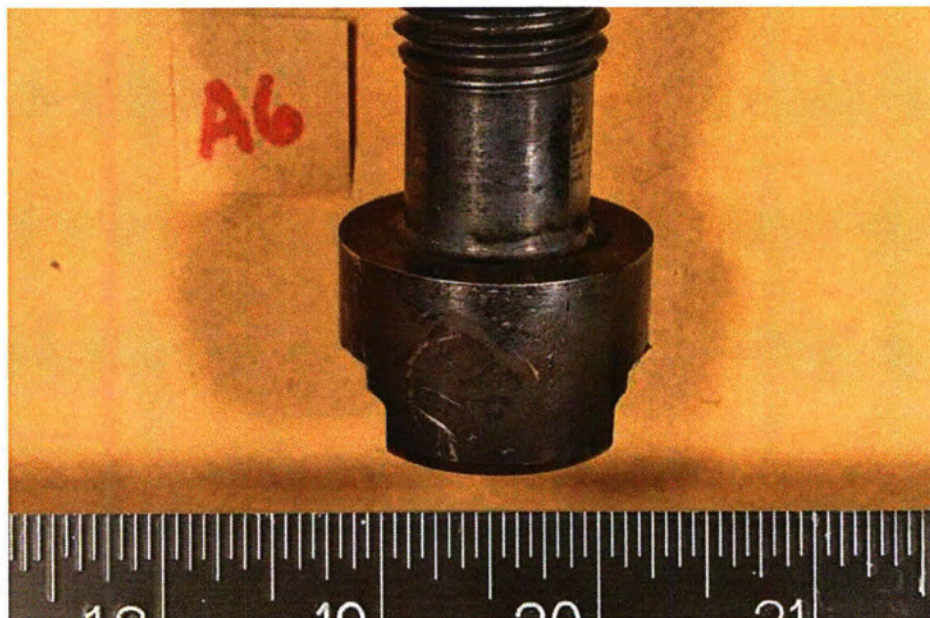
All of the thirteen (13) intact bolts contained cracking in the head/shank transition. No cracking was identified in the threaded region of any bolt. The amount of angled cracking varied among the bolts, from many angled cracks (e.g. 240°-7) to very minor angled cracking (e.g. 300°-1).

Figure 30: Receipt macro photograph for bolt 240°-7.

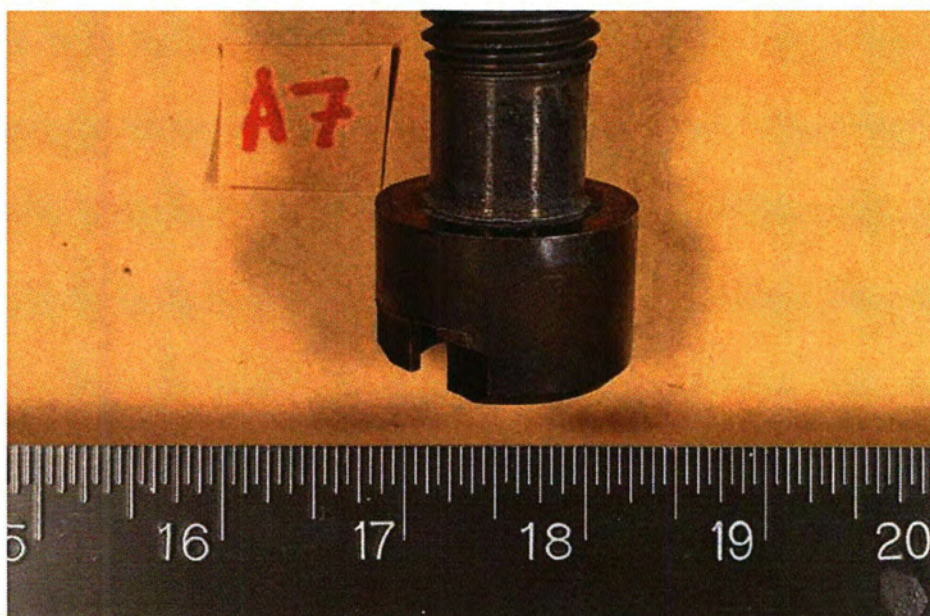
Figure 31: Receipt macro photograph for bolt 300°-1.
