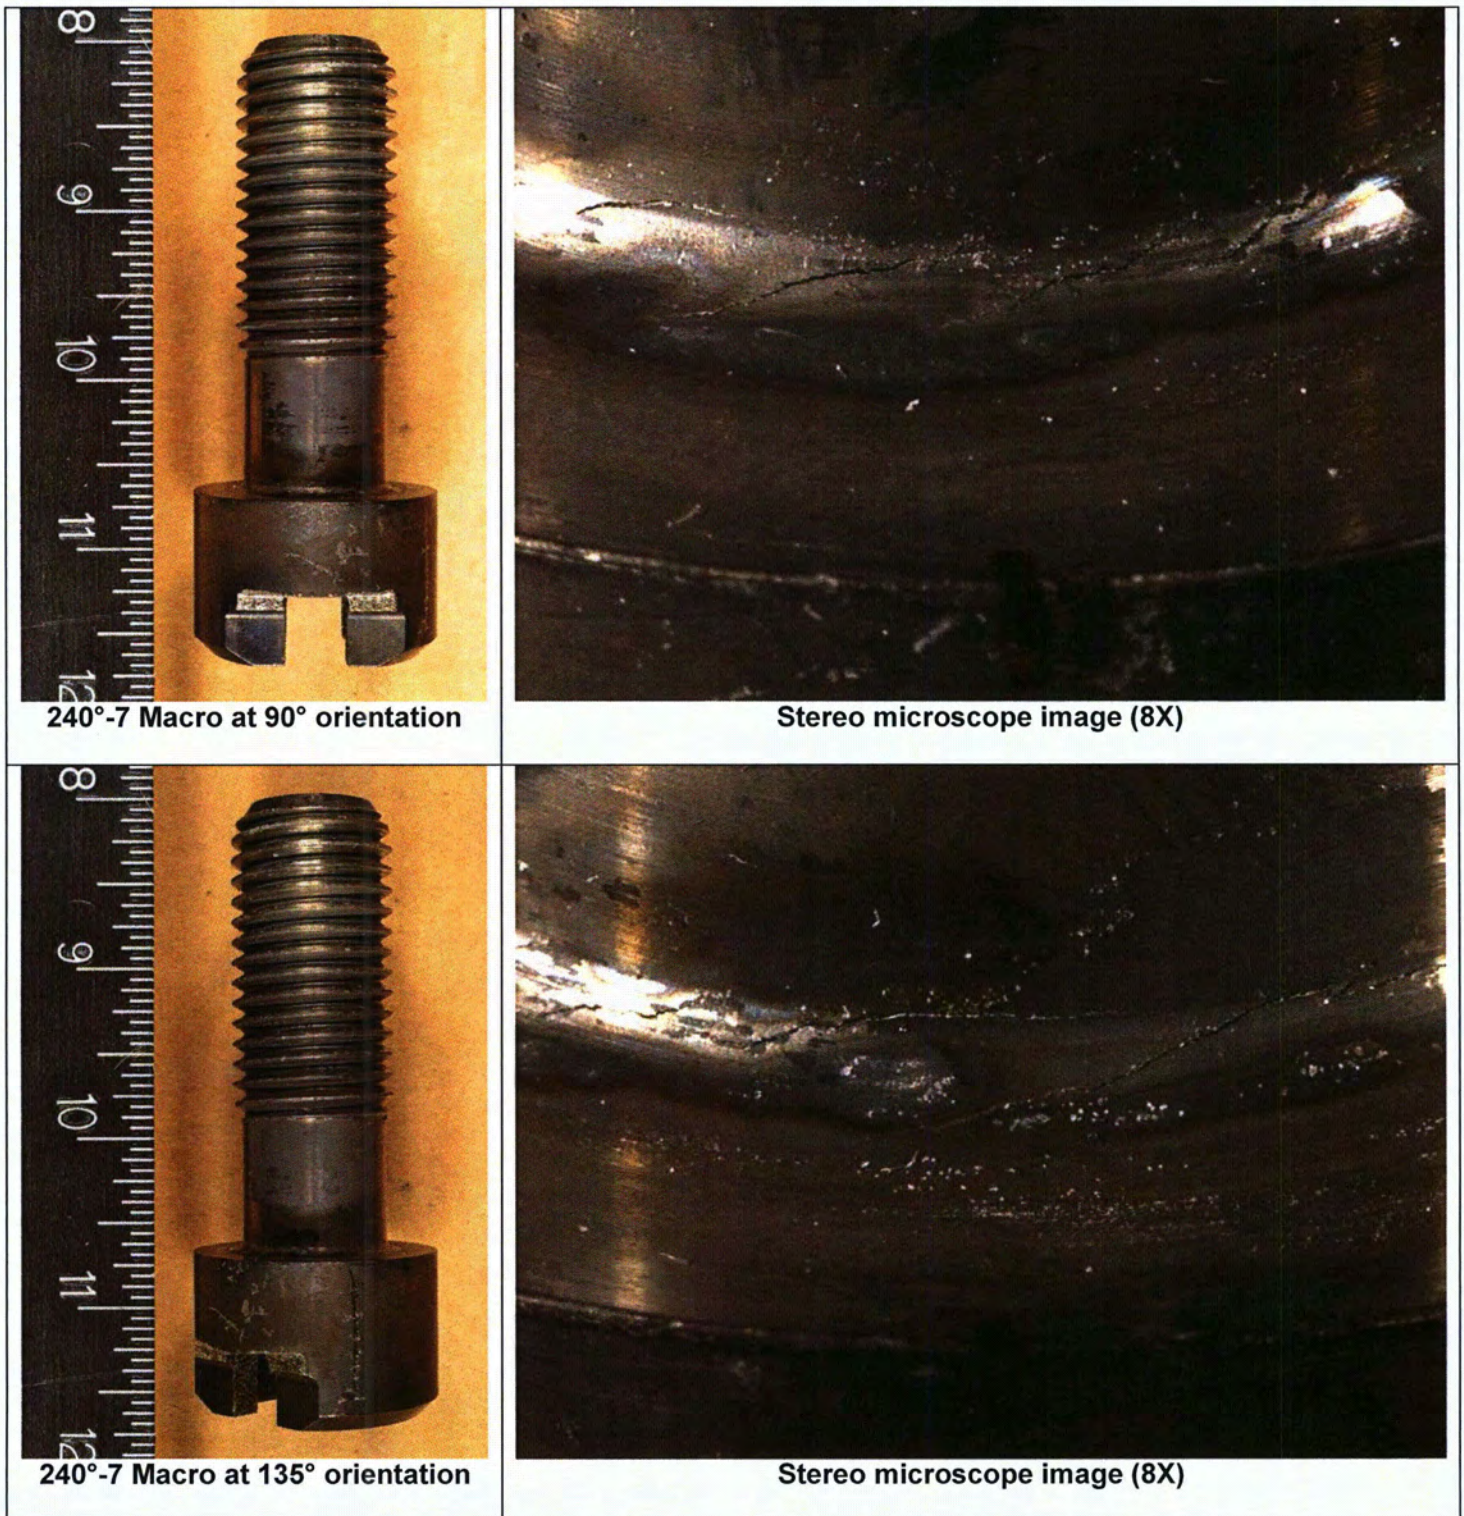
Figure 41 (continued): Macro and stereo photographs of bolt 240°-7 taken at 45° increments.

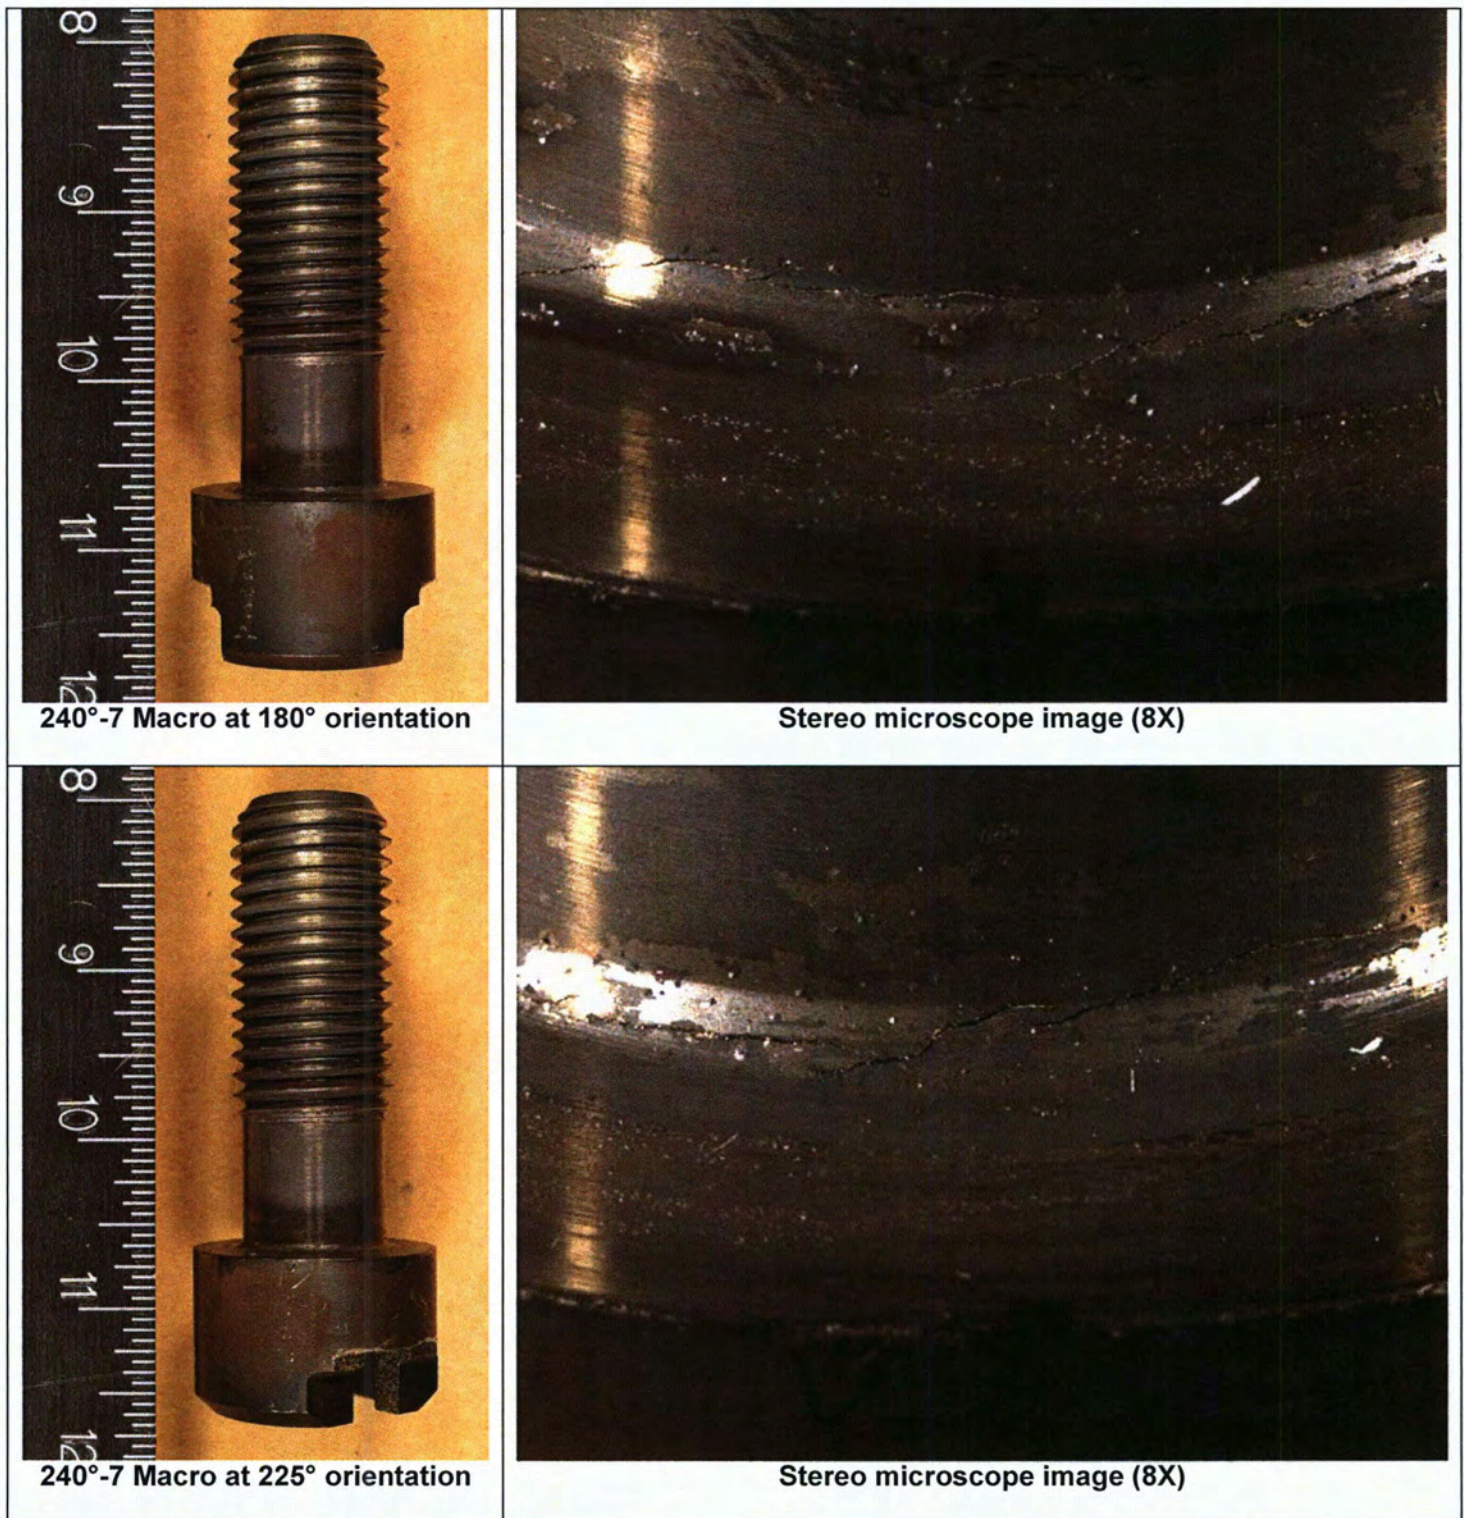
Figure 41 (continued): Macro and stereo photographs of bolt 240°-7 taken at 45° increments.

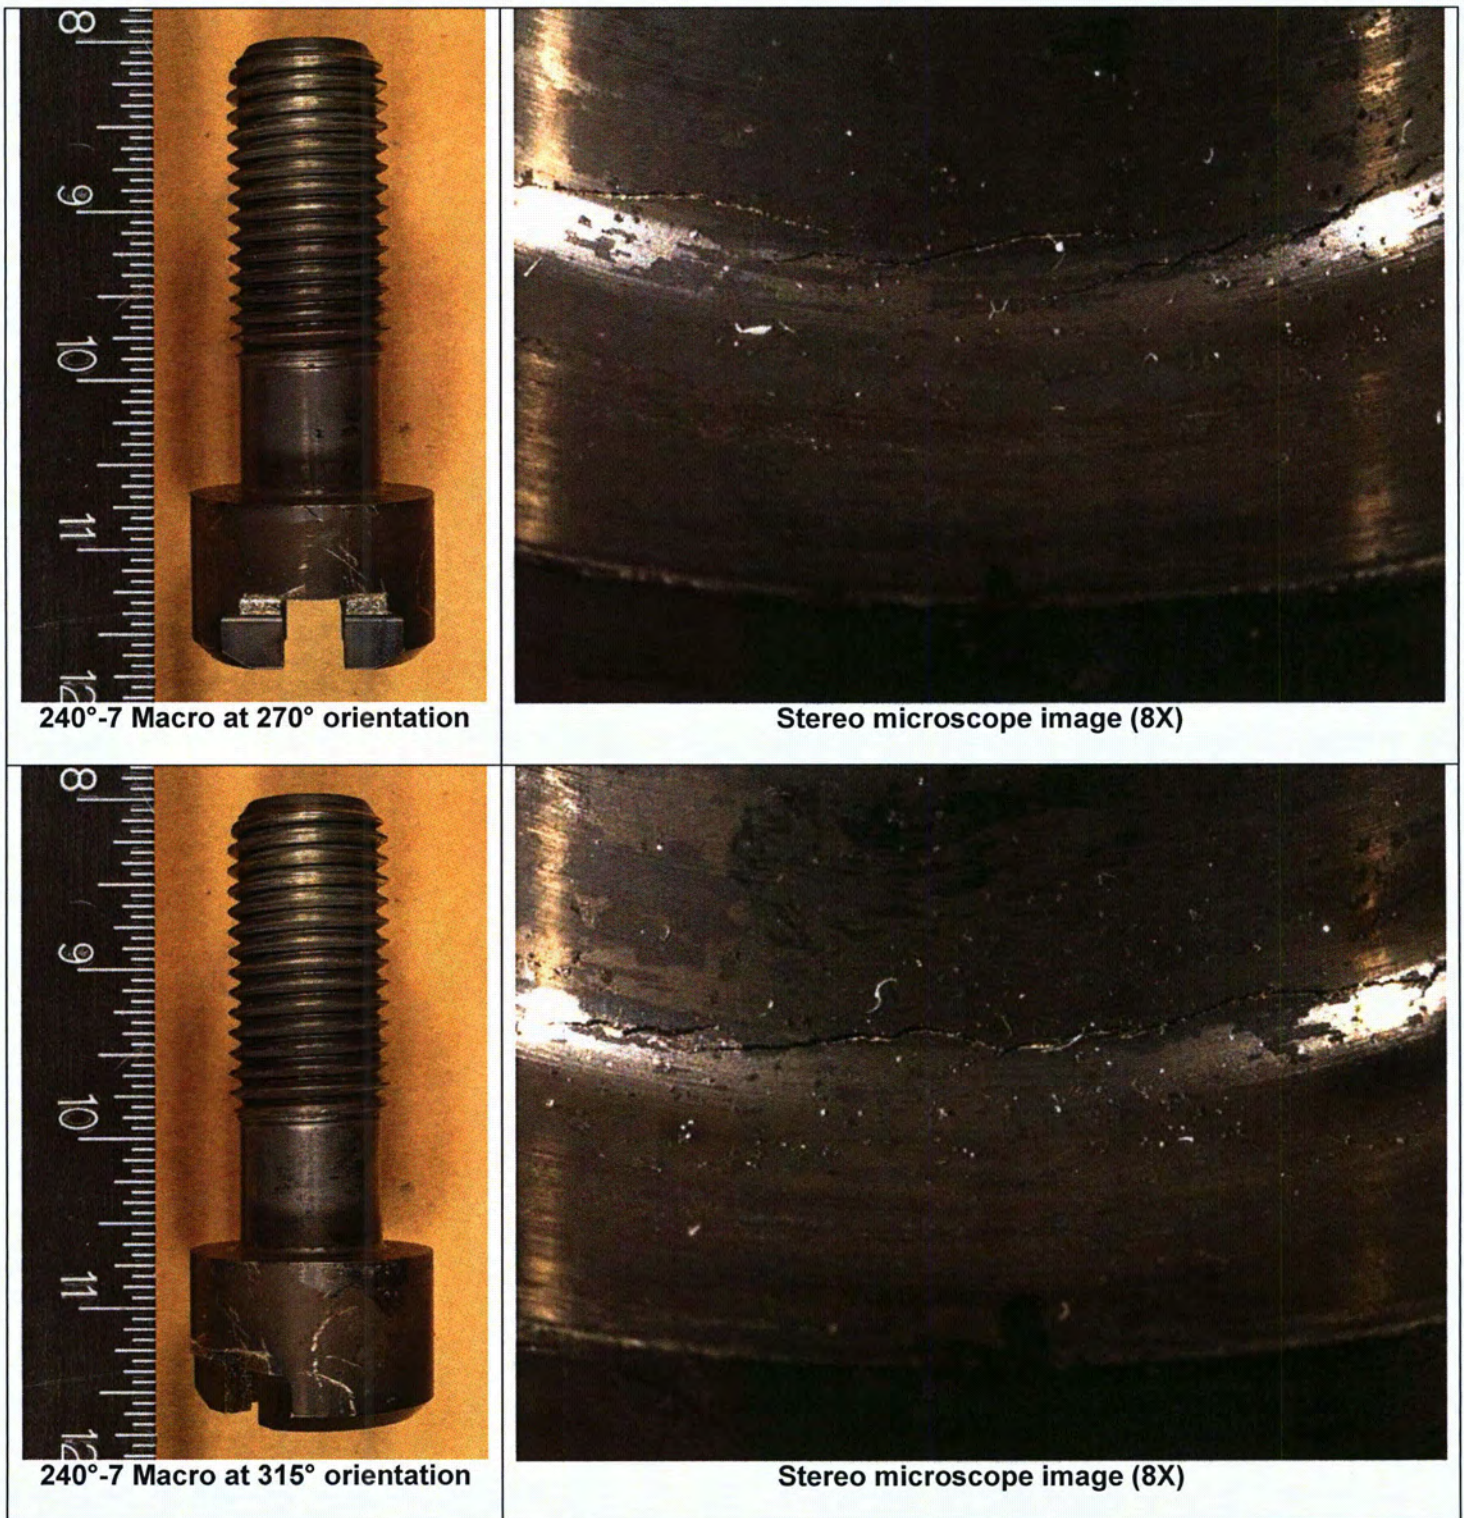
Figure 41 (continued): Macro and stereo photographs of bolt 240°-7 taken at 45° increments.

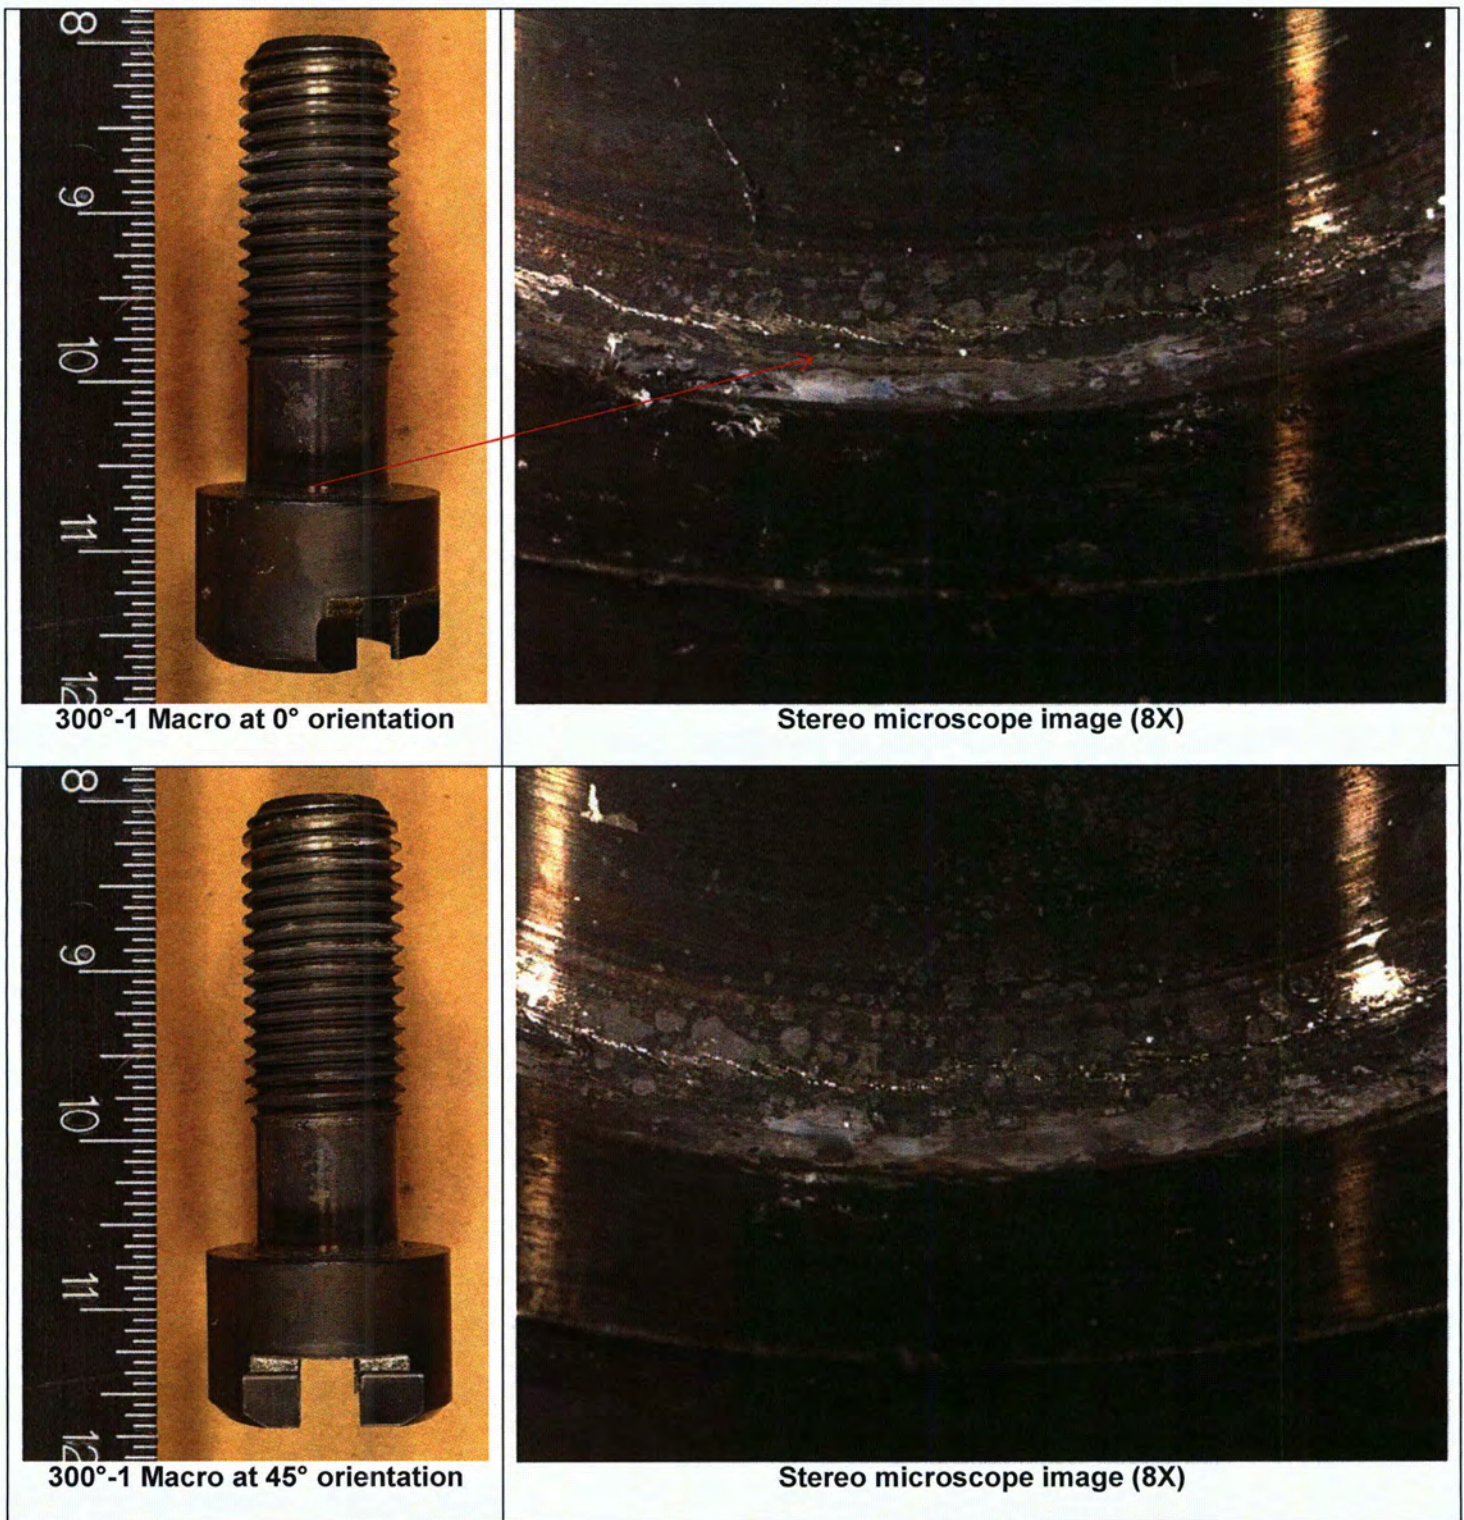
Figure 42: Macro and stereo photographs of bolt 300°-1 taken at 45° increments.

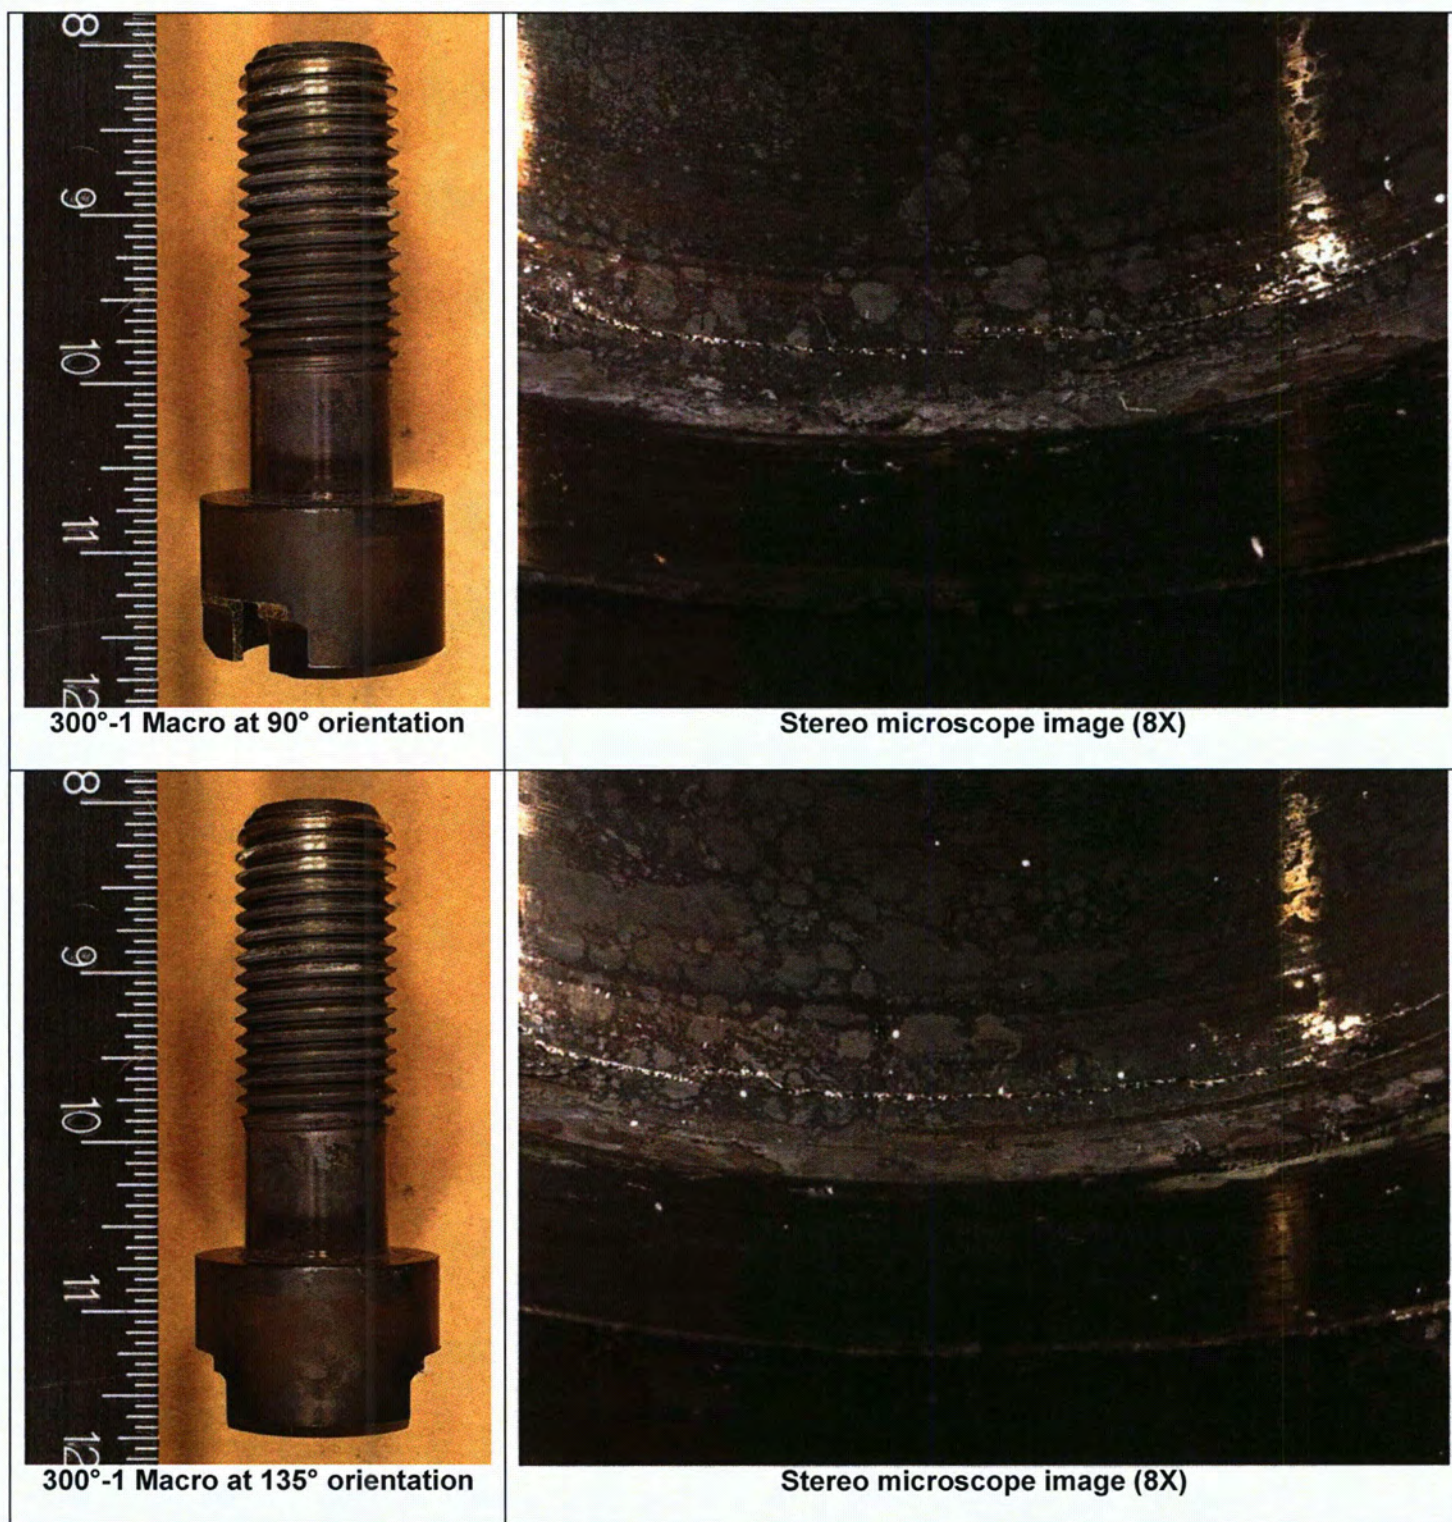
Figure 42 (continued): Macro and stereo photographs of bolt 300°-1 taken at 45° increments.

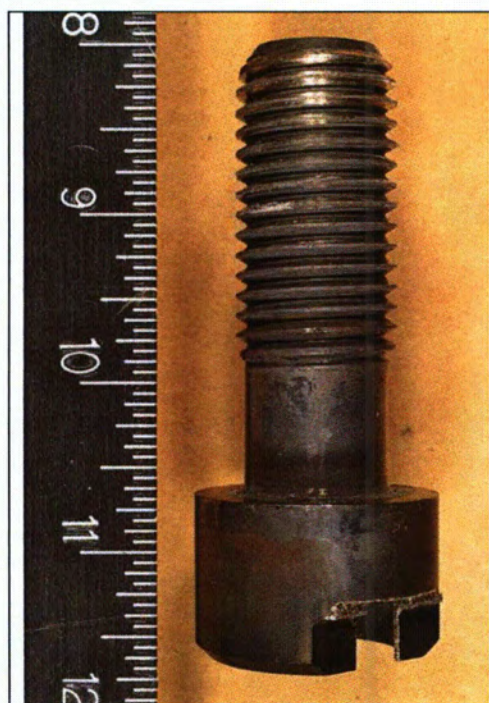
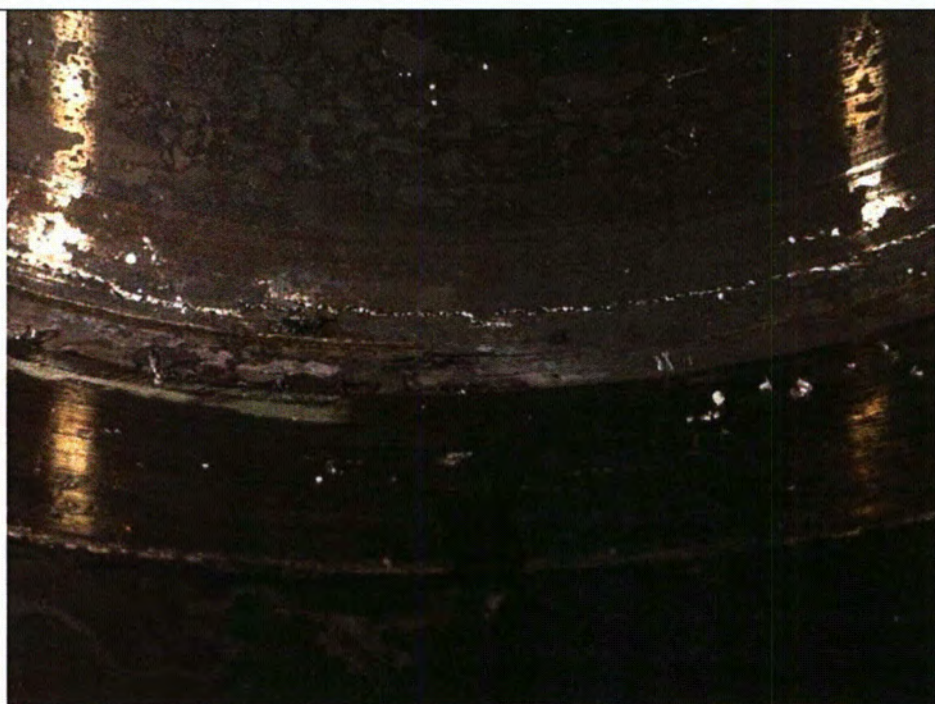
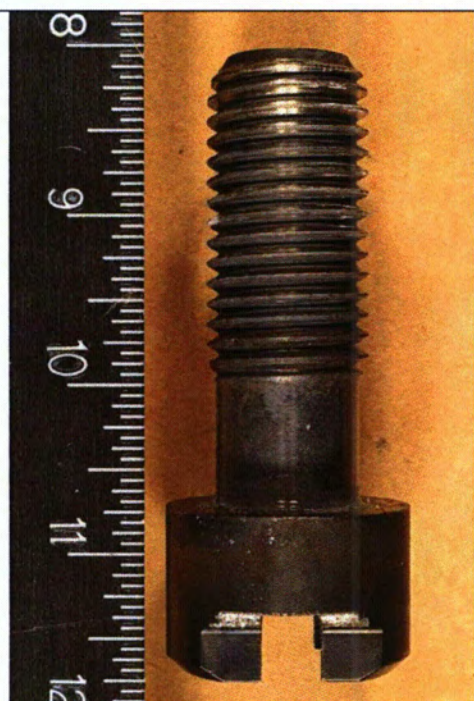
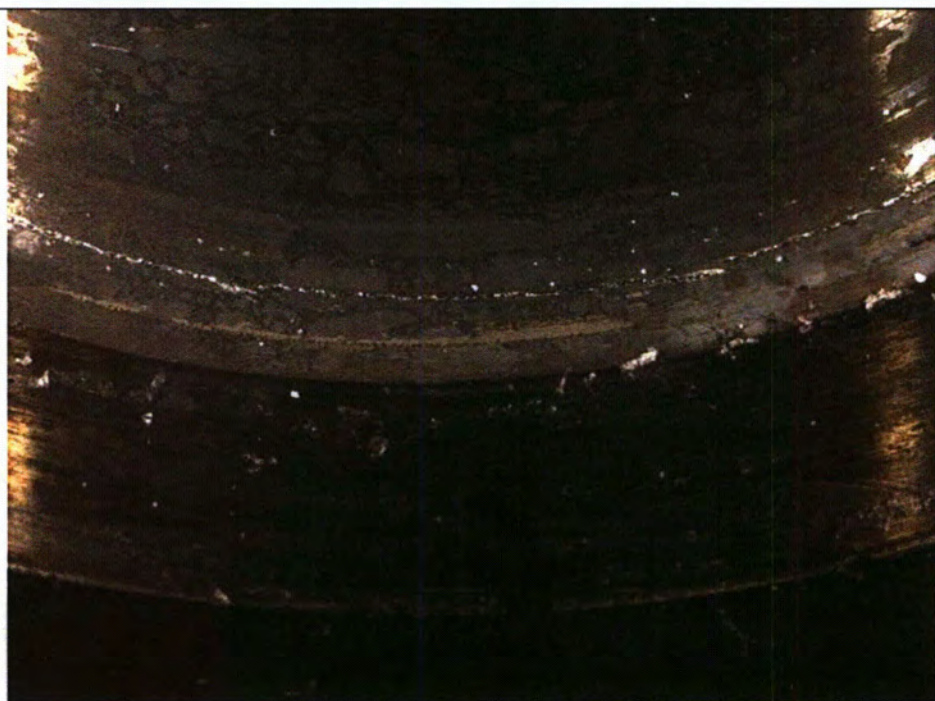
Figure 42 (continued): Macro and stereo photographs of bolt 300°-1 taken at 45° increments.

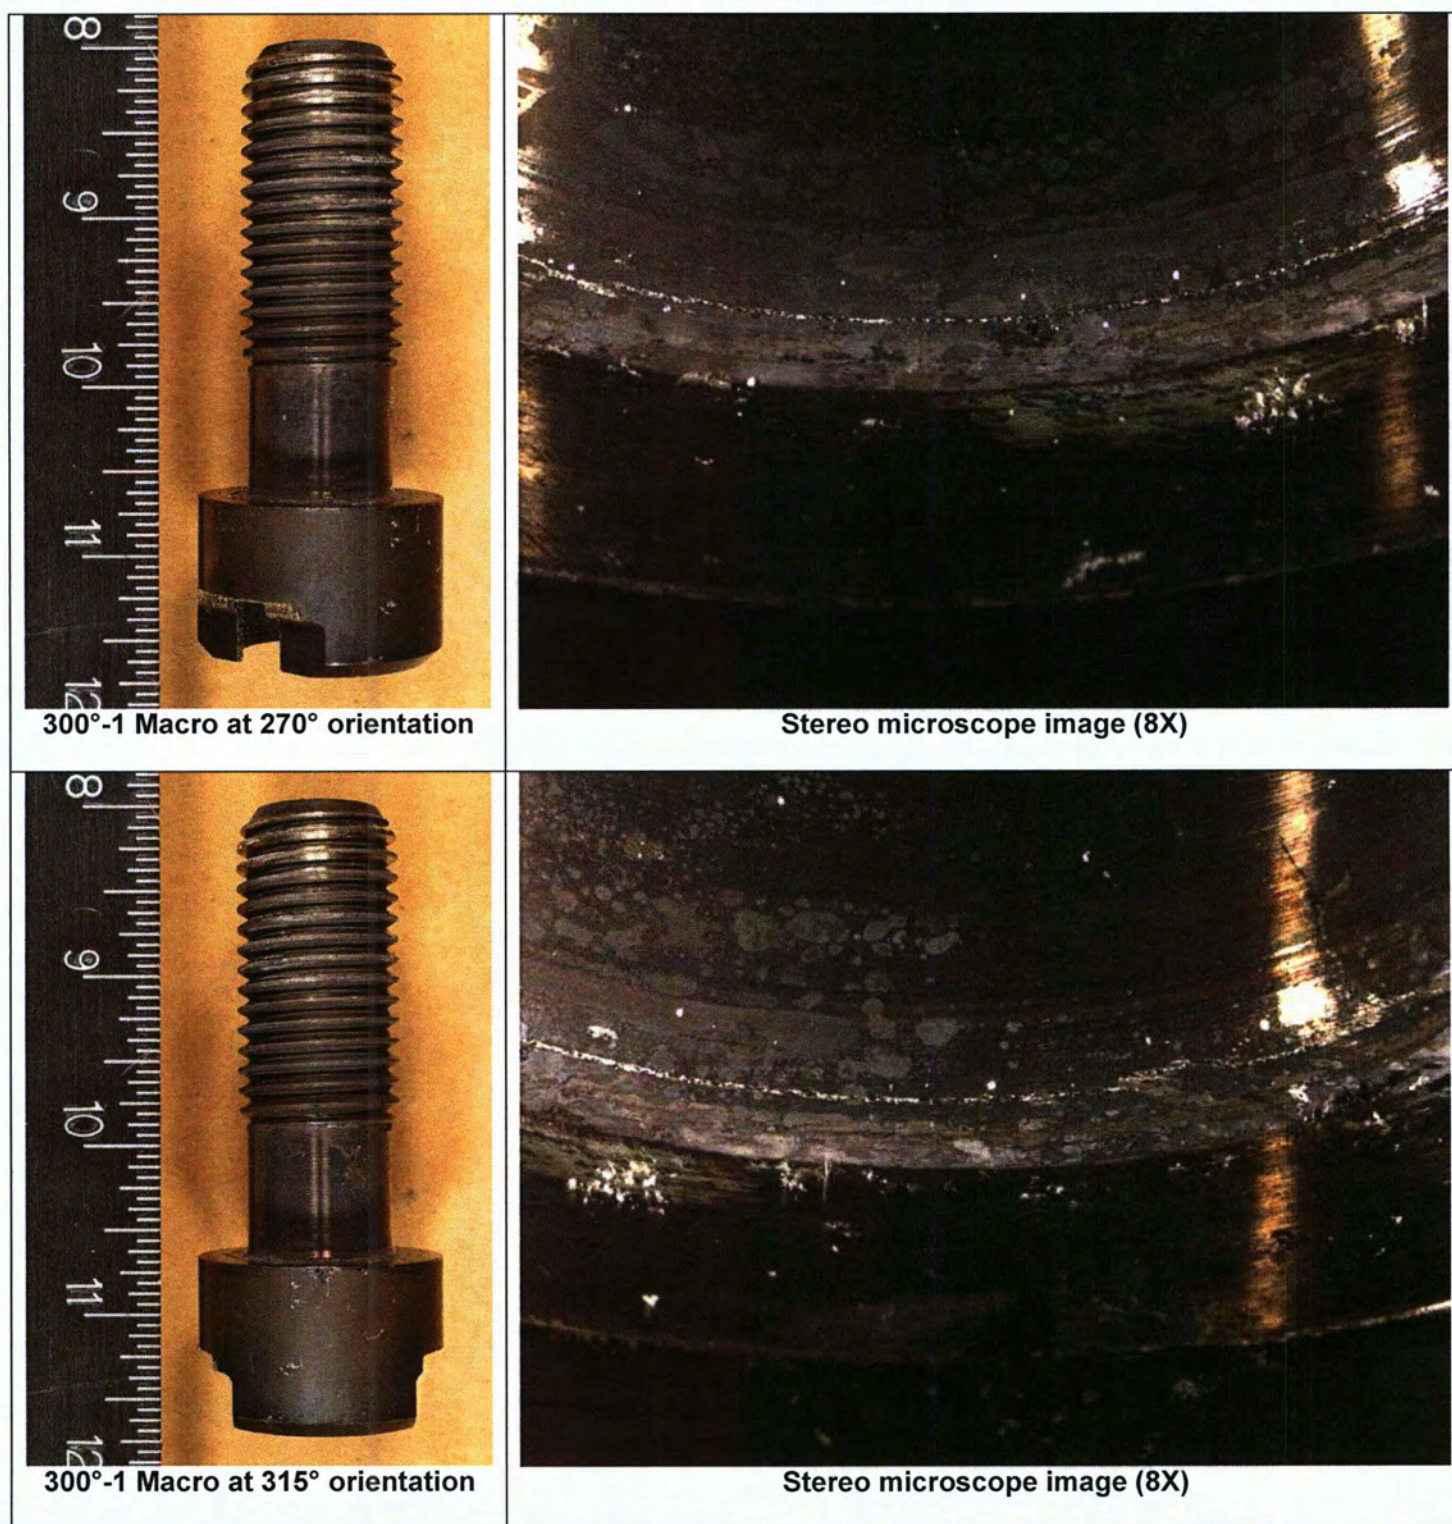
Figure 42 (continued): Macro and stereo photographs of bolt 300°-1 taken at 45° increments.

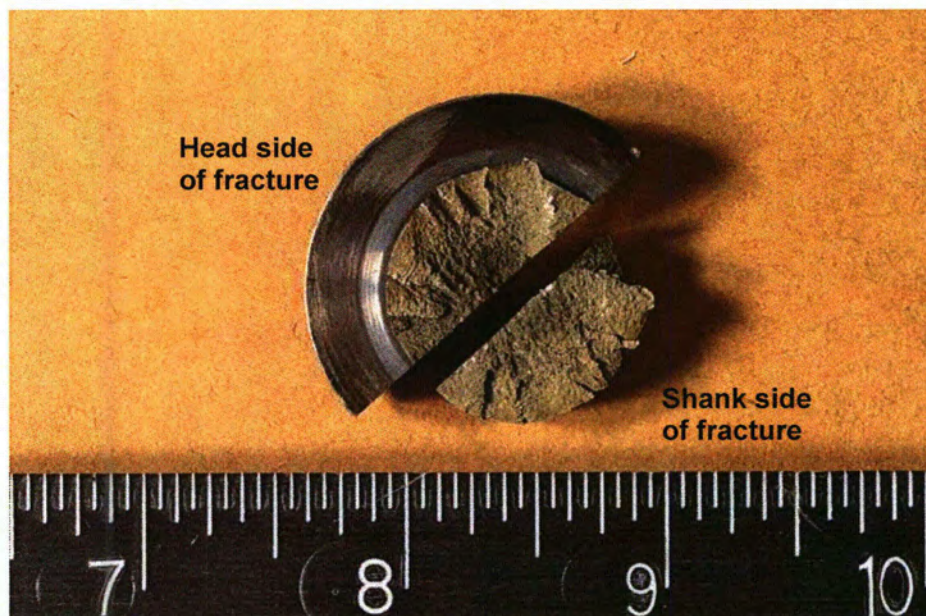
Figure 47: Bolt 240-7 after breaking open the crack for SEM/EDS. The two mating halves of the crack are shown. The head side of the fracture (to left) was analyzed by SEM/EDS.

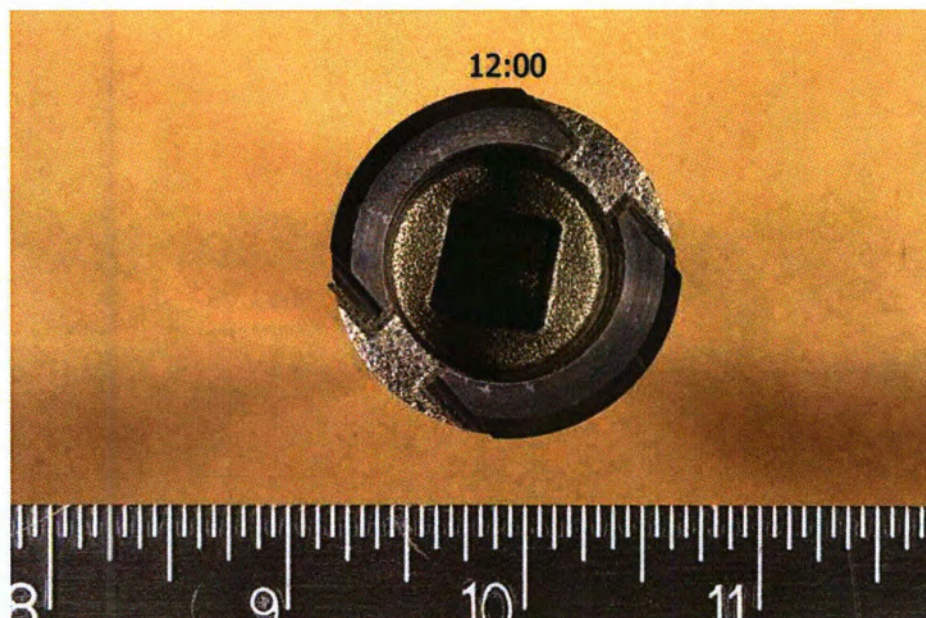
Figure 48: Bolt 300-1 showing plunge cut EDM surface, which removed much of the in-service cracking. Thickness measurements taken around the circumference indicated the EDM was skewed slightly toward the 270° direction (i.e. to the left in photo).

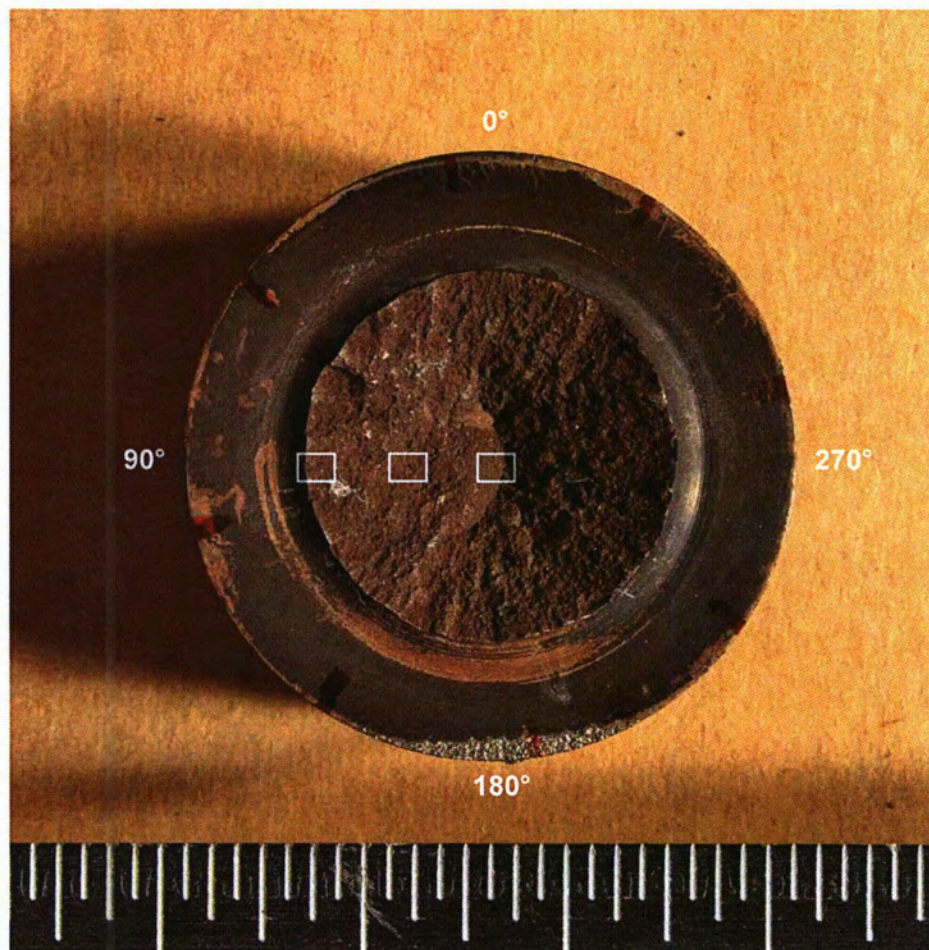
Figure 49: Macro photograph showing the open crack surface for bolt 120°-2. The areas within the white rectangles are shown at higher magnification in the following figures.

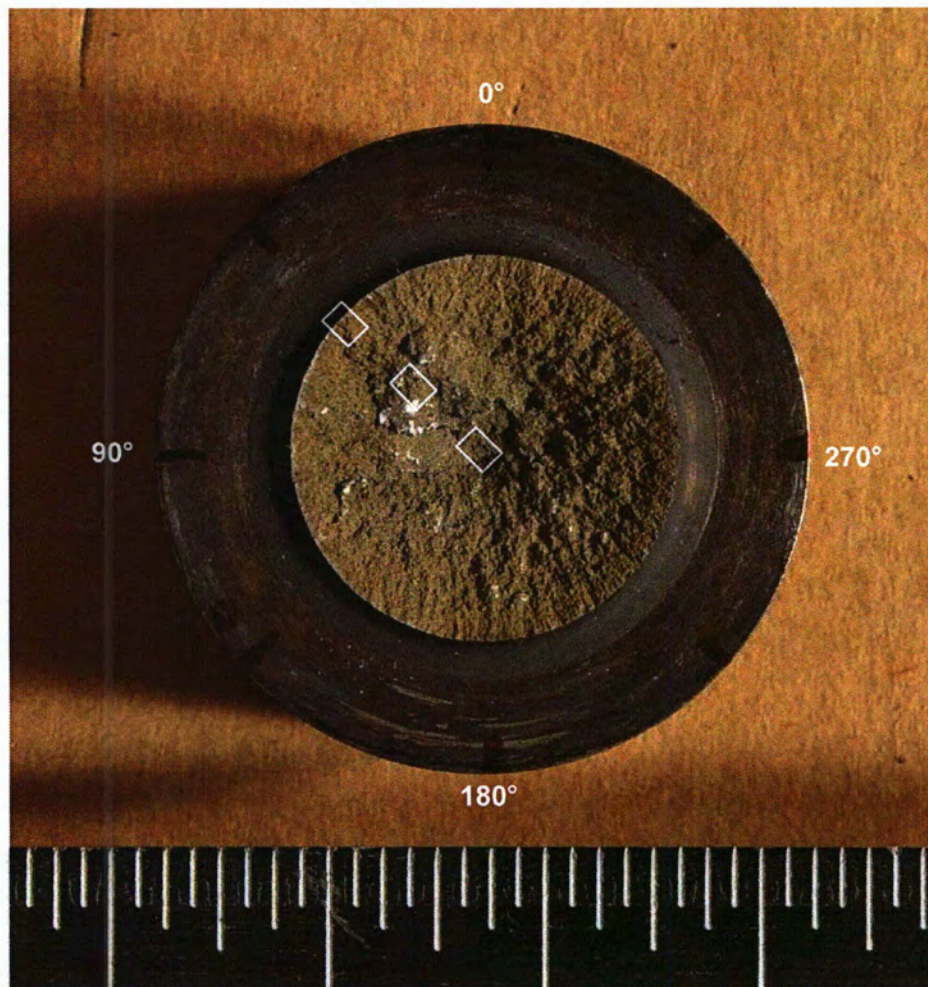
Figure 56: Macro photograph showing the open crack surface for bolt 120°-6. The areas within the white rectangles are shown at higher magnification in the following figures.
