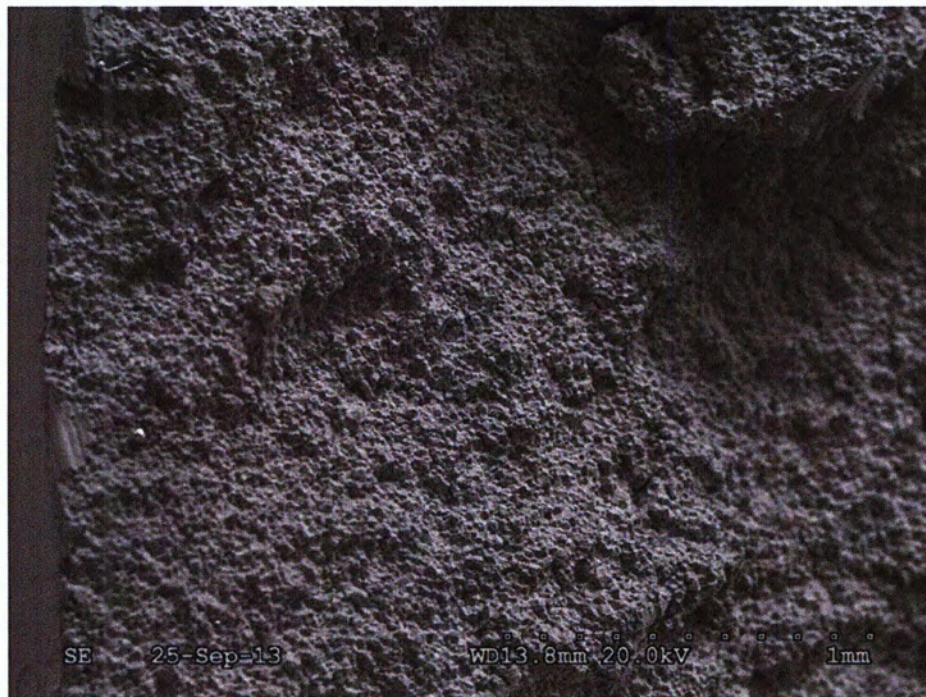
Figure 57: OD of bolt 120°-6 near 45°, 50X

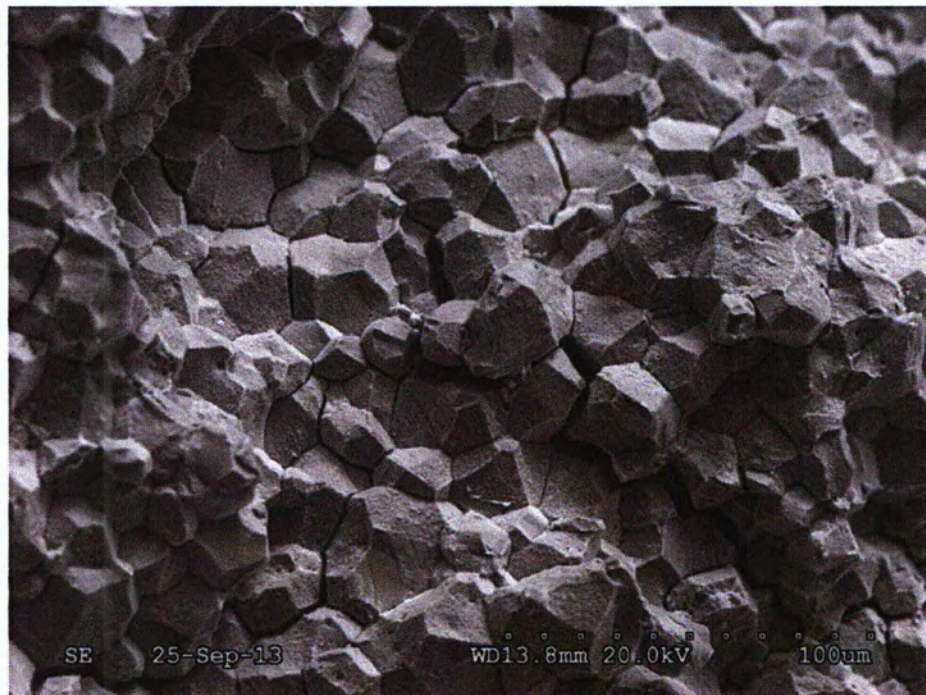
Figure 58: Center of Figure 57, 500X

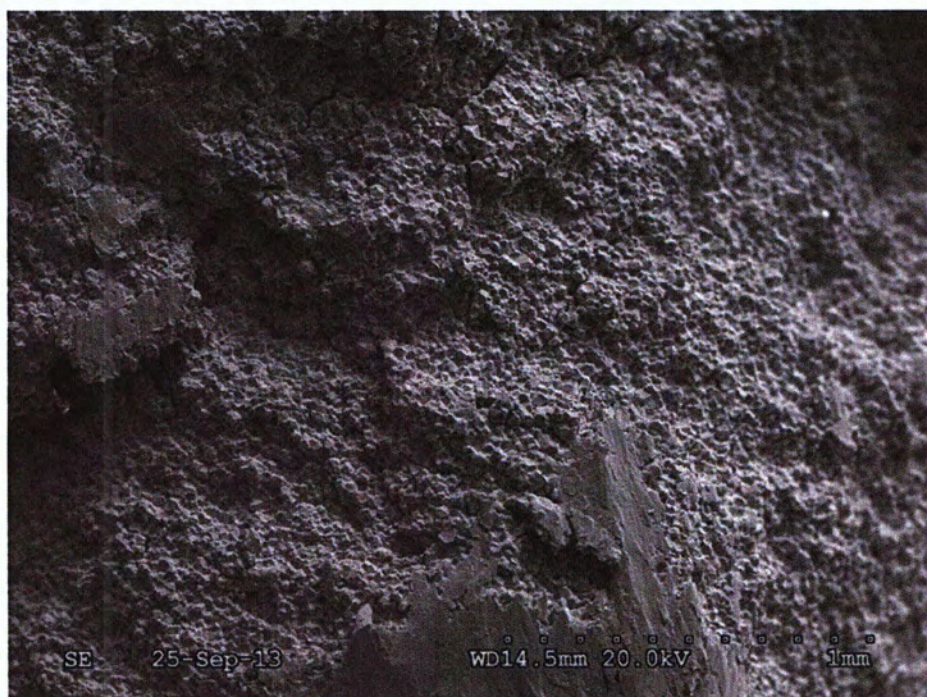
Figure 59: Mid-diameter of bolt 120°-6, 50X

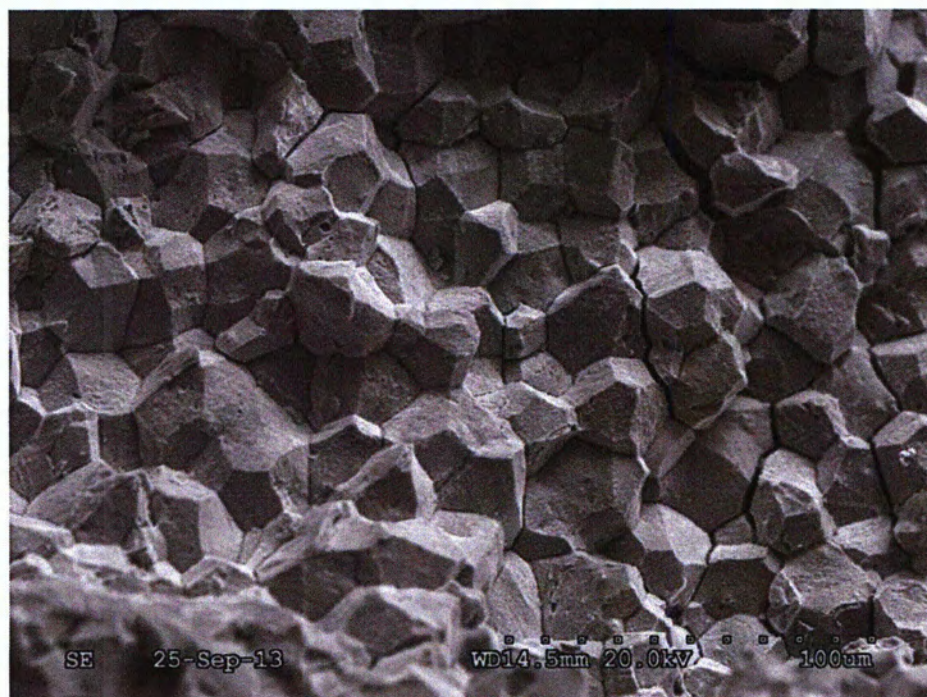
Figure 60: Center of Figure 59, 500X

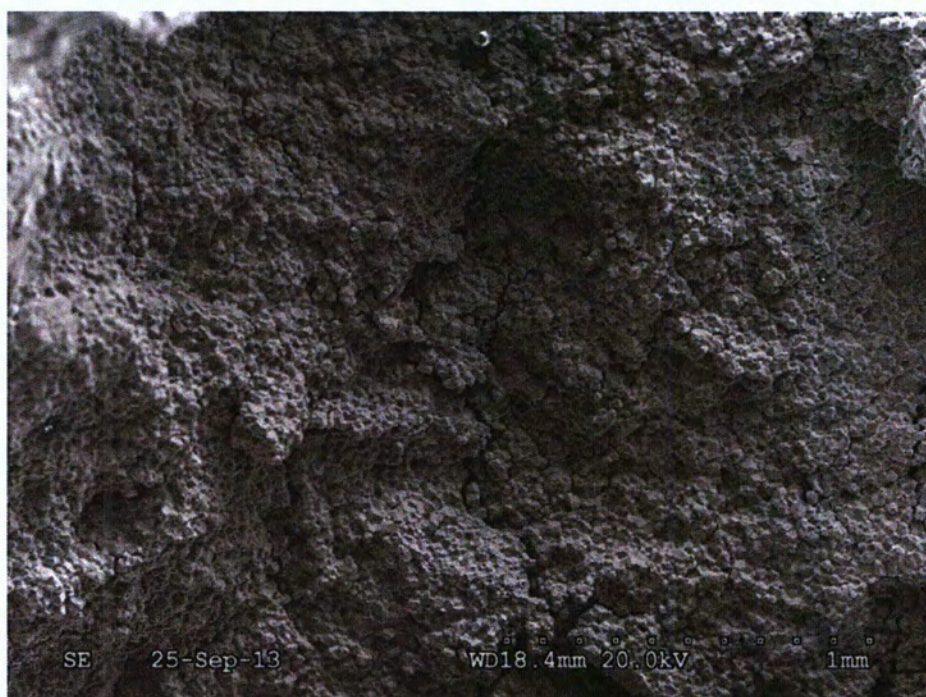
Figure 61: Center of 120°-6 fracture, 50X

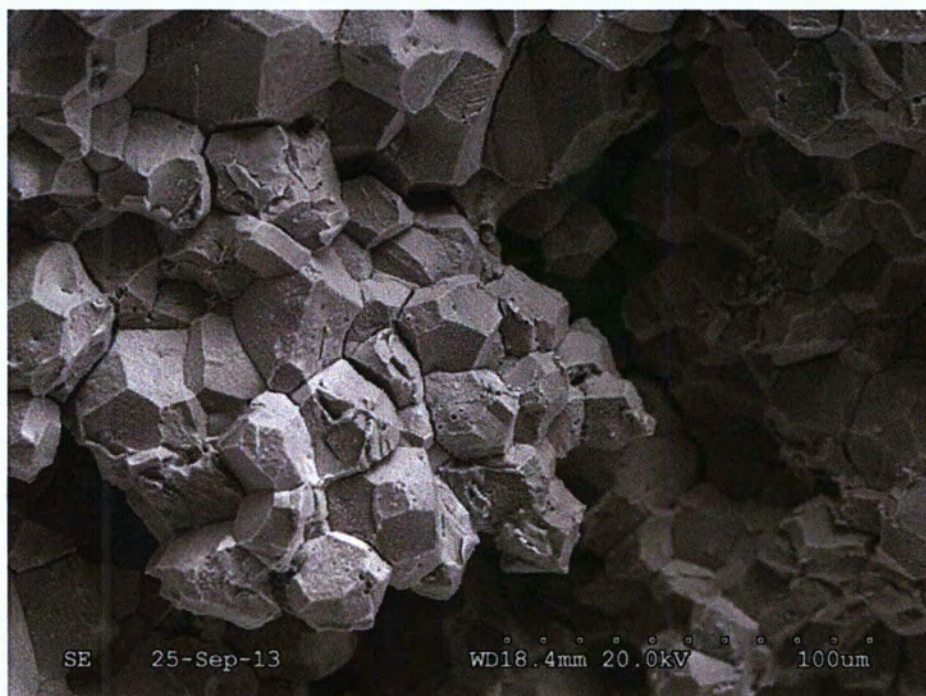
Figure 62: Center of Figure 61, 500X

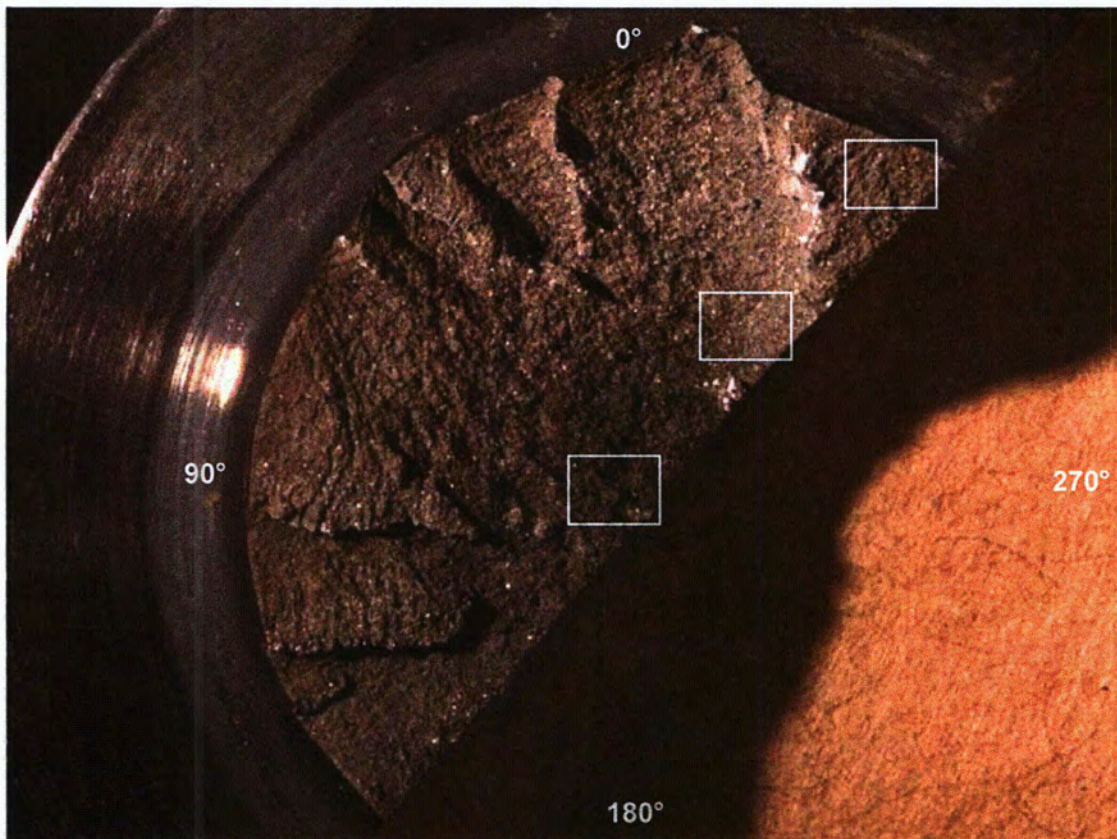
Figure 63: Stereo microscope photograph showing the open crack surface for bolt 240°-7. The areas within the white rectangles are shown at higher magnification in the following figures. 6X

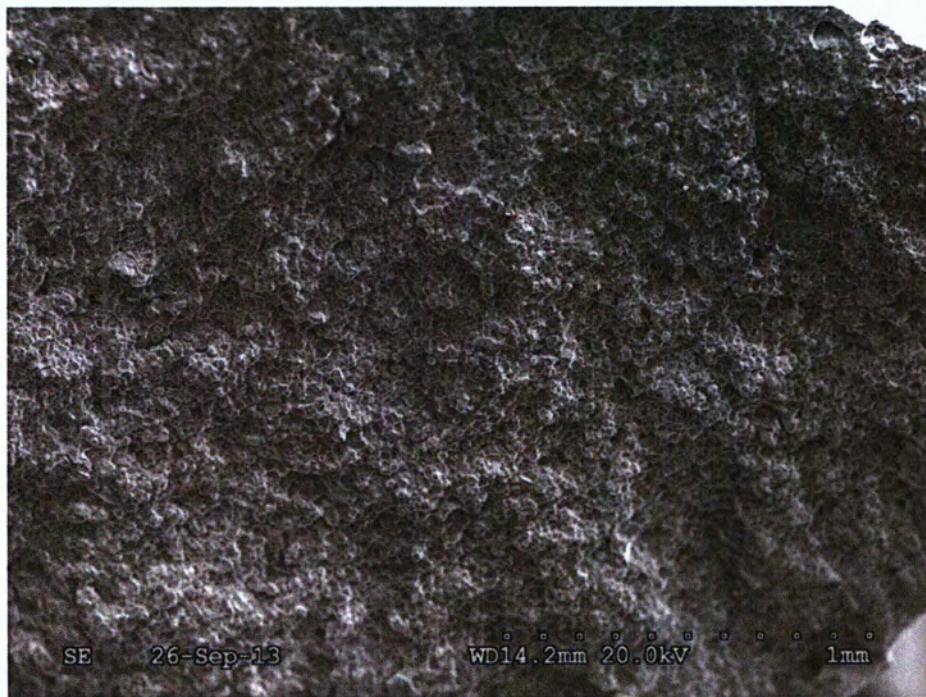
Figure 64: OD of bolt 240°-7 near 315°, 50X

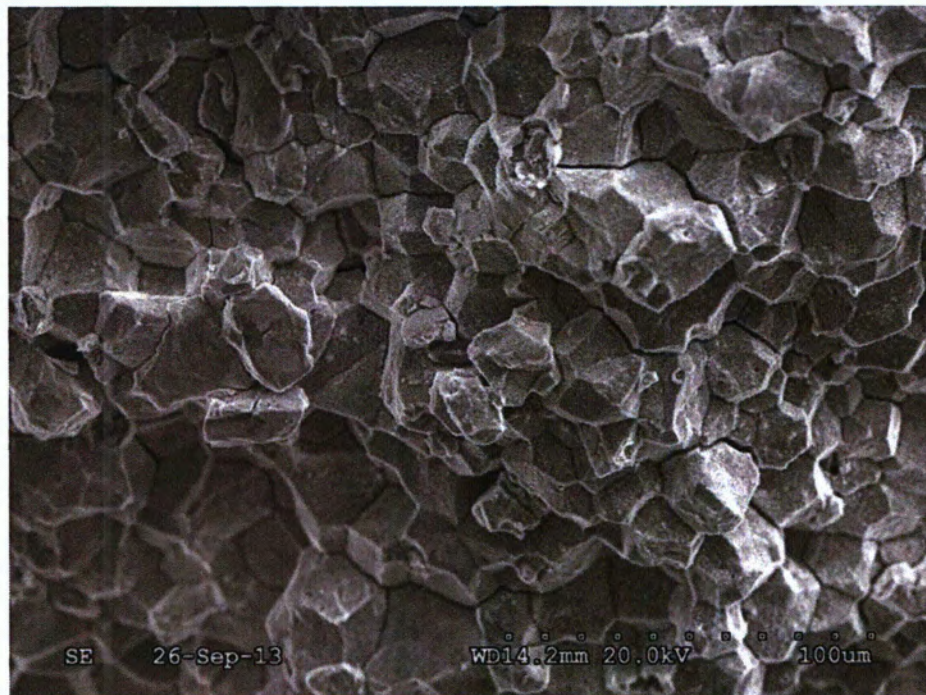
Figure 65: Center of Figure 64, 500X

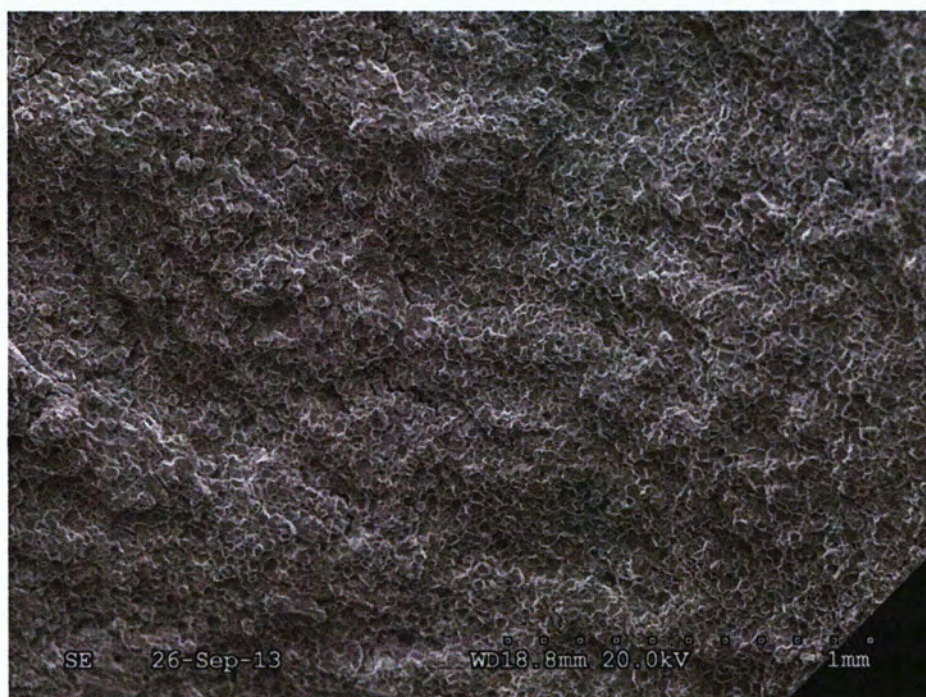
Figure 66: Mid-diameter of 240°-7, 50X

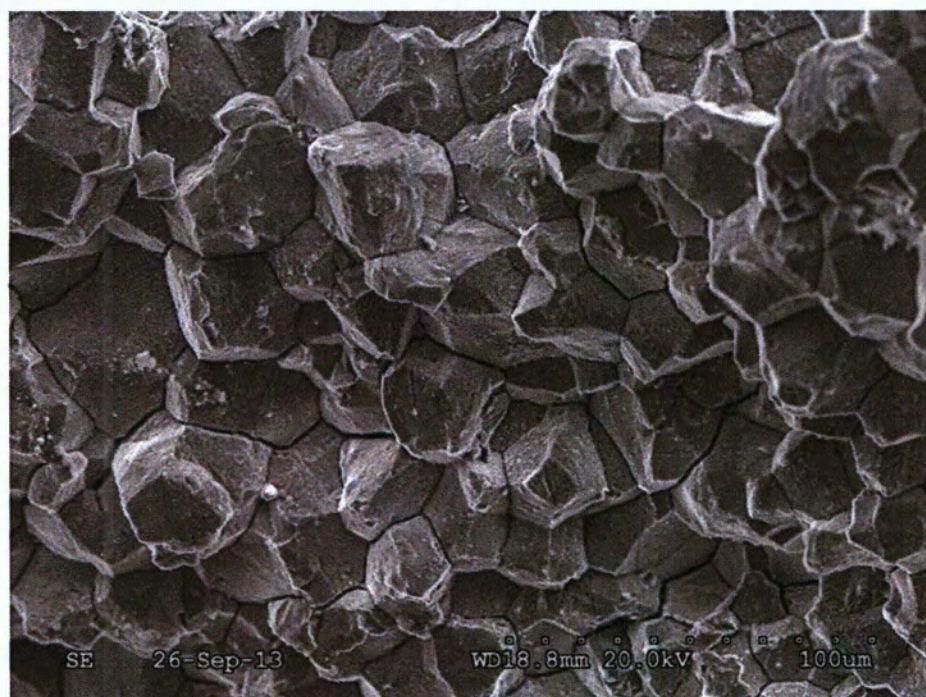
Figure 67: Center of Figure 66, 500X

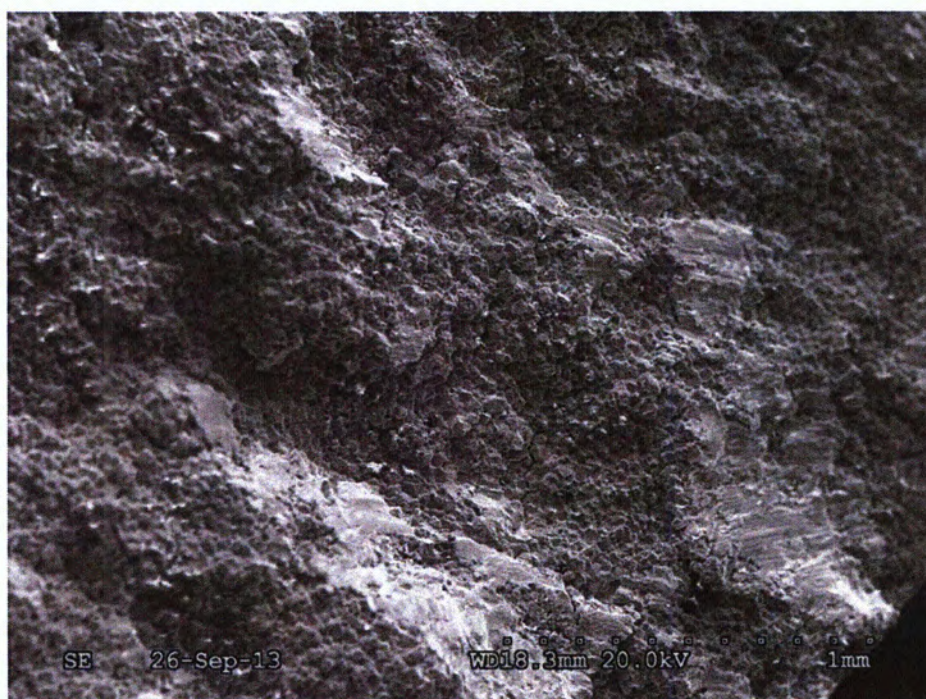
Figure 68: Center of 240°-7 fracture, 50X

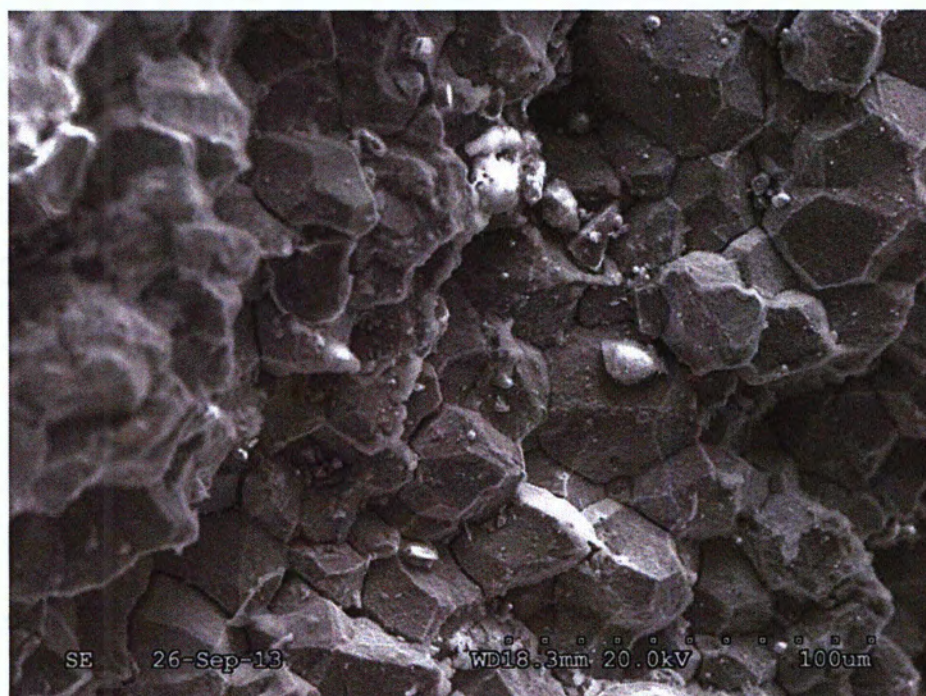
Figure 69: Center of Figure 68, 500X

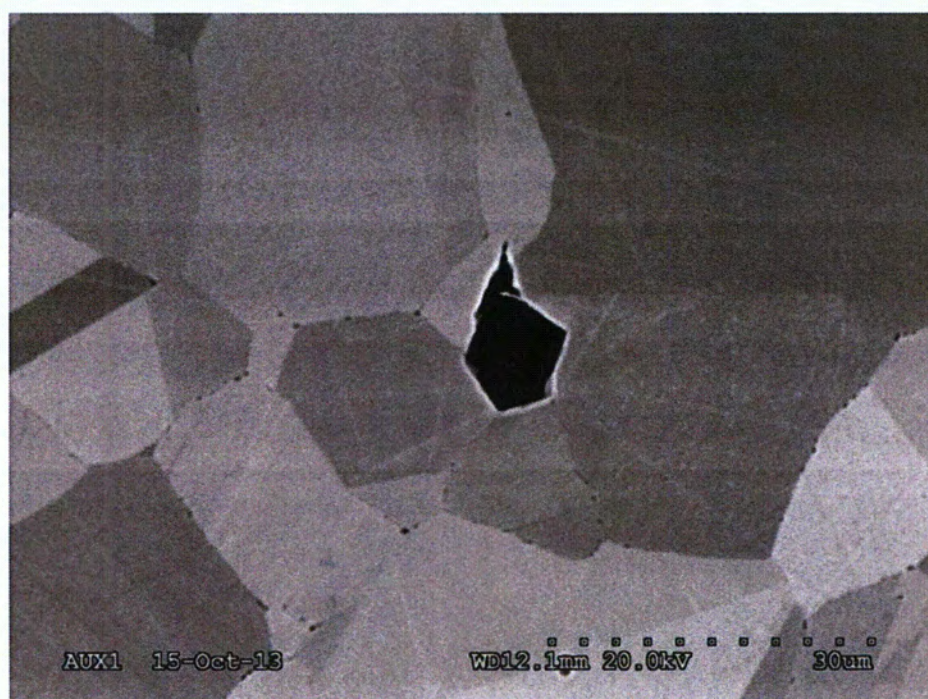
Figure 70: BSE image of titanium nitride ~15 μm in size, 1,500X

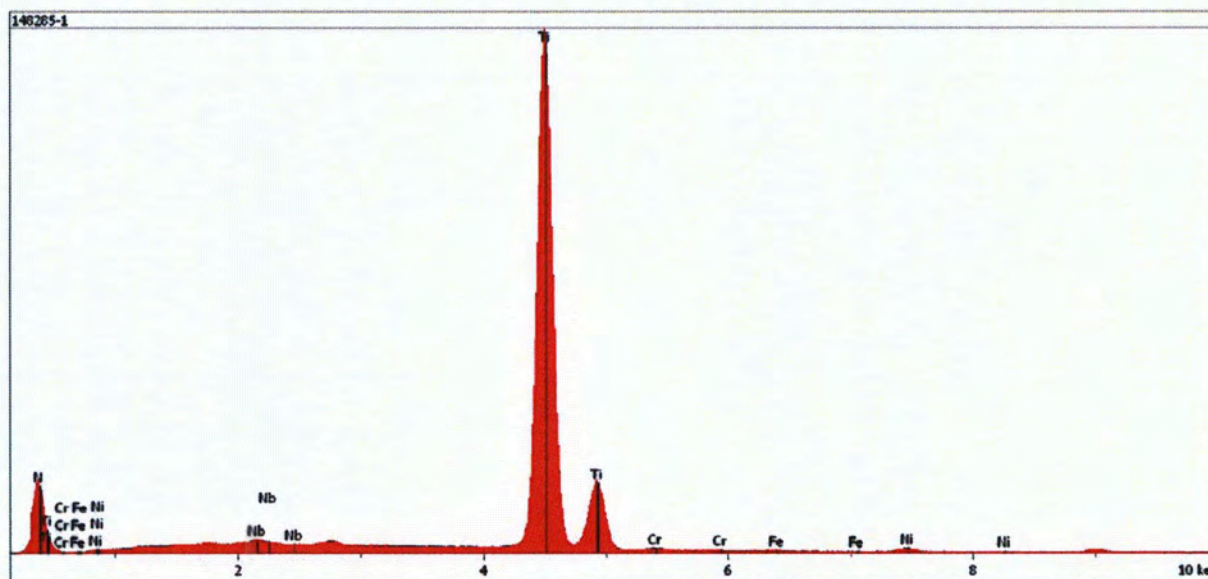
Figure 71: EDS spectrum collected from precipitate shown in Figure 70 above. Primary elements detected included titanium, nitrogen, and trace amount of nickel and niobium.

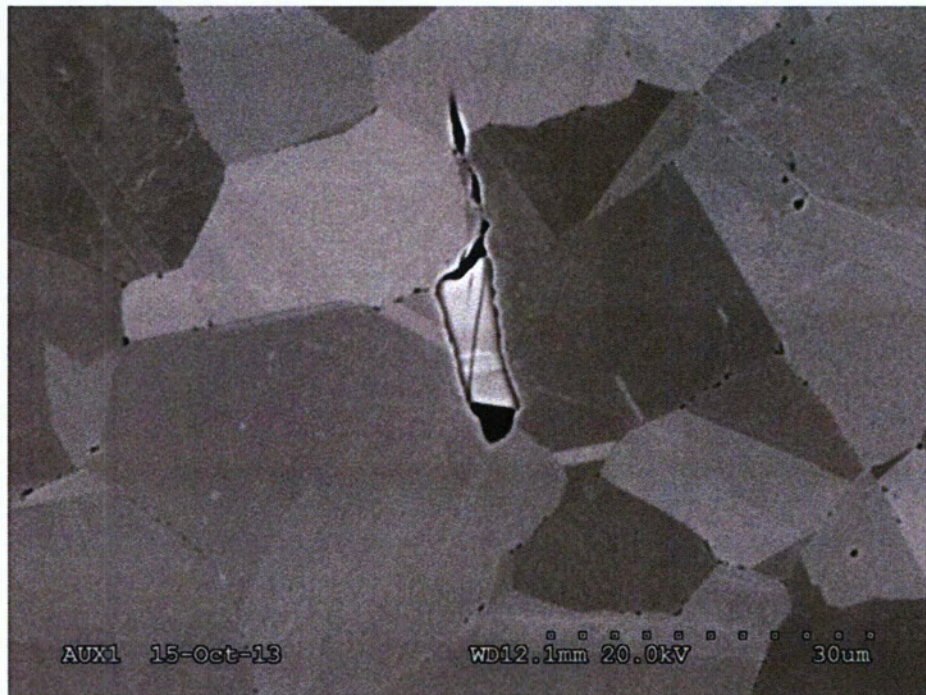
Figure 72: BSE image of niobium-titanium intermetallic ~20 μm long, 1,500X

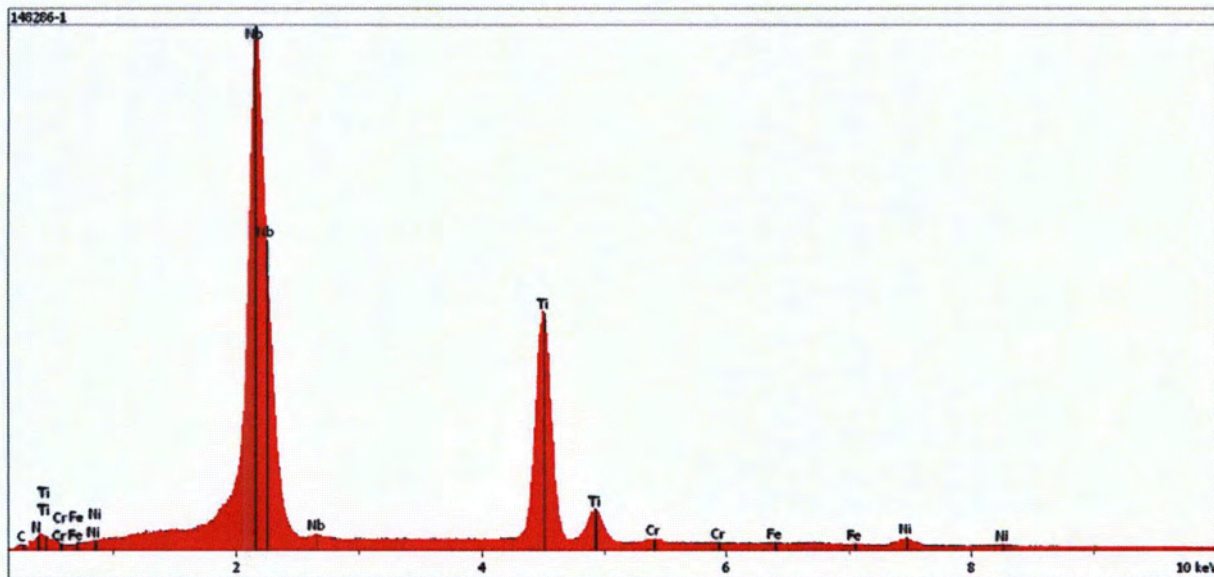
Figure 73: EDS spectrum collected from precipitate shown in Figure 72 above. Primary elements included niobium and titanium; trace levels of iron, chromium, and nickel were also present.

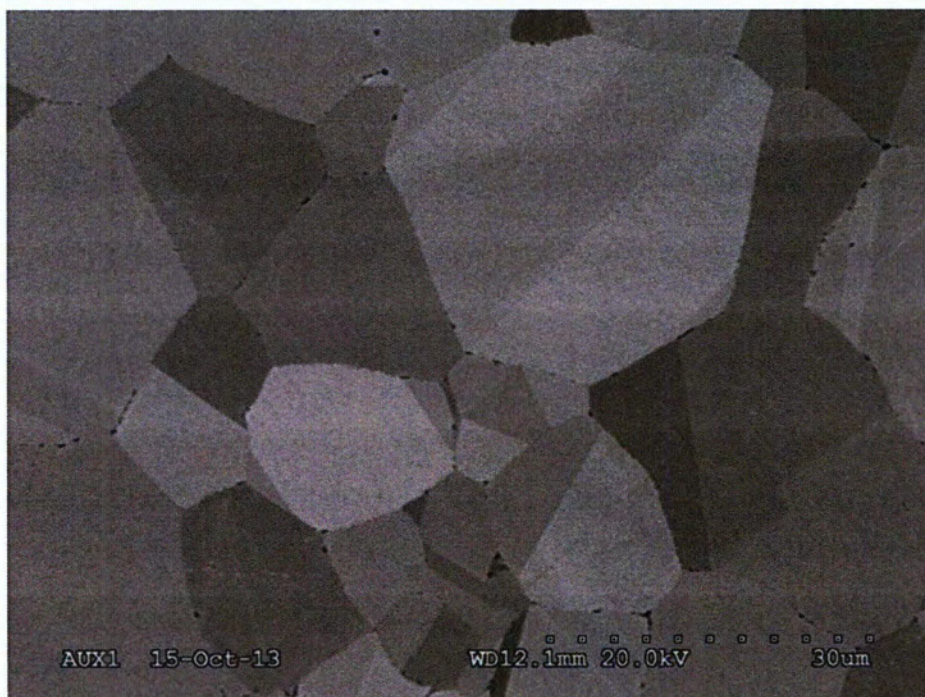
Figure 74: Typical area of polished cross section, 1,500X

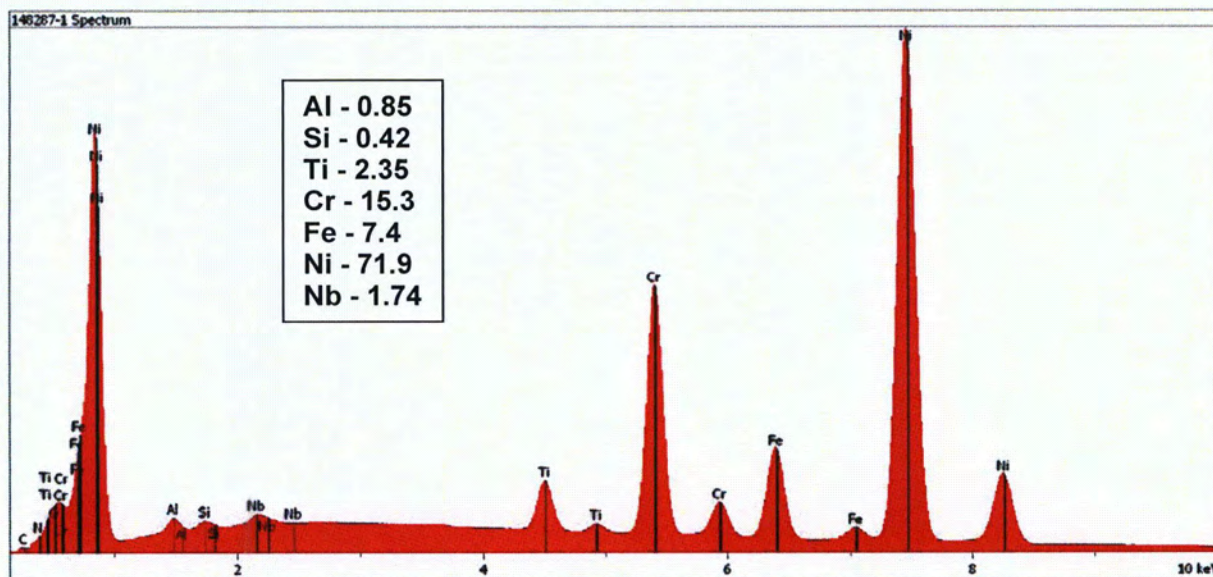
Figure 75: EDS spectrum collected from entire area shown in Figure 74. The quantitative results (inset) were generally consistent with nominal X-750.

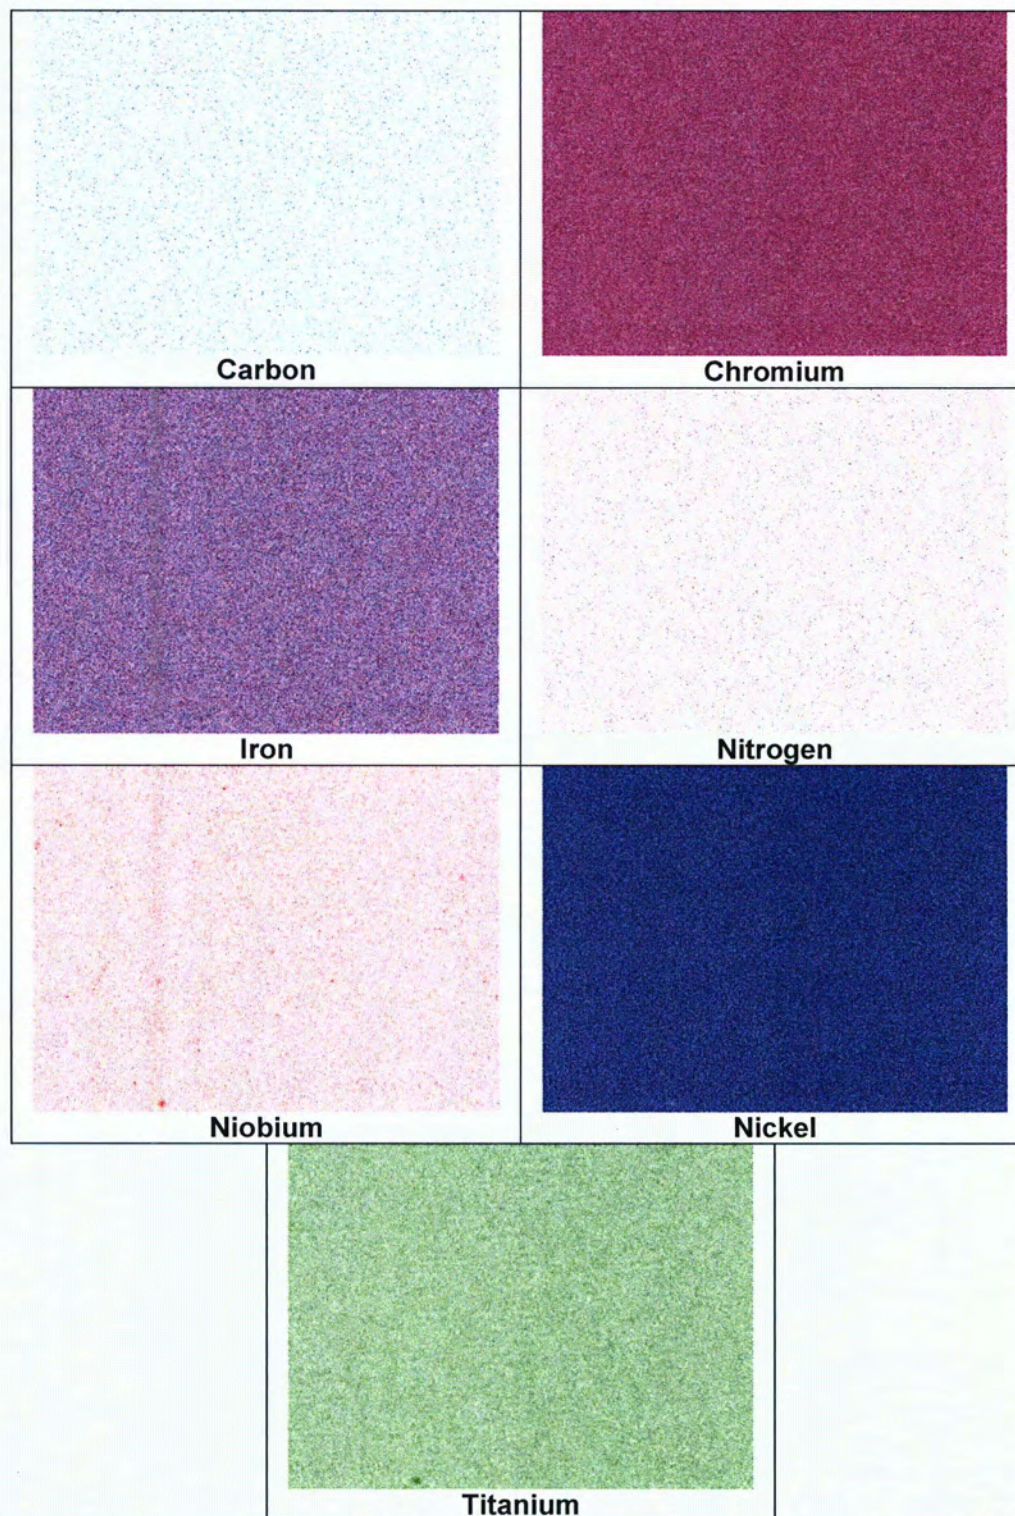
Figure 76: EDS dot maps collected from area shown in Figure 74. Primary constituents are nickel, chromium, and iron, as expected. Trace amounts of titanium and niobium were detected at discrete points as well. Carbon was not detected.

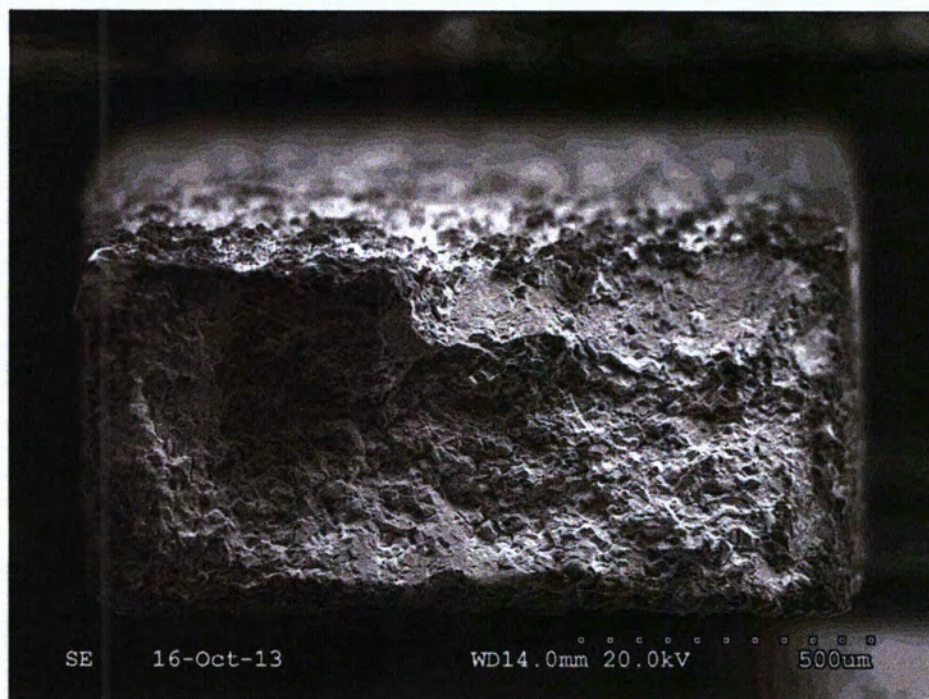
Figure 77: Tensile fracture surface for 240°-7L4, 80X

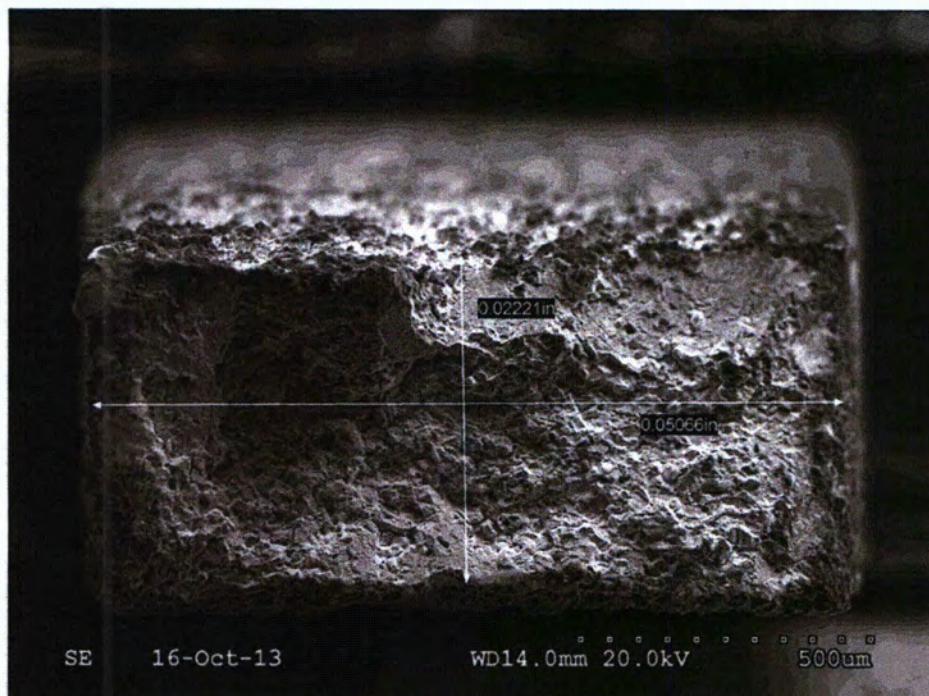
Figure 78: Same micrograph as Figure 77 annotated with reduction in area measurements, 80X

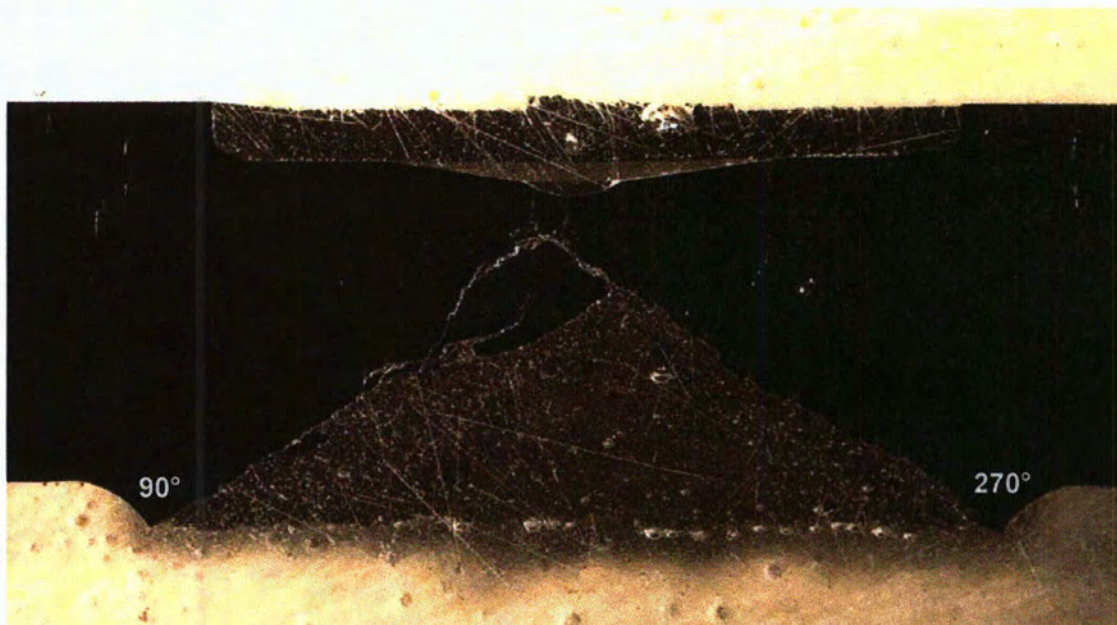
Figure 79: As-polished overview of bolt 120°-2 cross section. 6X

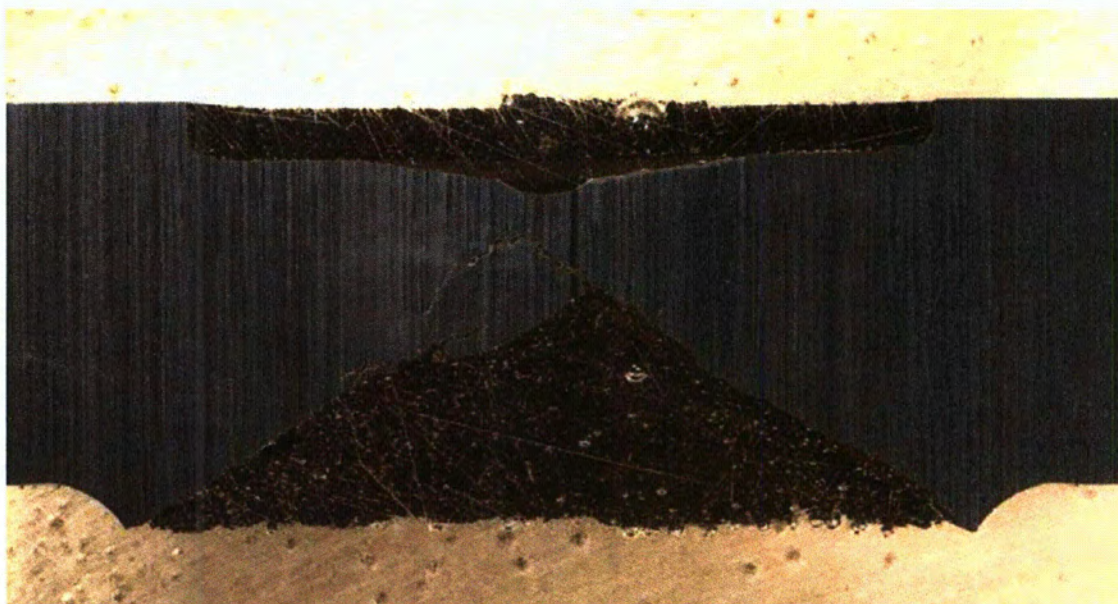
Figure 80: Same area as Figure 79 after phosphoric + nital etch. Structure is banded, as evidenced by the presence of vertical streaks. 6X

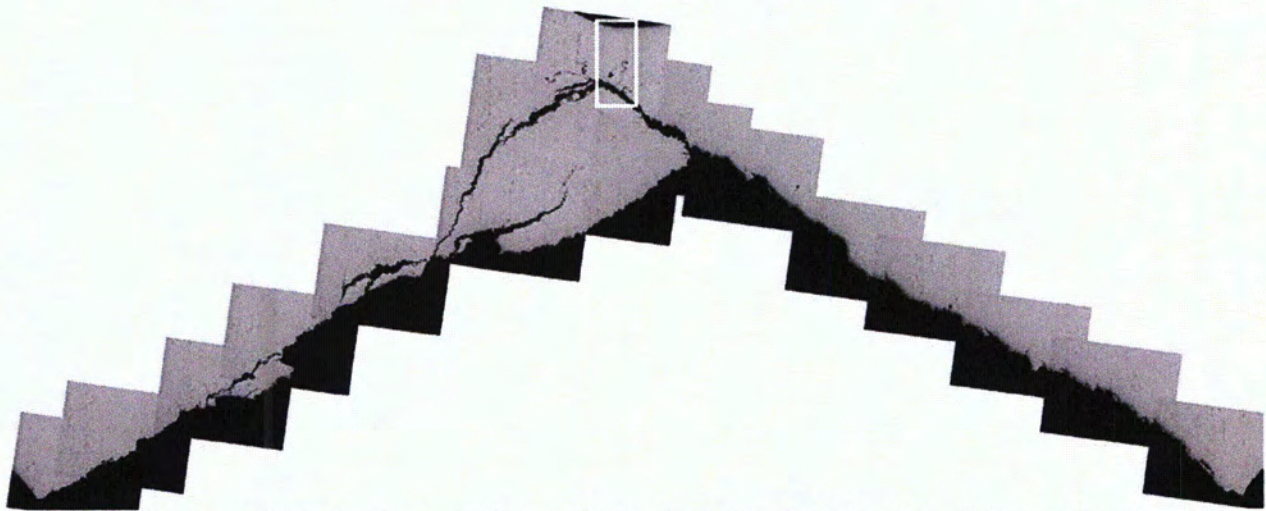
Figure 81: As-polished micrograph montage of crack. Area inside white box is shown in Figure 82. ~10X

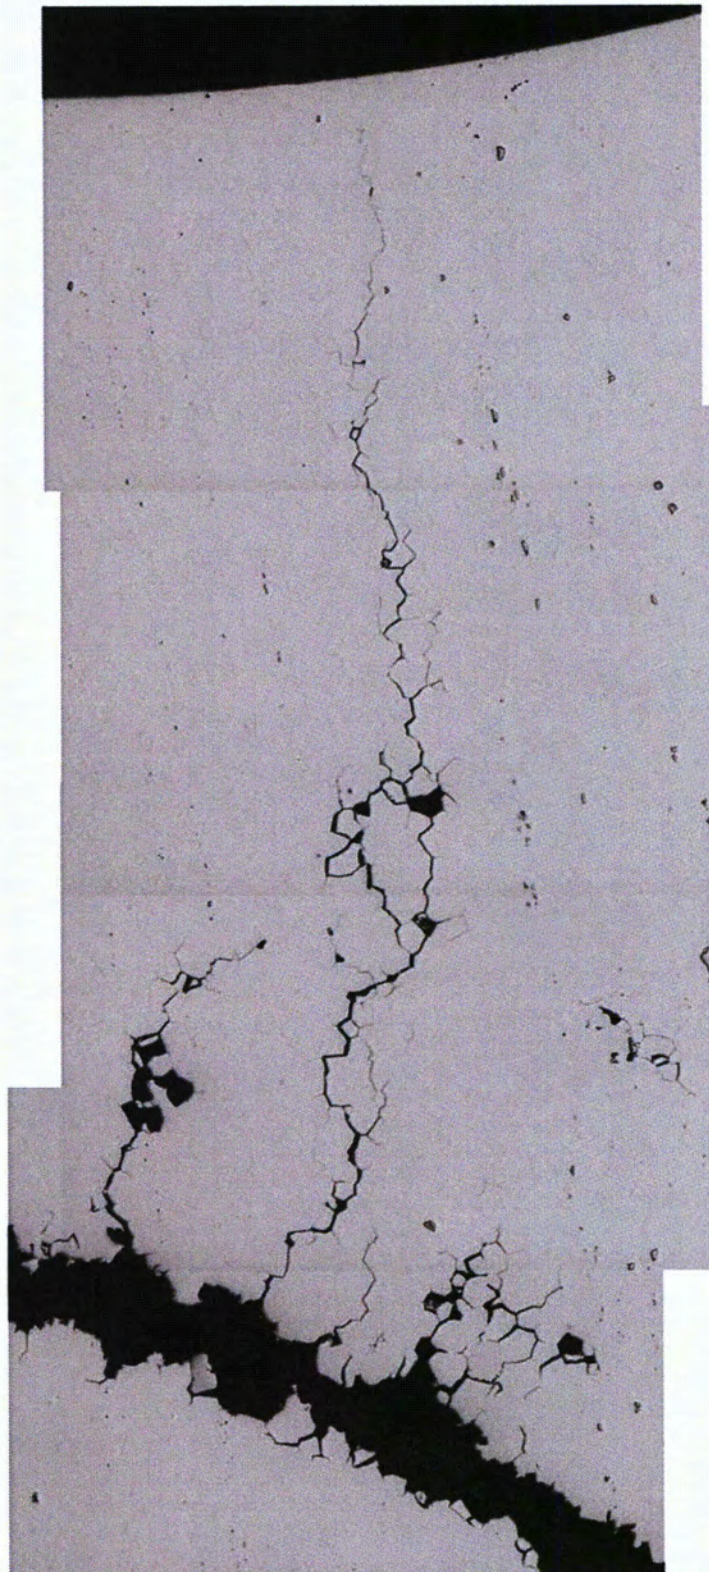
Figure 82: Higher magnification detail of Figure 81, as-polished. 140X

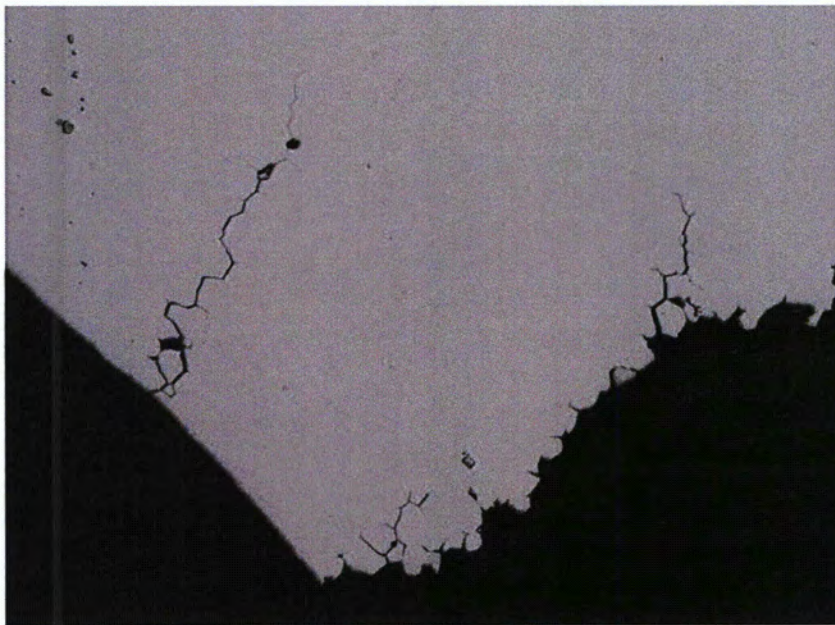
Figure 83: Detail of initiation near 90°. 180X

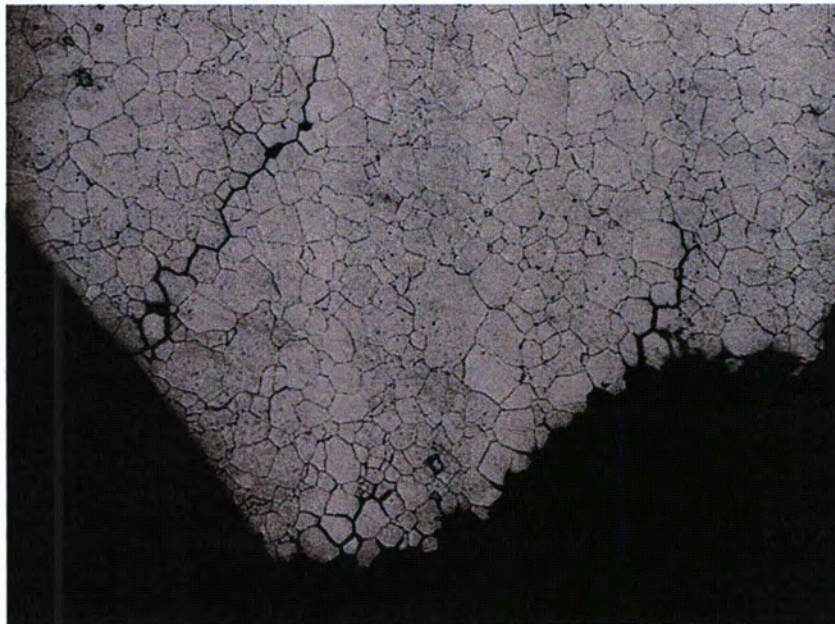
Figure 84: Same area as Figure 83 after phosphoric + nital etch. 180X

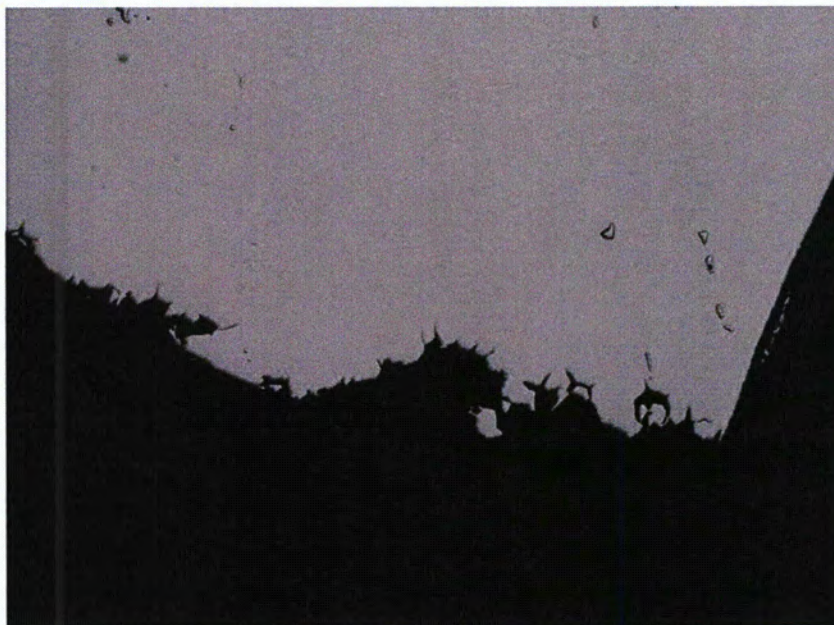
Figure 85: Detail of initiation near 270°. 180X

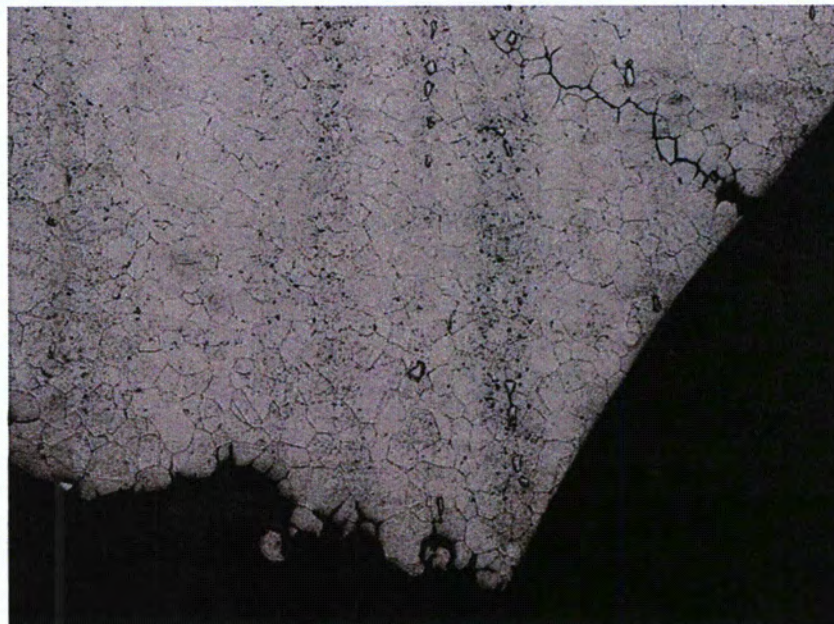
Figure 86: Same area as Figure 85 after phosphoric + nital etch. 180X

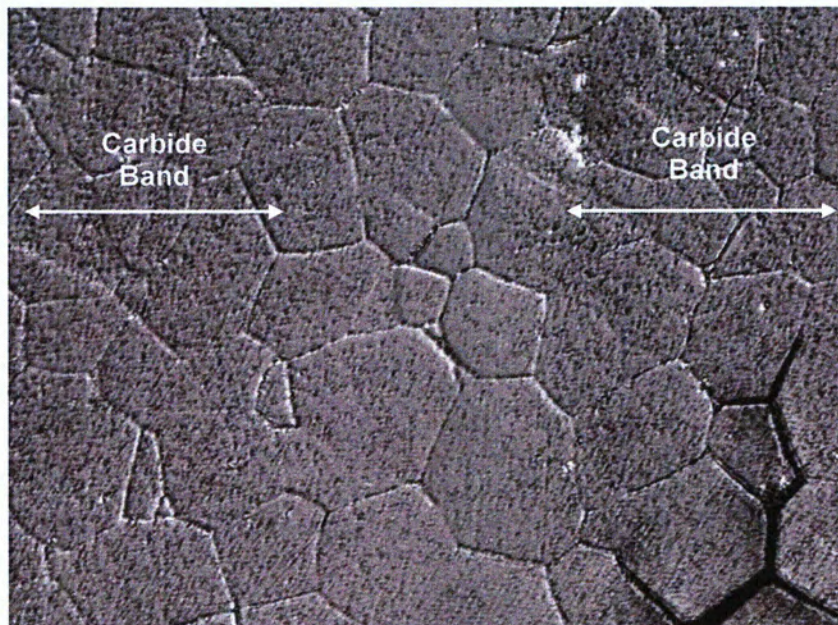
Figure 87: Typical microstructure after phosphoric etch, DIC, 660X.

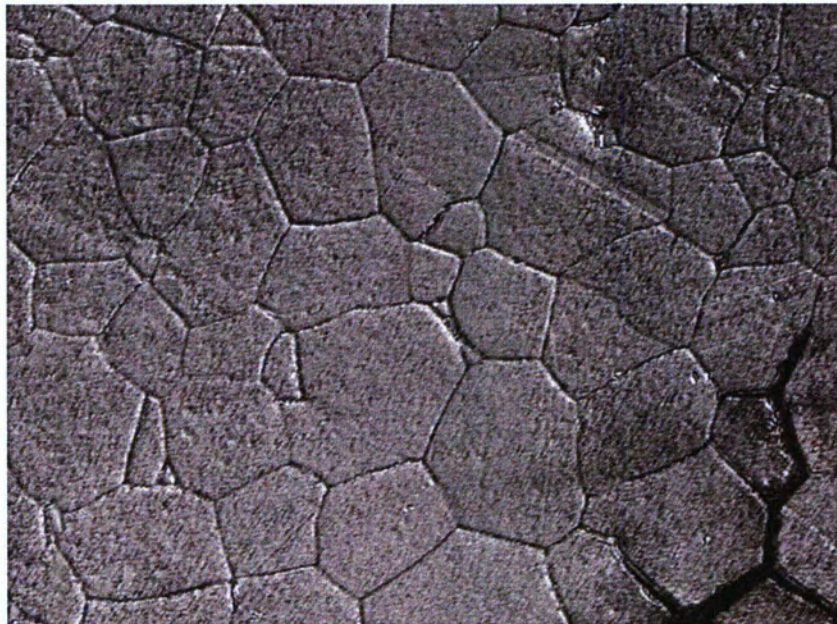
Figure 88: Same area as Figure 87 after phosphoric + nital etch, DIC, 660X.

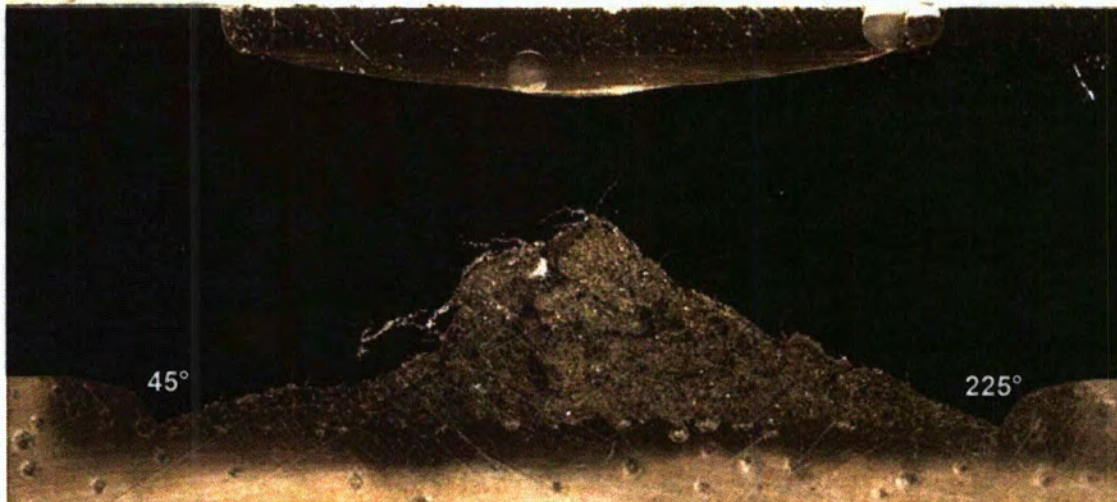
Figure 89: Bolt 120°-6 cross section as-polished overview. 6X
