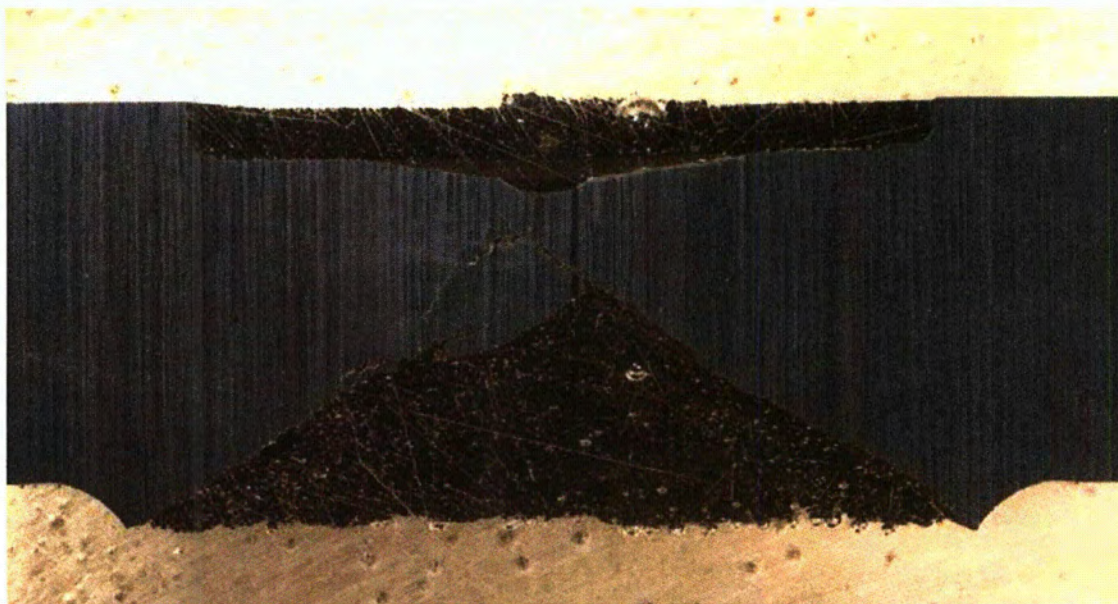
Figure 90: Same area as Figure 89 after phosphoric + nital etch. Structure is banded as evidenced by the presence of vertical streaks. 6X

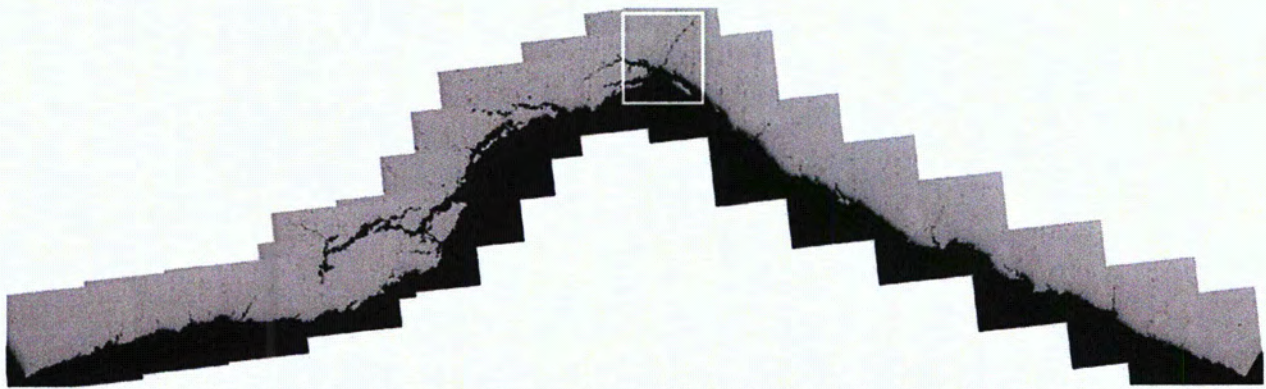
Figure 91: As-polished micrograph montage of crack. Area inside white box is shown in Figure 92. ~10X

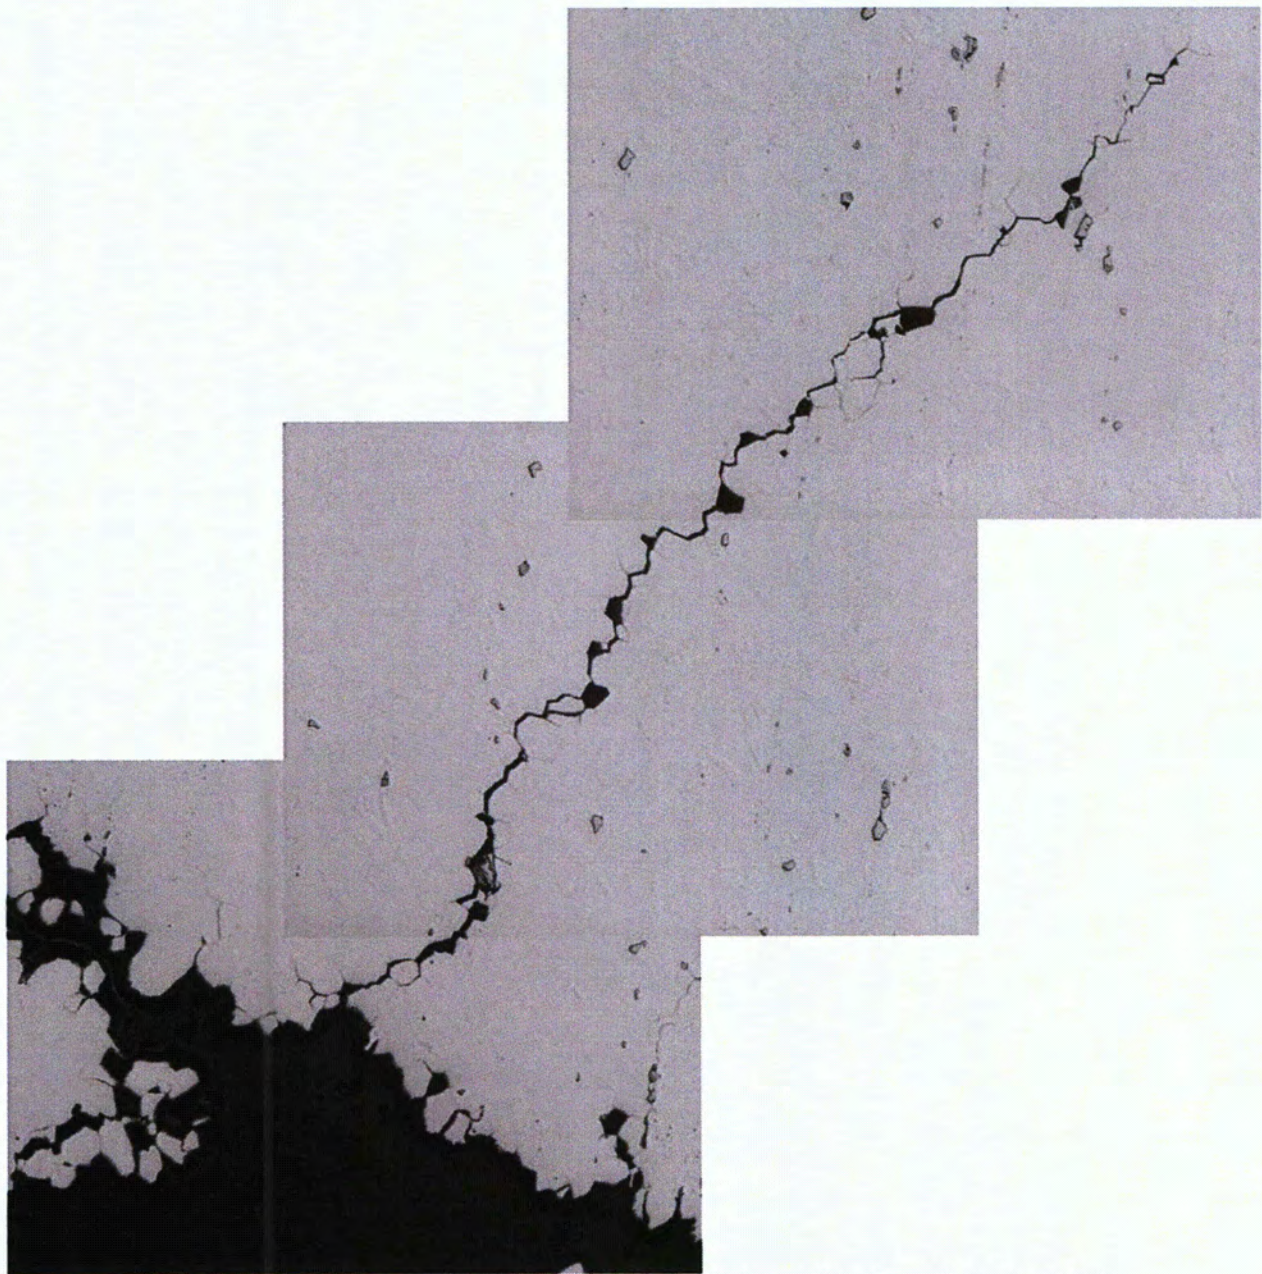
Figure 92: Higher magnification detail of Figure 91, as-polished. 140X
