KEY WORDS: LOWER RADIAL SUPPORT SYSTEM, LRSS, CLEVIS BOLTS, ALLOY X-750, LOW TEMPERATURE CRACK PROPAGATION, INTERGRANULAR STRESS CORROSION CRACKING, IGSCC

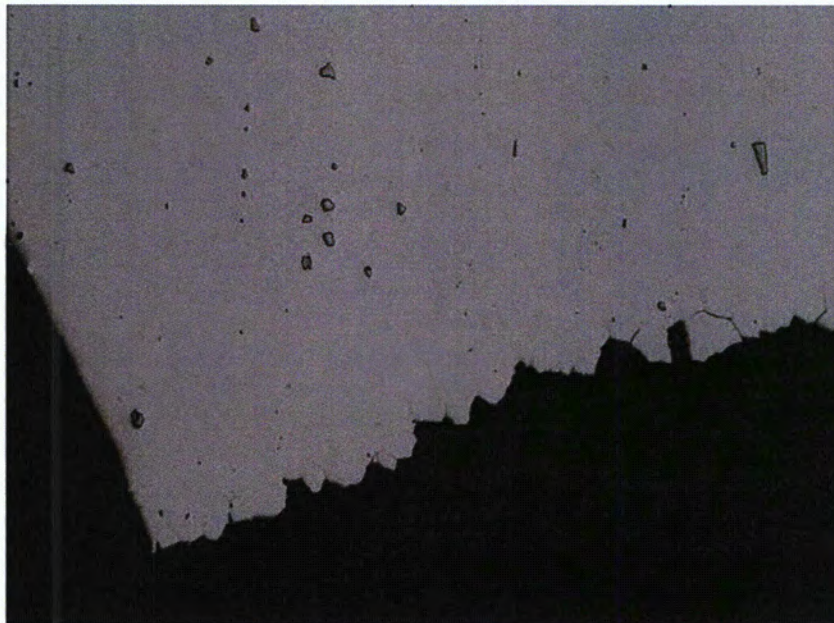
Figure 93: Detail of initiation near 45°. 180X

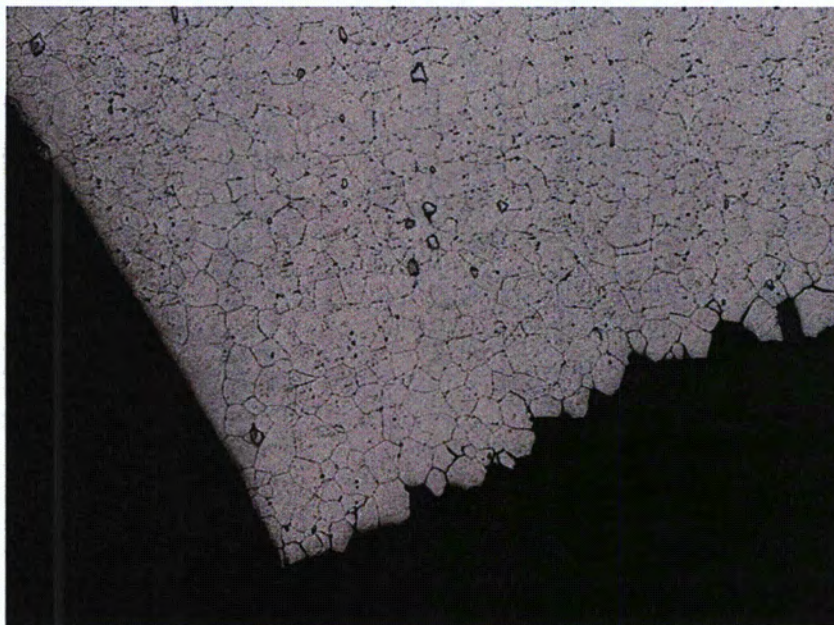
Figure 94: Same area as Figure 93 after phosphoric + nital etch. 180X

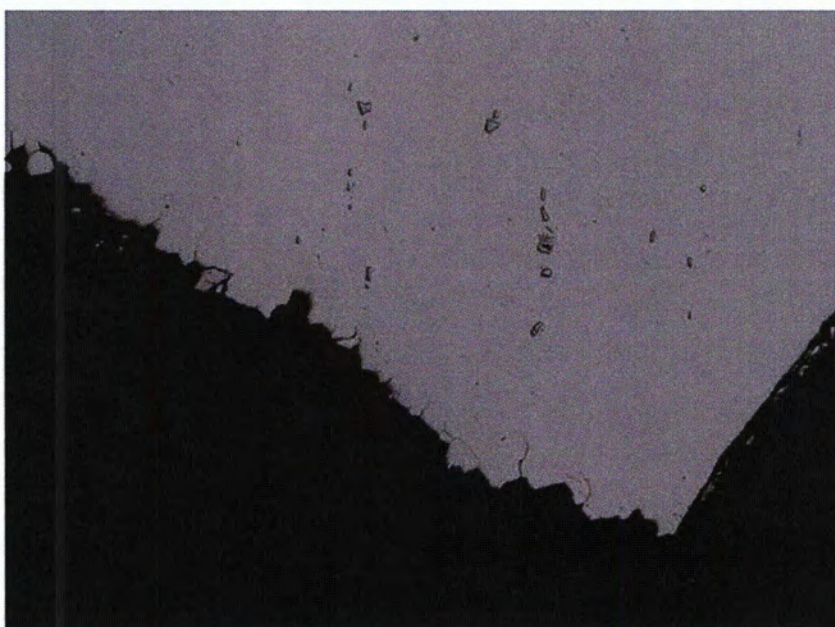
Figure 95: Detail of initiation near 225°. 180X

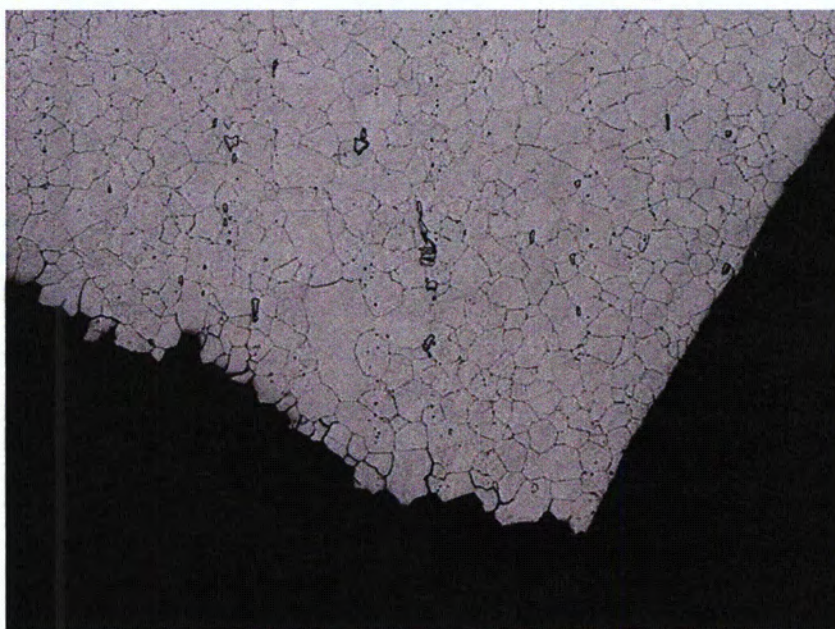
Figure 96: Same area as Figure 95 after phosphoric + nital etch. 180X

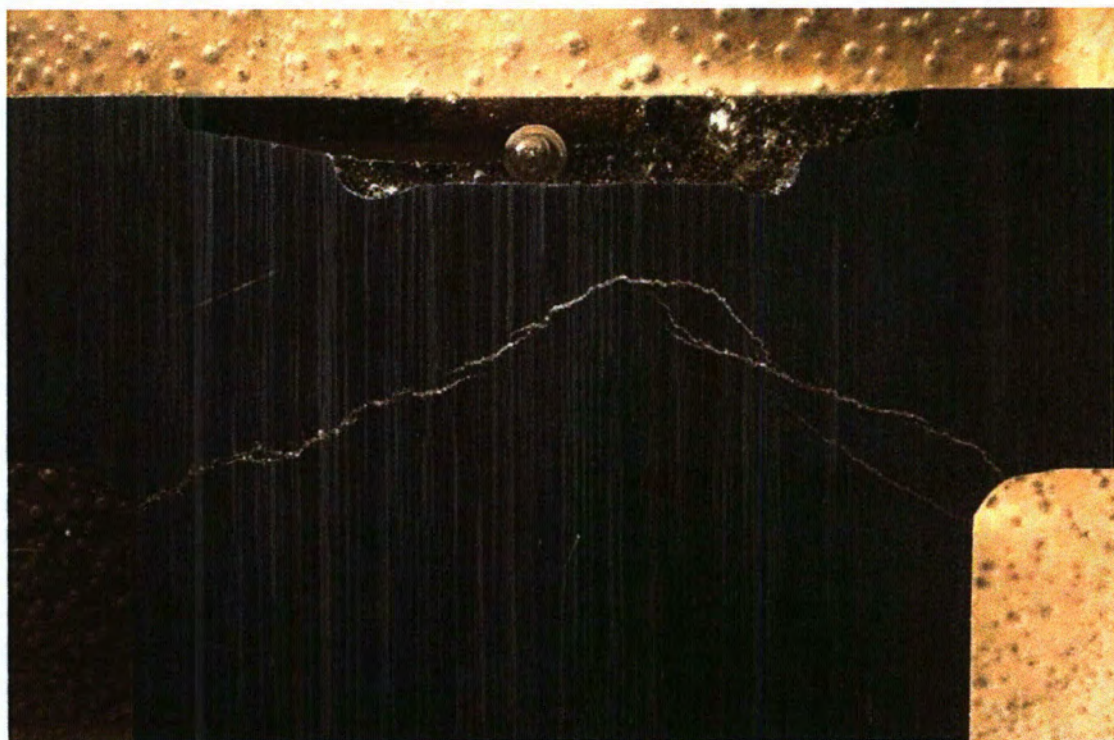
Figure 100: Same area as Figure 99 after phosphoric + nital etch. Structure is banded, as evidenced by the presence of vertical streaks. 6X

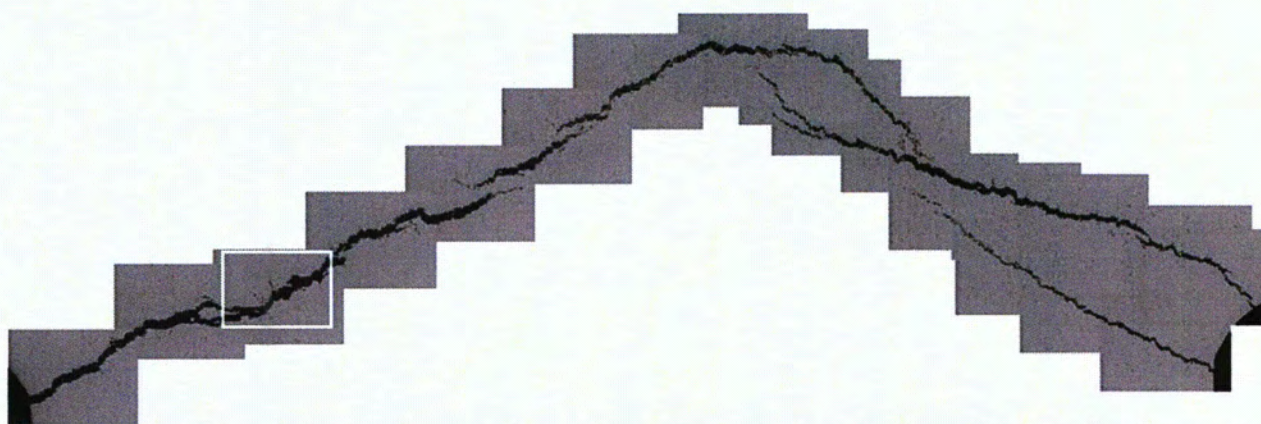
Figure 101: As-polished micrograph montage of crack. Area inside white box is shown at higher magnification in Figure 102. 13X

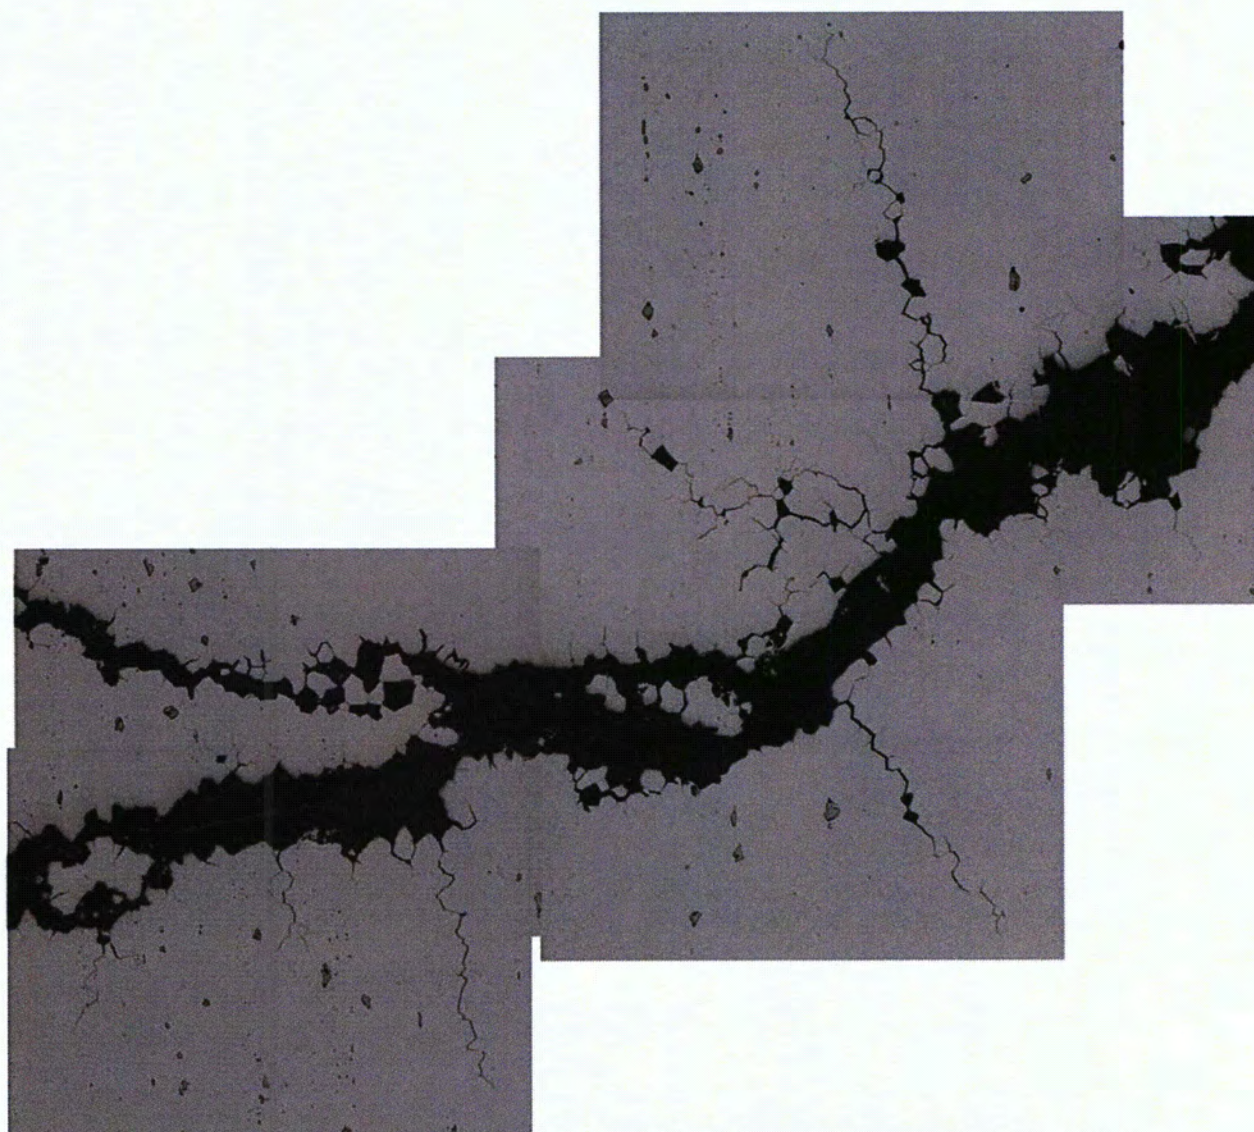
Figure 102: Higher magnification detail of Figure 101, as-polished. 120X

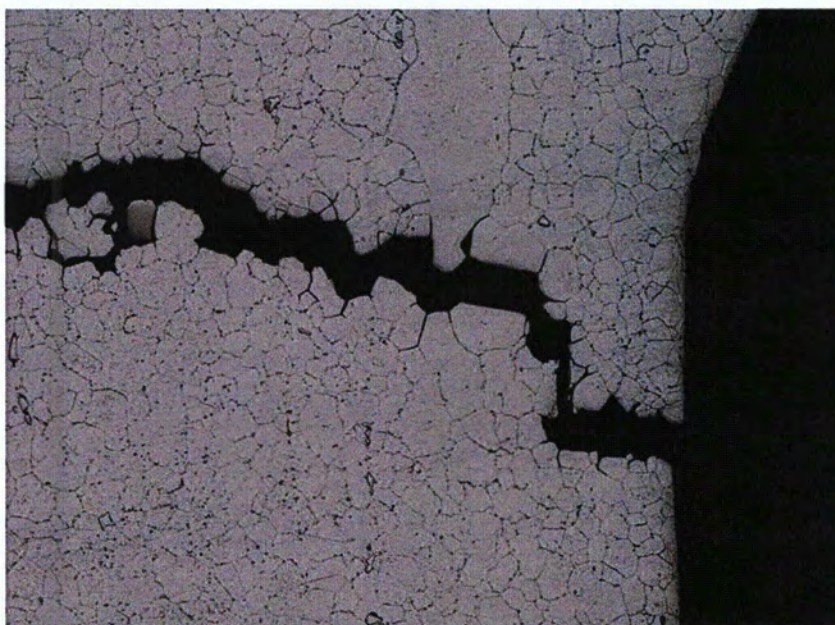
Figure 103: Detail of initiation near 315° after etching. 180X

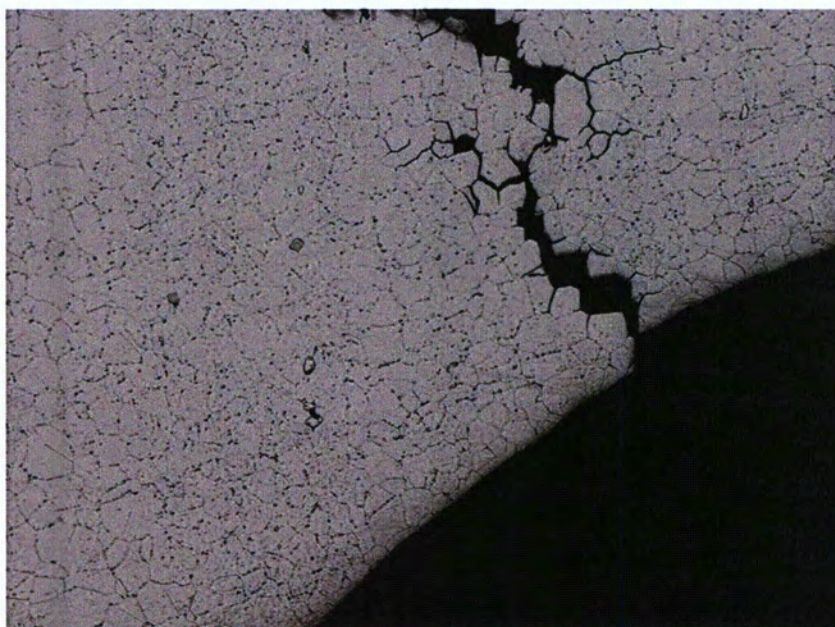
Figure 104: Second crack near 315° after etching. 180X

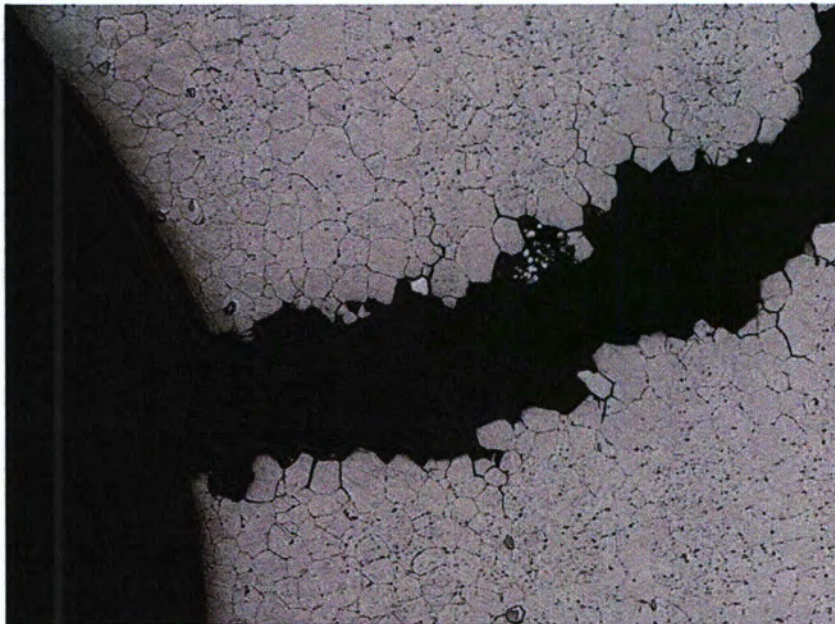
Figure 105: Detail of initiation near 135° after etching. 180X

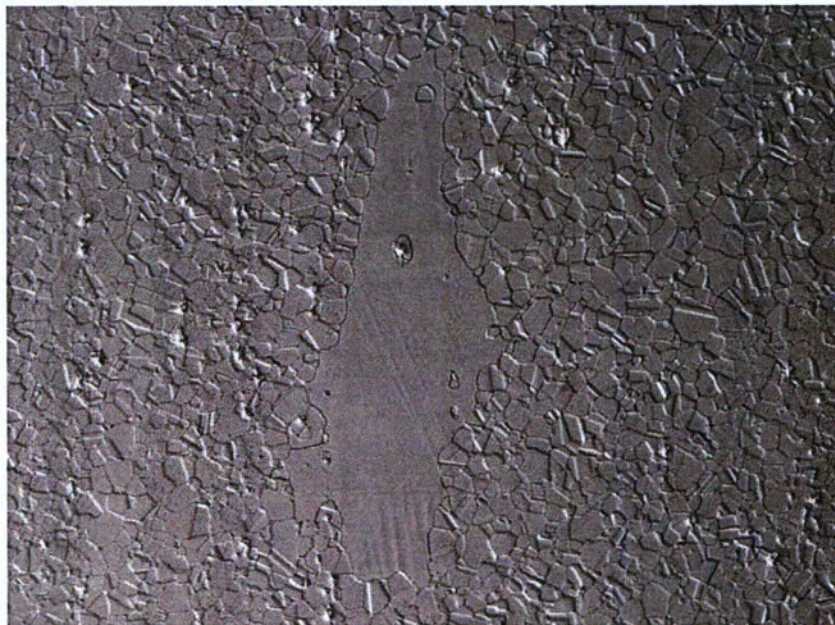
Figure 106: Typical appearance of intermittent duplex grain structure (i.e. large grain in center of micrograph), DIC. 90X

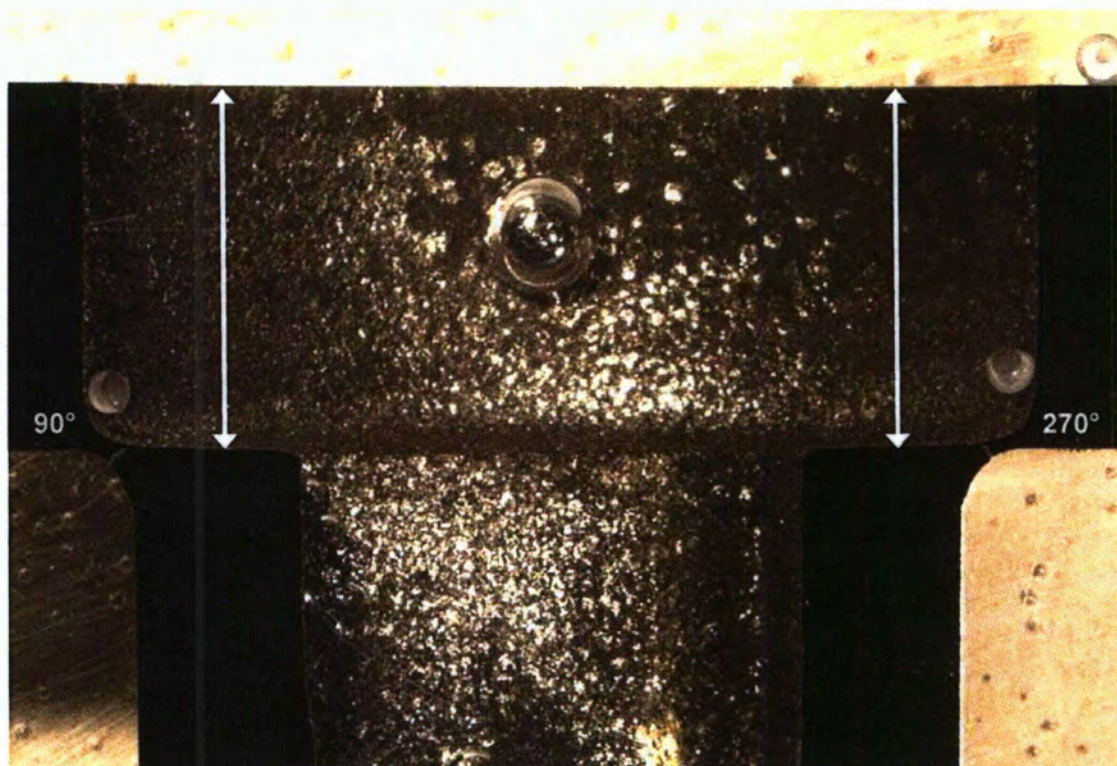
Figure 109: As-polished overview of 300°-1 cross section. Arrows show depth of the EDM plunge cut. 6X

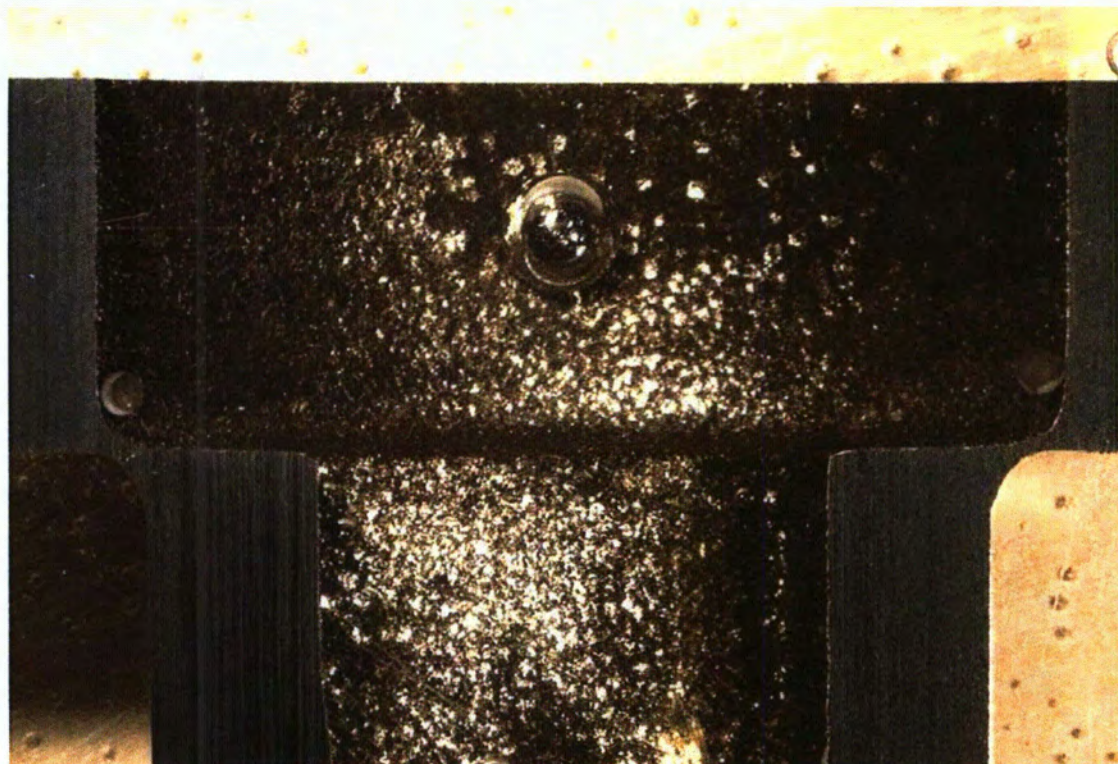
Figure 110: Same area as Figure 109 after phosphoric + nital etch. Structure is banded. 6X

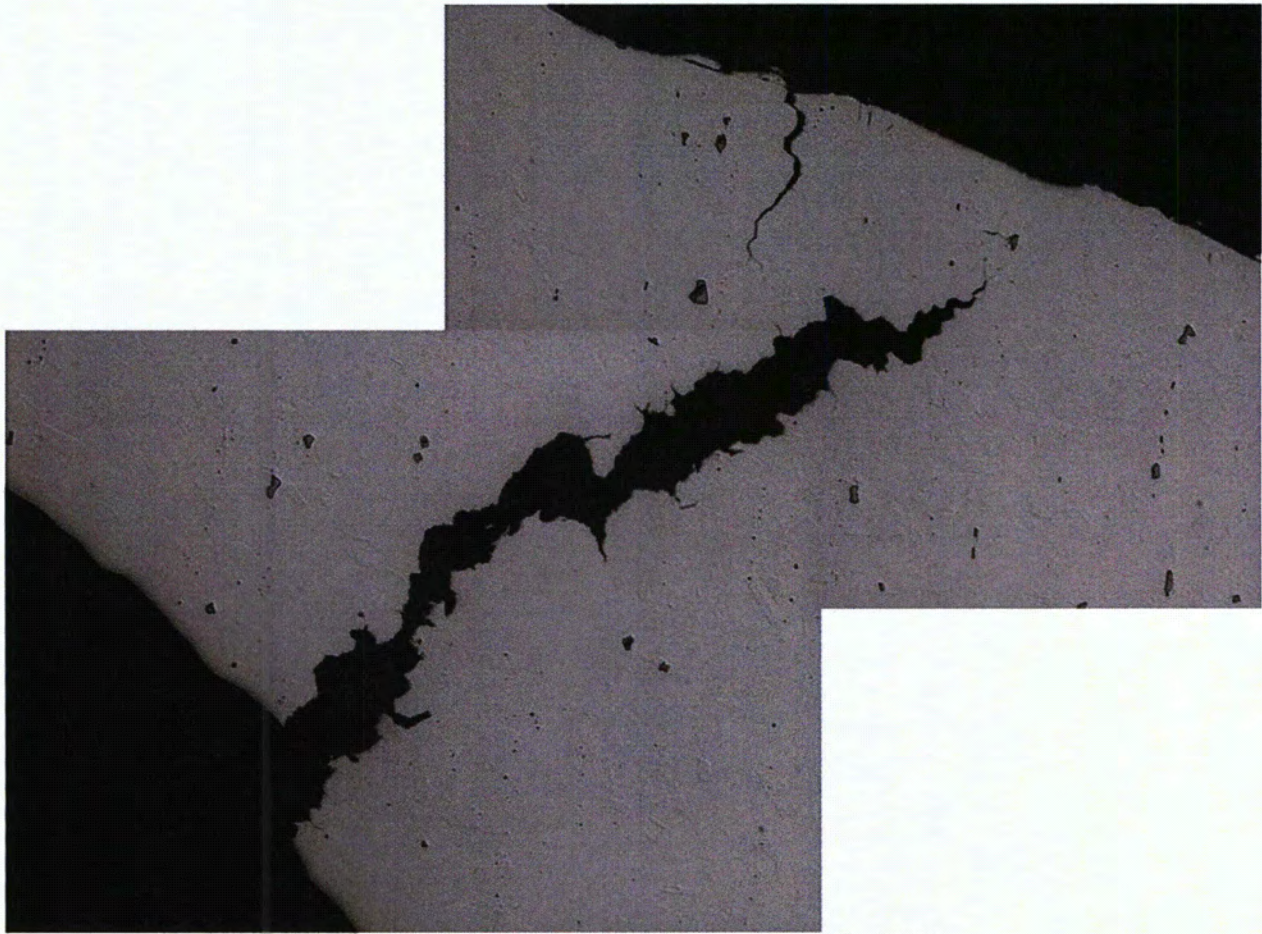
Figure 111: Detail of initiation near 90°. 180X

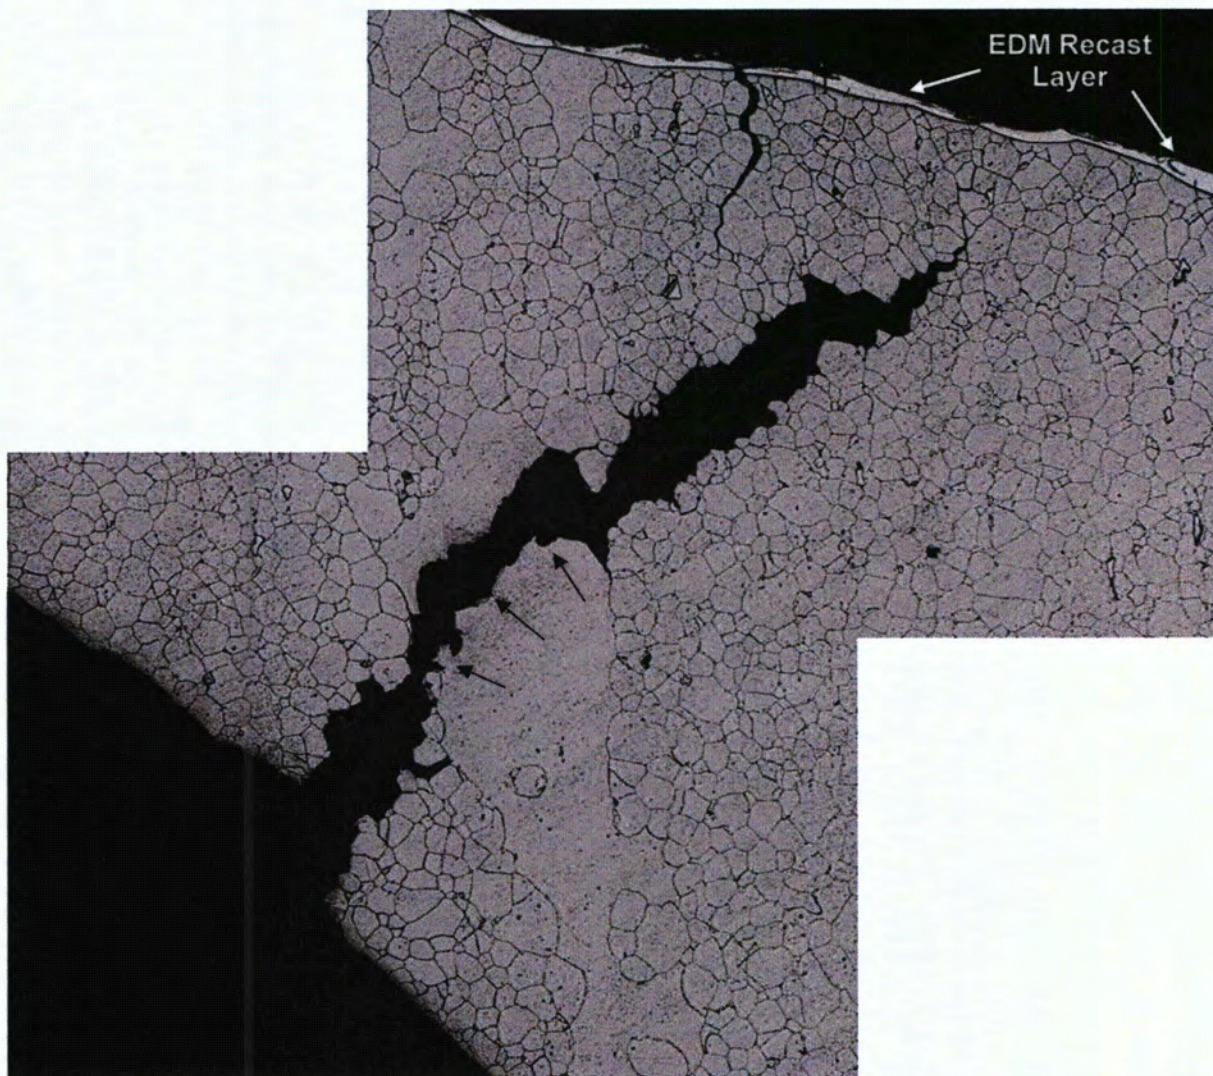
Figure 112: Same area as Figure 111 after etching. Cracking is intergranular, except for transgranular cracking through one large grain (arrows). 180X

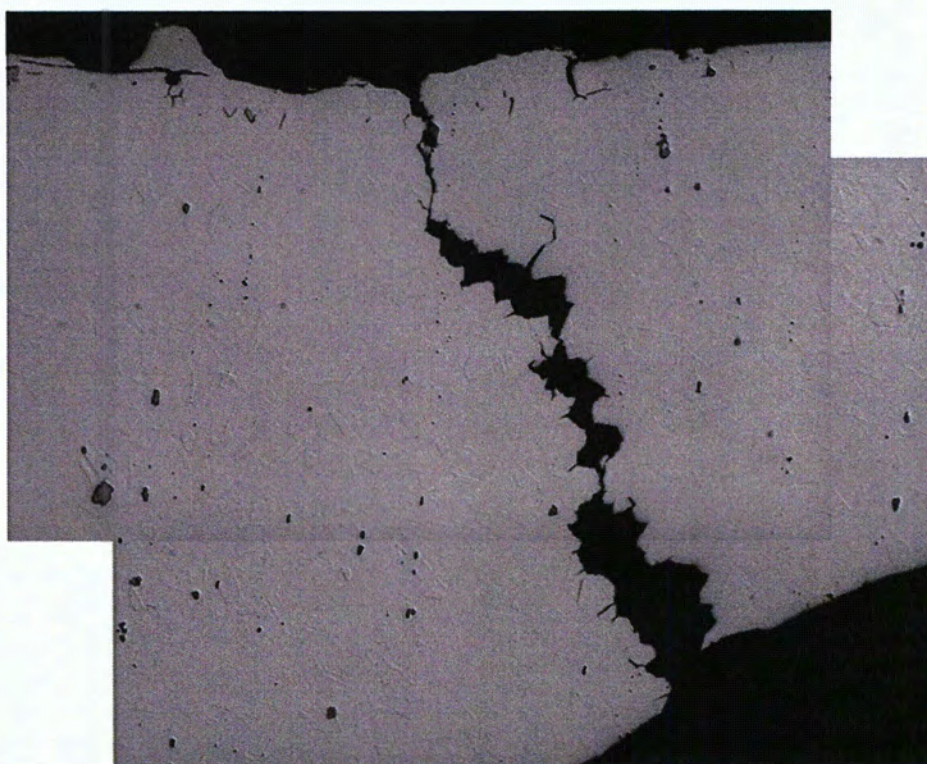
Figure 113: Detail of initiation near 270°. 180X

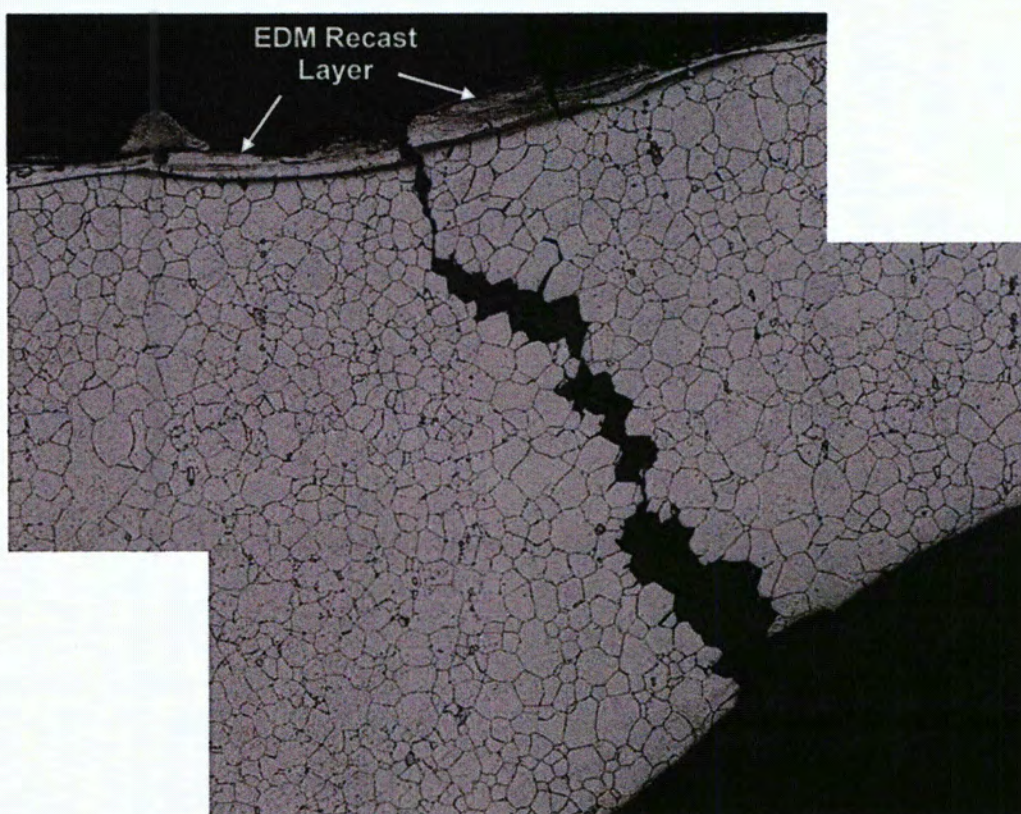
Figure 114: Same area as Figure 113 after etching. 180X
