Part 21 (PAR)

PART 21 REPORT - NOTIFICATION OF DEVIATION REGARDING HK CIRCUIT BREAKER PIVOT PIN

Subject: 10CFR Part 21 Notification of Deviation re. HK Circuit Breaker Pivot Pin

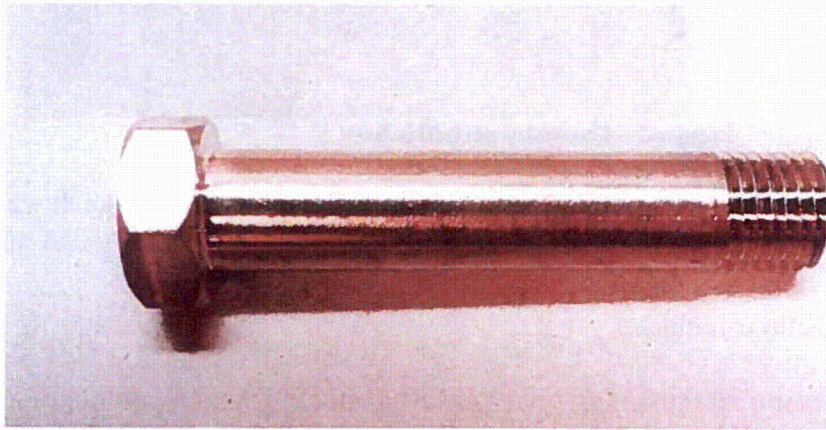
Figure 1 – Pivot Pin

1. This letter provides notification of a failure to comply with specifications associated with a pivot pin, part number 193610B00 (see Figure 1), used in HK circuit breakers. This pin is used as the pivot point for the arcing contacts. Information is provided as specified in 10CFR21 paragraph 21.21(d) (4).

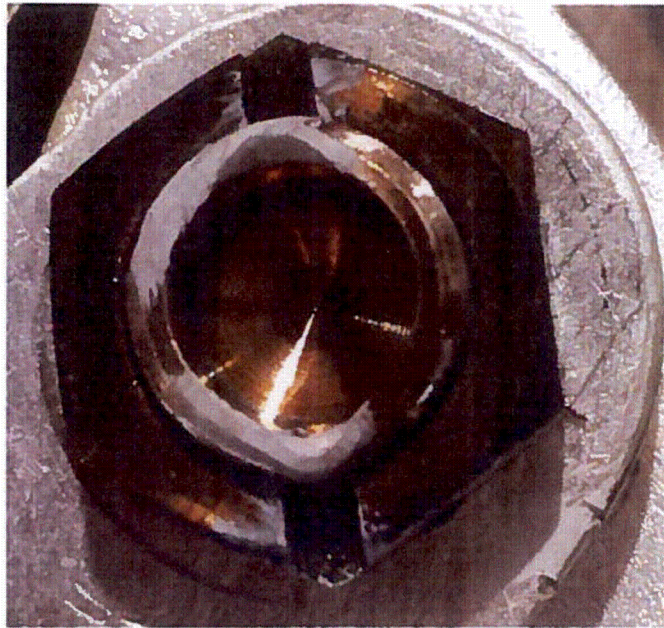
Figure 2 – Correctly peened pin

During a breaker refurbishment at the ABB Florence facility, it was noted that a pivot pin cracked at the threads during installation. The peening operation performed on the threaded end of the pivot pin (see Figure 2) caused cracking due to brittle failure. Laboratory testing revealed that this particular pivot pin was made from an incorrect material.

This pivot pin was purchased in April of 2015 and parts from this batch were used between 14 April and 28 May of 2015. There have been no field failures reported at this time.

- a. Removed all remaining pivot pins from stock. (Action complete)
- b. Contact primary vendor to investigate cause and correct on future orders. (Action Complete)
- c. Added material verification to our Critical Characteristic cards for future orders. (Action Complete)
- d. Upgrade of ABB's spectrometer to analyze this silicon bronze material on all future shipments. (Action Complete)
- e. Obtained and tested, via qualified laboratory, a batch of pivot pins to supply to customers. (Action Complete)
- f. Notification of the potential existence of this deviation to affected customers (Action to be completed the week of 10 August 2015)

If the part was installed in a breaker or assembly and the threaded end did not show signs of failure or fracture at installation, it is not considered to be part of the suspect population. ABB recommends that these pivot pins be visually inspected at the next convenient maintenance cycle.

If the pivot pin is in their inventory as a component item or in a kit and was shipped in the time interval of the suspect material, it should be returned to ABB for replacement.
