SUBJECT: LER 87-011-01:on 871202,cable room sprinkler sys inoperable
 due to design deficiency of pressure & flow rates.

FACILITY NAME (1)
Oconee Nuclear Station - Unit 1DOCKET NUMBER (2)
0 5 0 0 0 2 6 9 1 OF 1 6TITLE (4)
CABLE ROOM SPRINKLER SYSTEMS INOPERABLE DUE TO DESIGN DEFICIENCY OF PRESSURE AND FLOW RATES

FACILITY NAME (1)	DOCKET NUMBER (2)	LER NUMBER (6)			PAGE (3)		
		YEAR	SEQUENTIAL NUMBER	REVISION NUMBER			
Oconee Nuclear Station - Unit 1	05000269	87	011	01	02	OF	16

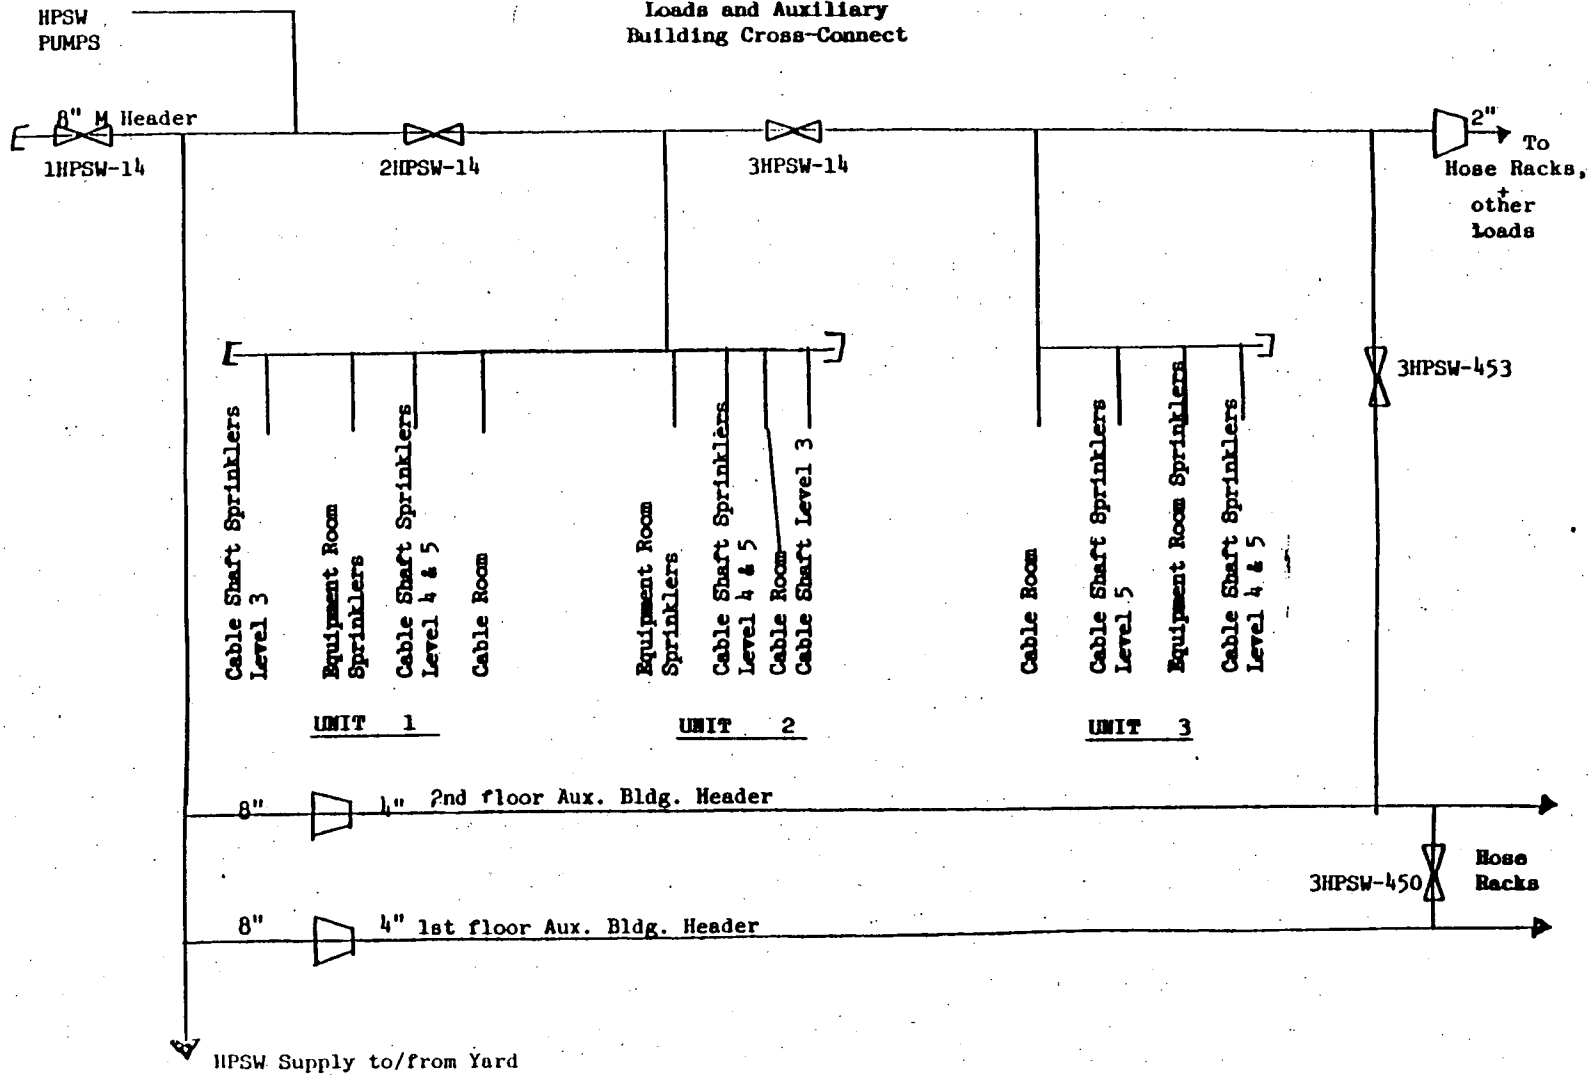
Attachment Schematic of M Header Loads and Auxiliary Building Cross-Connect

Design Engineer B completed preliminary calculations on October 23 which showed that the four inch cross-connect would not supply sufficient flow and pressure to the cable room sprinkler systems for all three units if 2HPSW-14 was closed, and that the Unit 3 Cable Room sprinkler system was inoperable if 3HPSW-14 was closed.

There was also a deficiency in the lack of consideration given to the Unit 3 cross-connect's ability to supply the M-header loads, with the M-header isolated. It is recognized that the original reason for installing the cross-connect was for supplying water to the Auxiliary Building from the Turbine Building's M-header. However, this installation did provide an alternate route for supplying the M-header loads and its ability to do so was not reviewed. Interviews with both Operations and Design Engineering personnel indicated that it is a reasonable conclusion, for someone reviewing flow diagrams, to consider the M-header loads to be operable if they were being supplied by the cross-connect with the M-header isolated. Therefore because the ability of the HPSW system to supply the sprinkler system was not analyzed, and the potential for using the cross-connect as an alternate supply to the sprinklers was not formally reviewed or proven, this event is classified as a Design Deficiency.

HPSW system could meet sprinkler demand. As for the cross-connect's ability to supply the sprinklers, it was installed to provide water flow and pressure to the Auxiliary Building and its potential use as an alternate supply to the M-Header sprinkler systems was not considered by Design Engineering.

- o An NSM was written to replace the four-inch pipe (EIIS:PSP) which supplied the Unit-3 Cable Room with a six inch diameter pipe.

- o The six inch pipe was installed which made the Unit 3 Cable Room system operable.
