SUBJECT: LER 89-009-01:on 890607,mgt deficiency resulted in incorrect  
 Tech Spec.

Subject: Oconee Nuclear Station  
Docket Nos. 50-269, -270, -287  
LER 269/89-09, Revision 1

FACILITY NAME (1) Oconee Nuclear Station, Unit 1										DOCKET NUMBER (2) 0 5 0 0 0 2 1 6 1 9 1 OF 1 2										PAGE (3) 1	
TITLE (4) A Management Deficiency Resulted in an Incorrect Technical Specification Which Allowed a Single Breaker Failure to Prevent the Emergency Power Switching Logic from Functioning																					
EVENT DATE (5)			LER NUMBER (6)				REPORT DATE (7)			OTHER FACILITIES INVOLVED (8)											
MONTH	DAY	YEAR	YEAR	SEQUENTIAL NUMBER	REVISION NUMBER	MONTH	DAY	YEAR	FACILITY NAMES					DOCKET NUMBER(S)							
									Oconee, Unit 2					0 5 0 0 0 2 1 7 1 0							
0 6	0 7	8 9	8 9	0 0 9	0 1 0	8	0 1	8 9	Oconee, Unit 3					0 5 0 0 0 2 1 8 1 7							
OPERATING MODE (9)		THIS REPORT IS SUBMITTED PURSUANT TO THE REQUIREMENTS OF 10 CFR §: (Check one or more of the following) (11)																			
N		20.402(b)				20.406(e)				80.73(a)(2)(iv)				73.71(b)							
POWER LEVEL (10)		20.408(a)(1)(i)				80.38(a)(1)				80.73(a)(2)(v)				73.71(e)

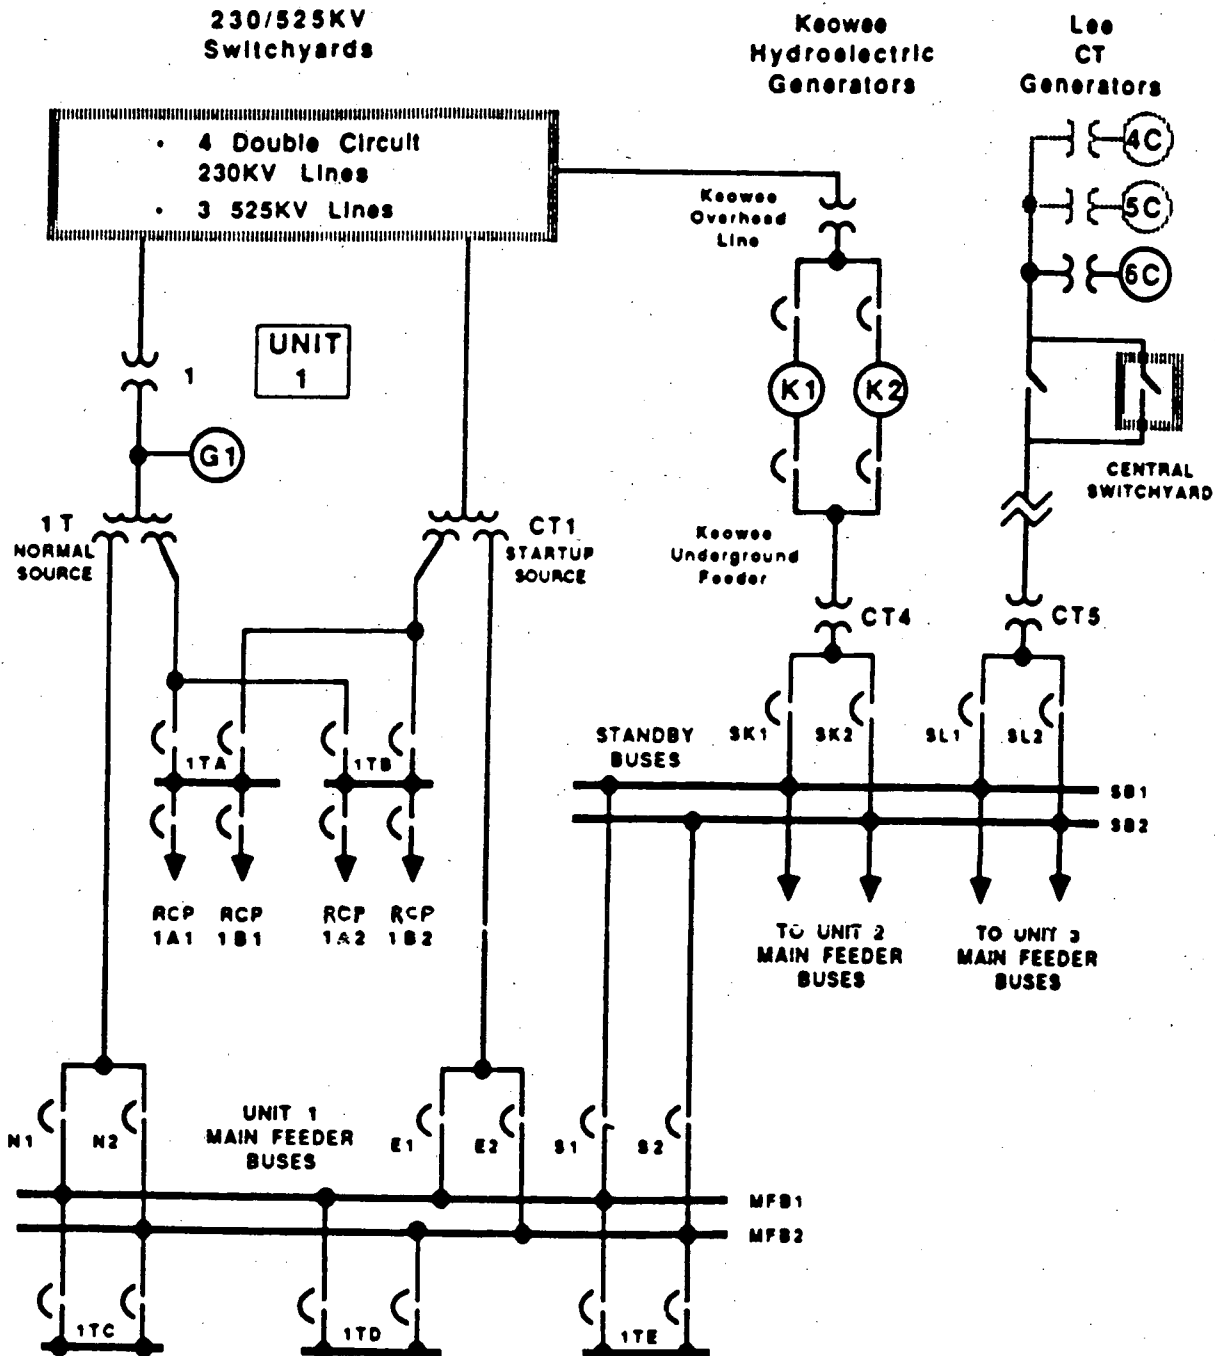
## OCONEE NUCLEAR STATION Power System

If the plant had been operating in the Technical Specification-allowed configuration of having one Standby Bus removed from service, then the plant's ability to mitigate a loss of coolant accident concurrent with a loss of off-site power would have been hampered by a single failure of the operable standby bus to main feeder bus (S) breaker (reference the attached drawing).

Remembering that the plant configuration of concern was the removal of one of the Standby Buses from service, the LOCA unit could then only be supplied from one Standby Bus and its corresponding SK and S breakers. At this point, if a failure of the operable S breaker was pre-existing or had occurred then the underground path would have been ineffective in supplying power to the main feeder bus. In this situation, the Retransfer to Startup Logic portion of the EPSL would not detect that the underground path had become ineffective because it still sensed sufficient voltage on the operable Standby Bus. This sensing of voltage would have falsely indicated to the EPSL that the underground path was providing power to a main feeder bus. At this time, manual operator action would have been required. (This result also applies if the S breaker control switches were in "manual" because the breakers would not have automatically closed and the EPSL would still have sensed voltage on the Standby Buses - regardless if one or both buses were in service.)
