SUBJECT: LER 89-014-00:on 890921,overhead emergency power path  
 rendered inoperable due to mgt deficiency.

Subject: Oconee Nuclear Station  
Docket Nos. 50-269, -270, -287  
LER 269/89-14

FACILITY NAME (1) <b>Oconee Nuclear Station, Unit 1</b>										DOCKET NUMBER (2) <b>0 5 0 0 0 2 6 9</b>										PAGE (3) <b>1 OF 1</b>																					
TITLE (4) <b>Overhead Emergency Power Path Rendered Inoperable Due to Management Deficiency When Certain PCBs Were Removed From Service</b>																																									
EVENT DATE (5)						LER NUMBER (6)						REPORT DATE (7)						OTHER FACILITIES INVOLVED (8)																							
MONTH			DAY			YEAR			YEAR			SEQUENTIAL NUMBER			REVISION NUMBER			MONTH			DAY			YEAR			FACILITY NAMES						DOCKET NUMBER(S)								
																											<b>Oconee Unit 2</b>						<b>0 5 0 0 0 2 7 0</b>								
<b>0 9</b>			<b>2 1</b>			<b>8 9</b>			<b>8 9</b>			<b>0 1</b>			<b>4</b>			<b>0 0</b>			<b>1 0</b>			<b>2 0</b>			<b>8 9</b>			<b>Oconee Unit 3</b>						<b>0 5 0 0 0 2 8 7</b>					
OPERATING MODE (9) <b>N</b>						THIS REPORT IS SUBMITTED PURSUANT TO THE REQUIREMENTS OF 10 CFR 5: (Check one or more of the following) (11)

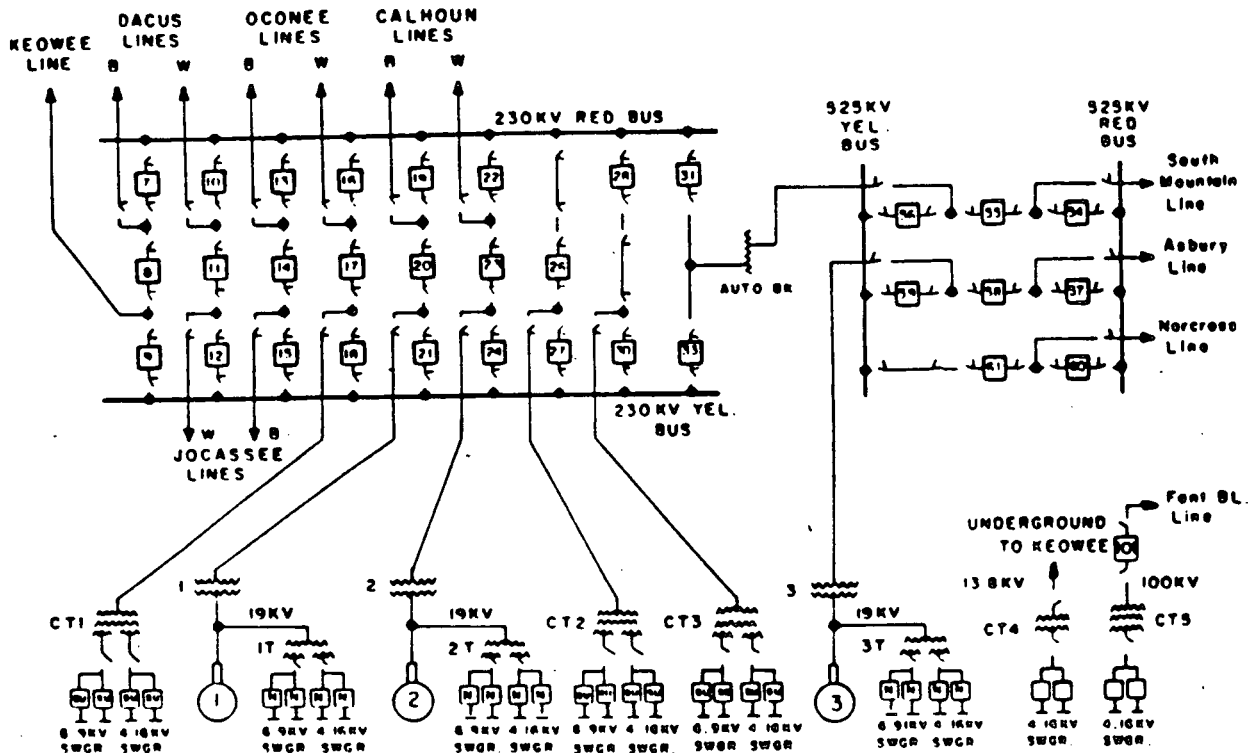
## ATTACHMENT 1

The Oconee 230 KV switchyard [EIIS:FK] is an interface between the 230 KV Duke transmission line network and Oconee Units (reference attachment 1). Abnormal conditions in the 230 KV switchyard result in switching operations that are initiated by protective relaying. One of the protective relaying circuits is the External Grid Trouble Protective System [EIIS:EK]. This system is designed to monitor the voltage and frequency of both the red and yellow buses in the 230 KV switchyard. When this system detects abnormal conditions, it initiates a startup of the Keowee hydro units [EIIS:EK] and provides a path to provide emergency power from Keowee to the Oconee Startup transformers [EIIS:XFMR] CT-1, CT-2, and CT-3 by closing Power Circuit Breakers (PCBs) 9, 18, 27, and 30 and by tripping open PCBs 8, 12, 15, 17, 21, 24, 26, 28, and 33 to isolate the yellow bus from the grid.

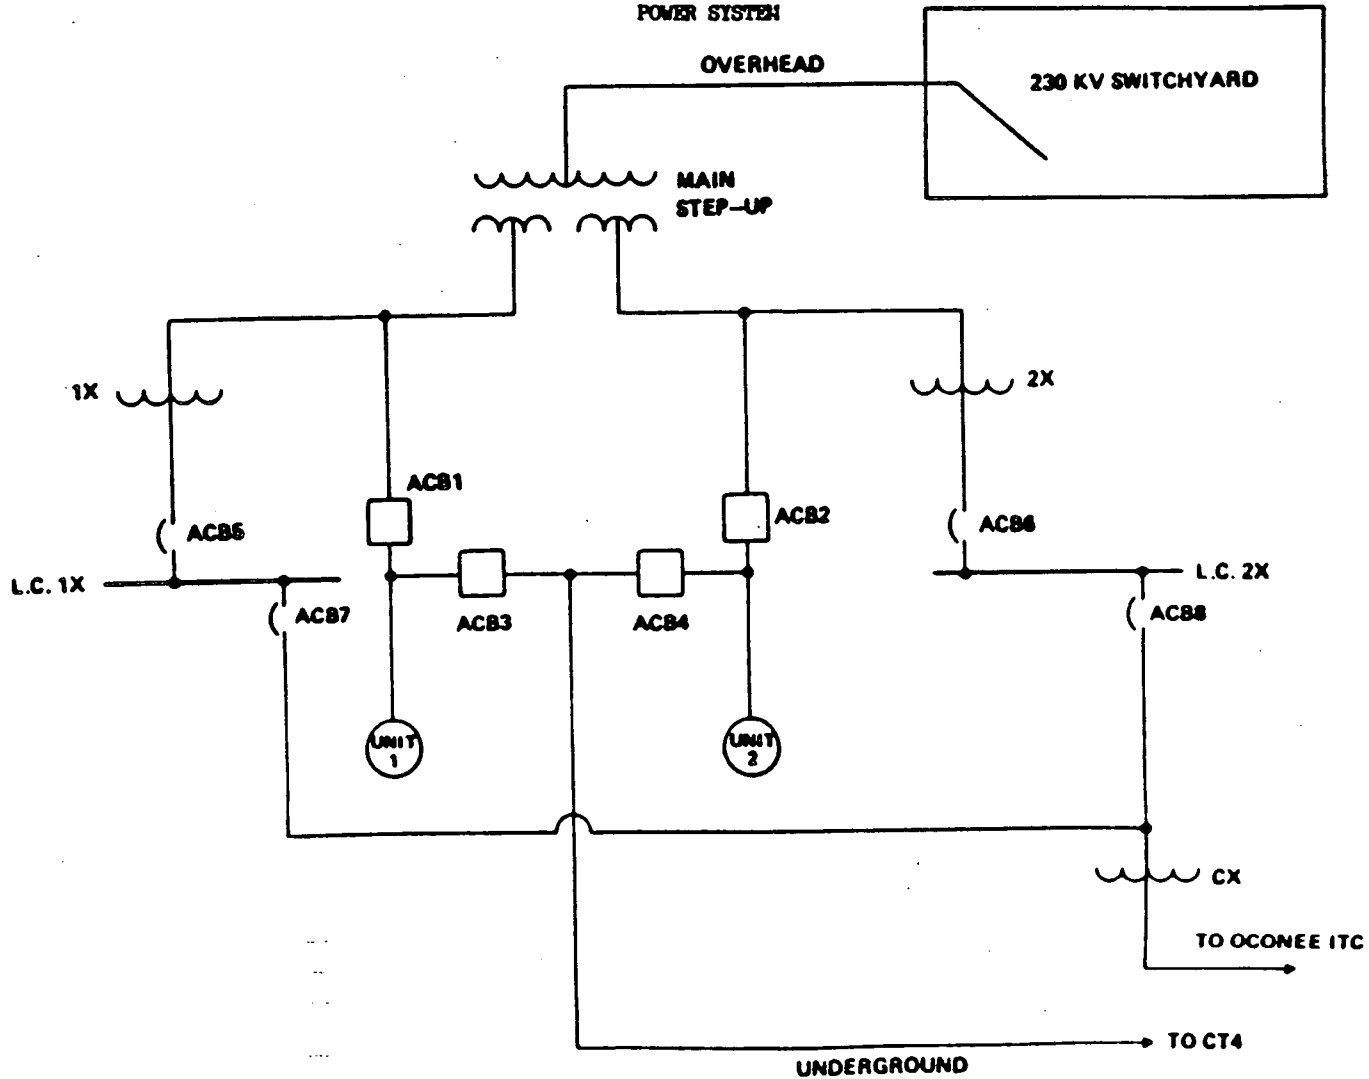
## ATTACHMENT 2

On September 21, 1989 with Units 2 and 3 at 100% full power and Unit 1 at 75% full power, licensee trainees were discussing the operability of the Keowee auxiliary transformers 1X and 2X (reference attachment 2). This discussion was prompted due to the trainees recently completing training given by the Operations Support group on the Emergency Power Switching Logic [EIIS:EK] and a proposed revision to Technical Specification (TS) 3.7. In their discussion, they questioned how the removal of PCB-9 from service would affect the operability of transformers 1X and 2X as required by the proposed revision to TS 3.7. They concluded from their discussion that the auxiliary transformers (1X and 2X) would be rendered inoperable while PCB-9 was out of service because Air Circuit Breaker (ACB 1 or 2) would not close due to the "switchyard isolate complete" logic not being satisfied. Operations Manager 'A', responsible for switchyard operations, was then consulted on this matter. Operations Manager 'A' agreed with the trainees conclusion and stated that no further action was necessary since the Keowee backup auxiliary transformer (CX) was available and because all Oconee Units would then be under a Limiting Condition of Operation as required by TS 3.7.2 (a) due to the removal of PCB-9 from service. Operations Manager 'A' then contacted Design Engineering (DE) personnel accountable for electrical systems to determine if the removal of either PCBs 18, 27, and 30 (the other PCBs required to close on a switchyard isolation signal) from service could affect more than just that Oconee Unit's respective overhead emergency power path. DE concluded that disabling either PCB 18, 27, or 30 (Oconee Units' 1, 2, and 3 Startup transformer feeders, respectively) would not only disable the respective unit's overhead emergency power path, but it would disable the overhead emergency power path for all Oconee units. This situation would occur because the "switchyard isolate complete" logic would sense that the switchyard PCBs were not aligned to their required switchyard isolation position and therefore no automatic close permissive would be given to ACB-1 or 2 to allow either Keowee hydro unit to close onto the overhead emergency power path. Therefore, during periods while one Oconee unit was shutdown, maintenance or testing may have been performed on the shutdown Unit's respective startup feeder PCB (18, 27, or 30) while the requirements of TS 3.7.2 (a) were not met for any remaining Oconee units above 200 degrees Fahrenheit. It was subsequently concluded that when any of the other switchyard isolation PCBs (8, 12, 15, 17, 21, 24, 26, 28, and 33) are removed from service such that they are unable to operate to their

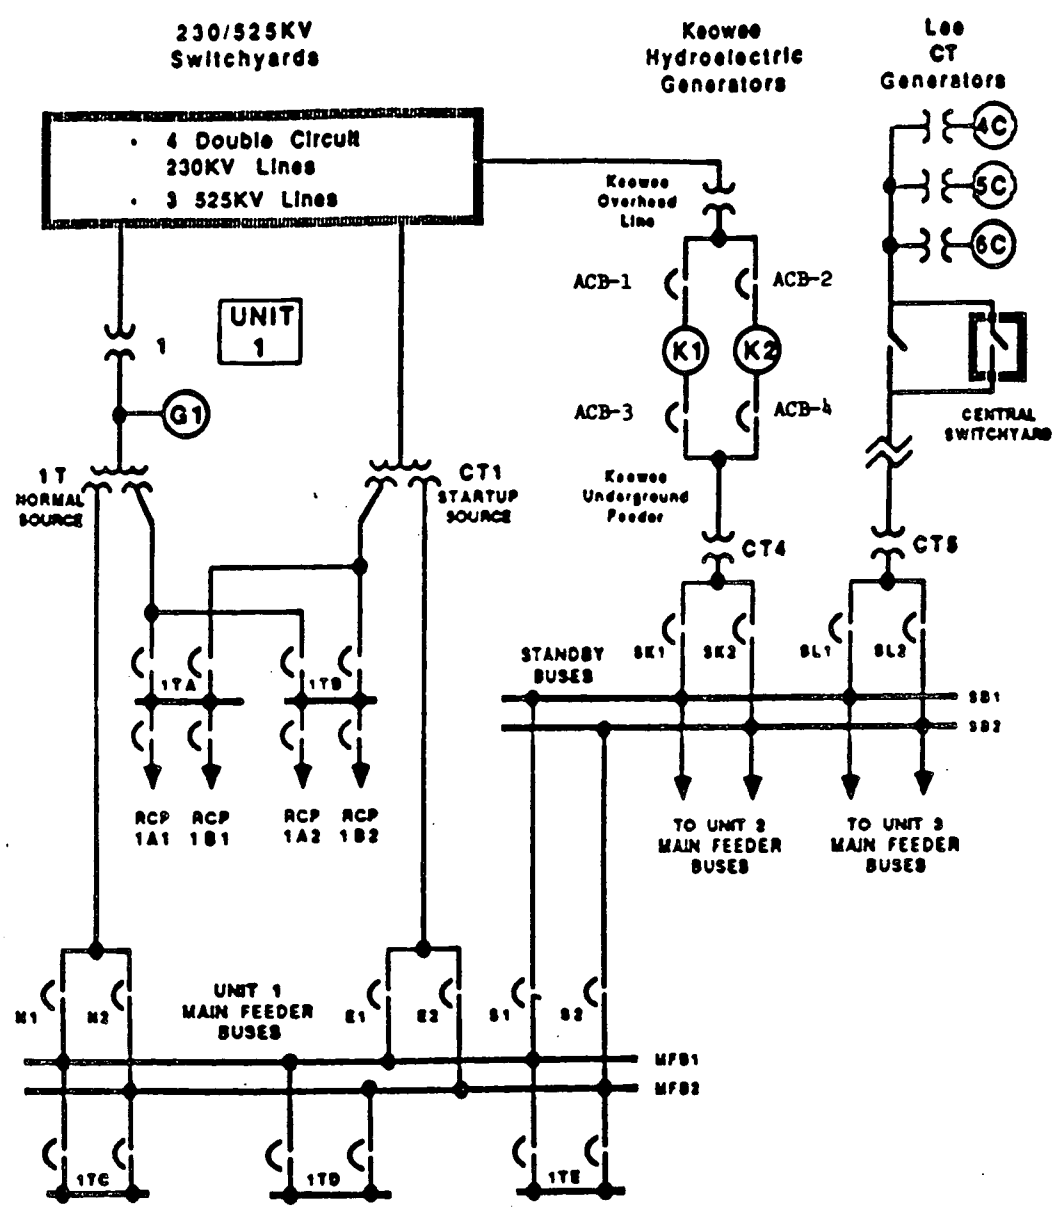
ATTACHMENT 3

If certain 230 KV switchyard Power Circuit Breakers (PCBs) are removed from service in such a way that they are disabled from operating, potential scenarios exist where essential station auxiliaries may not receive sufficient power (reference attachment 3). In order to evaluate the impact of this situation, two scenarios need to be addressed.
