SUBJECT: LER 88-015-00: on 890921, inoperable containment isolation
 valves following failure to test after maint/mod.

LICENSEE EVENT REPORT (LER)

FACILITY NAME (1) Oconee Nuclear Station, Unit 1										DOCKET NUMBER (2) 0 5 0 0 0 2 6 9										PAGE (3) 1 OF 2 4																					
TITLE (4) Inoperable Containment Isolation Valves Following Failure to Test After Maintenance/ Modification Resulting From Inappropriate Action and Management Deficiency																																									
EVENT DATE (5)						LER NUMBER (6)						REPORT DATE (7)						OTHER FACILITIES INVOLVED (8)																							
MONTH			DAY			YEAR			YEAR			SEQUENTIAL NUMBER			REVISION NUMBER			MONTH			DAY			YEAR			FACILITY NAMES						DOCKET NUMBER(S)								
																											Oconee, Unit 2						0 5 0 0 0 2 7 0								
0 9			2 1			8 9			8 9			0 1			5			0 0			1 0			2 1			8 9			Oconee, Unit 3						0 5 0 0 0 2 8 7					
OPERATING MODE (9) N						THIS REPORT IS SUBMITTED PURSUANT TO THE REQUIREMENTS OF 10 CFR §: (Check one or more of the following) (11)

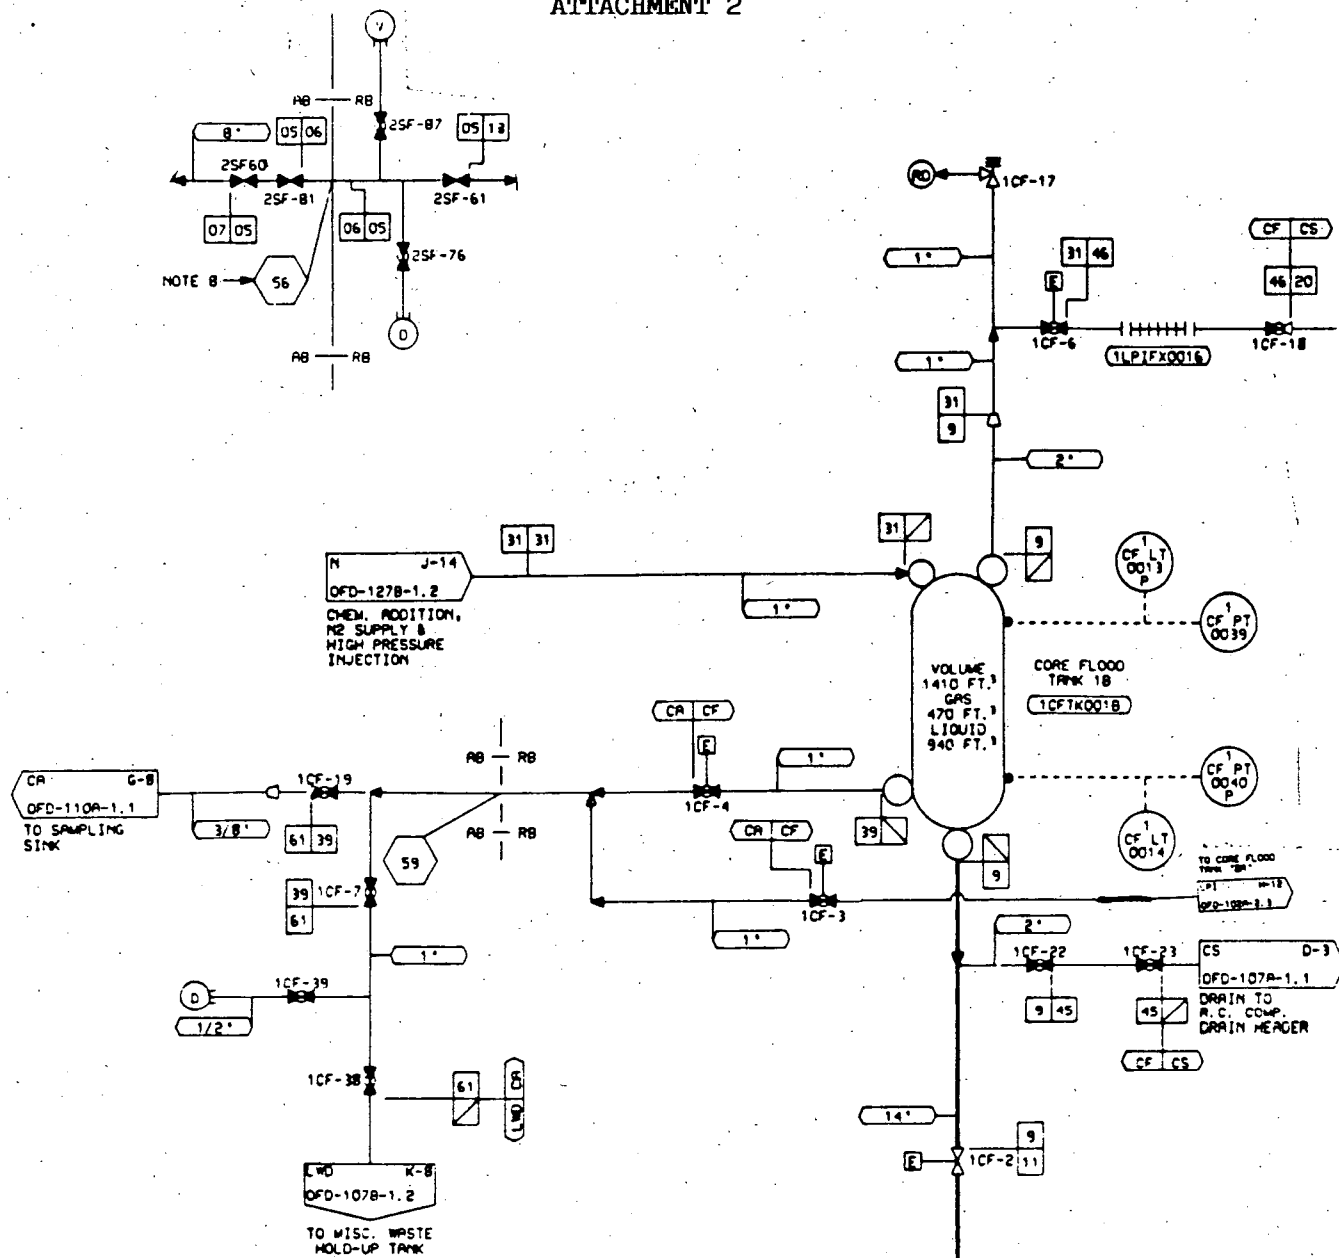
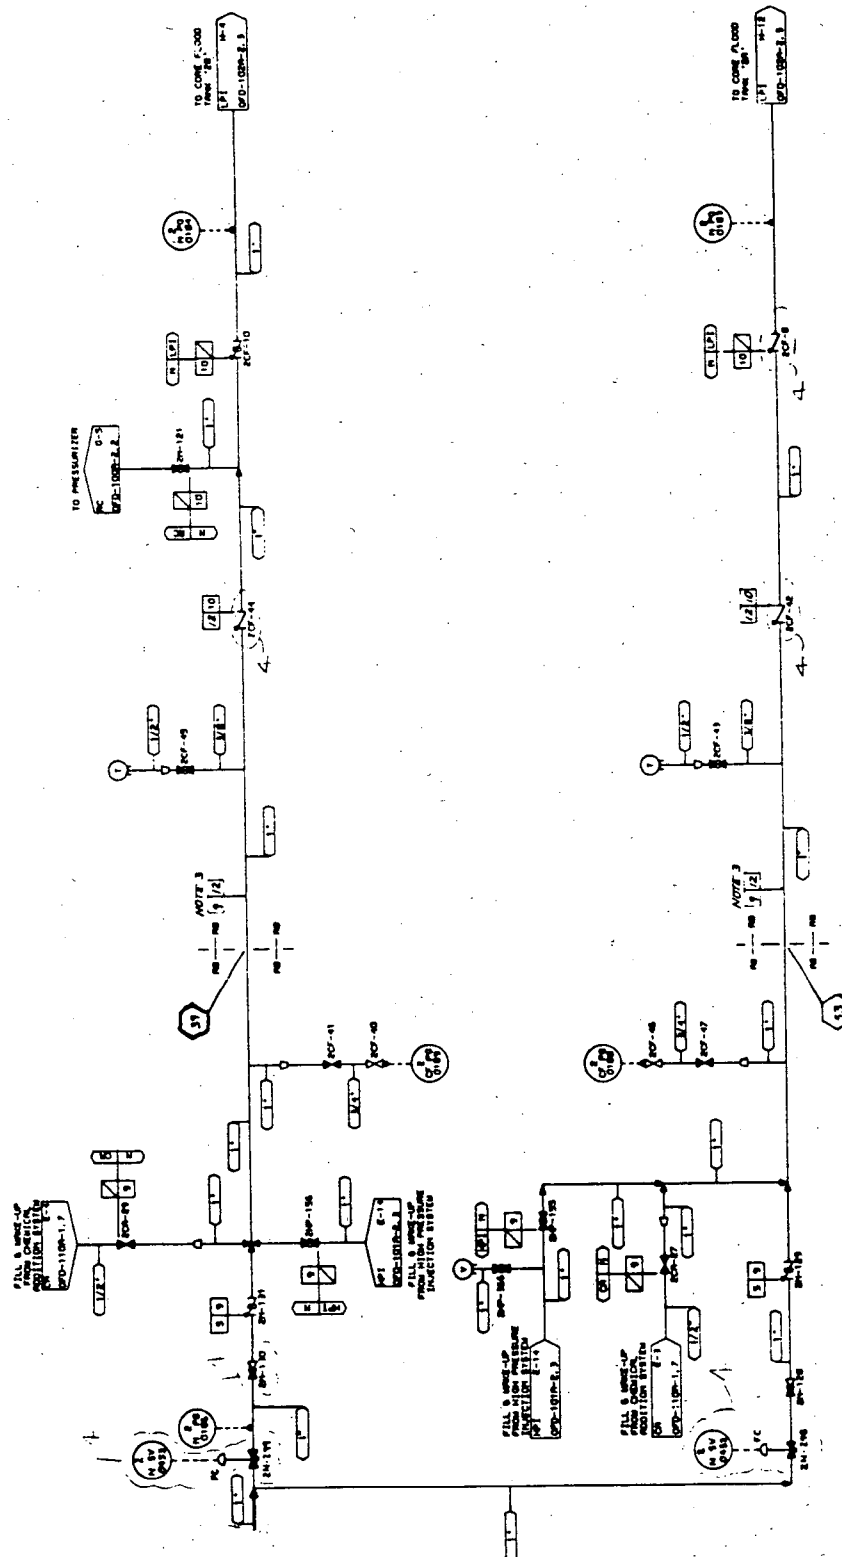
ATTACHMENT 2

NOTE: A Sequence of Events is included as Attachment 1. Piping arrangements for affected penetrations are shown on Attachment 2.

53 on all units could not be documented to meet seismic criteria from a point inside the reactor building wall to CF-8 and CF-10 [EIIS:V], which were Core Flood System [EIIS:BP] check valves used as containment isolation valves inside the building. The resolution to this problem was to install new check valves, CF-42 and CF-44, closer to the Reactor Building wall with additional hangers [EIIS:SPT] as required to upgrade the short runs of pipe. This work was performed as Nuclear Station Modification (NSM) 1328.

During procedure preparation for a Type A test scheduled for the next Unit 3 refueling outage, Performance Engineer A noted that the new design would not permit the new check valves (CF-42 and CF-44) to be vented to the reactor building atmosphere such that the penetration could be challenged during a Type A test. Therefore, in December, 1980, he submitted a request for revision of the NSM design. The request was reviewed by Performance Section management prior to approval. This portion of the NSM was designed by station personnel, in the configuration requested by Performance, with review by Design Engineering. The 10CFR50.59 safety evaluation for this revision to NSM 1328 was signed on April 1, 1981, and does not address the change of Penetrations 39 and 53 from a closed system, not expected to be open to post accident atmosphere, to a system which is expected to be open and, therefore, require testing. Performance Engineer A had requested the addition of a vent valve on both penetrations between the new check valves and the building wall, in order to permit testing as required by Appendix J. However, a vent valve at the location requested still would not test the new check valve. During this investigation, Performance Engineer A could not recall the exact reasoning

NSM 1328 was installed during a refueling outage on Unit 3 and "tested" via a Type A test with these vent valves open in February, 1981. Due to the location of the test vent valves, the isolation function of the new isolation valves was not tested.

1. Modifications will be made to permit Type C testing of Penetrations 39 and 53 on all three units.
2. An Integrated Leak Rate Test (Type A) will be performed during the next refueling outage on each unit.
3. Performance will review the entire containment leak testing program against current interpretations of requirements and verify that all requirements are either met or have approved exceptions. Furthermore, approved exceptions, including those in Technical Specifications, will also be reviewed to assure that
