SUBJECT: LER 90-004-00:on 900301,unanticipated sys interaction during  
 undervoltage condition in 230 kV switchyard. W/9 ltr.

## LICENSEE EVENT REPORT (LER)

FACILITY NAME (1) Oconee Nuclear Station, Unit 1										DOCKET NUMBER (2) 0 5 0 0 0 2 6 9				PAGE (3) 1 OF 1 3		
TITLE (4) Unanticipated System Interaction During Undervoltage Condition In The 230KV Switchyard Results In Failure To Comply With Technical Specifications																
EVENT DATE (5)			LER NUMBER (6)				REPORT DATE (7)			OTHER FACILITIES INVOLVED (8)						
MONTH	DAY	YEAR	YEAR	SEQUENTIAL NUMBER	REVISION NUMBER	MONTH	DAY	YEAR	FACILITY NAMES				DOCKET NUMBER(S)			
									Oconee, Unit 2				0 5 0 0 0 2 7 0			
0	3	0	1	9	0	9	0	0	0	4	3	0	9	0	Oconee, Unit 3	0 5 0 0 0 2 8 7
OPERATING MODE (9)		THIS REPORT IS SUBMITTED PURSUANT TO THE REQUIREMENTS OF 10 CFR §: (Check one or more of the following) (11)														
N		20.402(b)				20.405(a)				50.73(a)(2)(iv)				73.71(b)		
POWER LEVEL (10)		20.405(a)(1)(i)				50.73(a)(1)				50.73(a)(2)(v)				73.71(a)		
1		20.405(a)(1)(ii)				50.73(a)(2)				50.73(a)(2)(vi)				OTHER (Specify in Abstract below and in Text, NRC Form 308A)

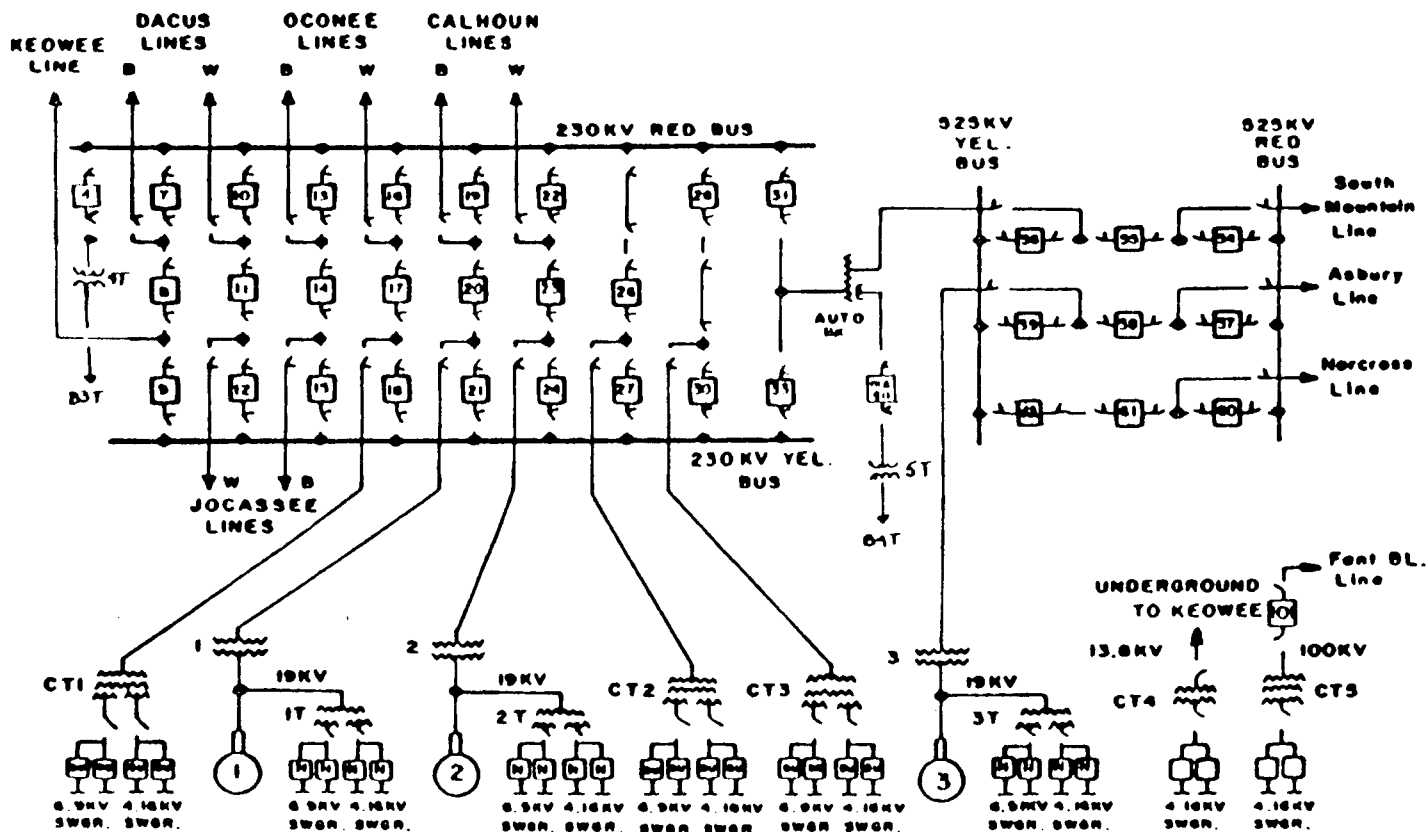
ATTACHMENT 1

The Oconee 230 kV Switchyard [EIIS:FK] is an interface between the 230 kV Duke transmission line network and Oconee Units (see Attachment 1 diagram). Abnormal conditions in the 230 kV Switchyard result in switching operations that are initiated by protective relaying. One of the protective relaying circuits is the External Grid Trouble Protection System [EIIS:EK]. This system is designed to monitor the voltage and frequency of both the red and yellow buses in the 230 kV Switchyard. When this system detects abnormal conditions, it initiates an automatic startup of the Keowee Hydro Units [EIIS:EK] and provides a path for emergency power from Keowee to the Oconee Startup Transformers CT-1, CT-2, and CT-3 via the 230 kV switching station. In order for this path (Keowee Overhead) to be established, several Power Circuit Breakers (PCBs) are closed and others are tripped open to isolate the yellow bus from the grid.
