SUBJECT: LER 90-007-00:on 900516,actuation of emergency safeguards  
 sys due to defective procedure.

Subject: Oconee Nuclear Station  
Docket Nos. 50-269, -270, -287  
LER 269/90-07

FACILITY NAME (1) Oconee Nuclear Station, Unit 1										DOCKET NUMBER (2) 0 5 0 0 0 2 6 9 1				PAGE (3) OF 0 9						
TITLE (4) Actuation of Emergency Safeguards System Due to Defective Procedure, Lack of Procedural Precautions																				
EVENT DATE (5)			LER NUMBER (6)				REPORT DATE (7)			OTHER FACILITIES INVOLVED (8)										
MONTH	DAY	YEAR	YEAR	SEQUENTIAL NUMBER	REVISION NUMBER	MONTH	DAY	YEAR	FACILITY NAMES				DOCKET NUMBER(S)							
0	5	1	6	9	0	9	0	0	0	7	0	0	0	6	1	4	9	0	N/A	0 5 0 0 0
OPERATING MODE (9)		THIS REPORT IS SUBMITTED PURSUANT TO THE REQUIREMENTS OF 10 CFR §. (Check one or more of the following) (11)																		
N		20.402(b)				20.406(e)				X 50.73(a)(2)(iv)				73.71(b)						
POWER LEVEL (10)		- 1 0 -				20.406(a)(1)(i)				50.73(a)(2)(v)				73.71(c)

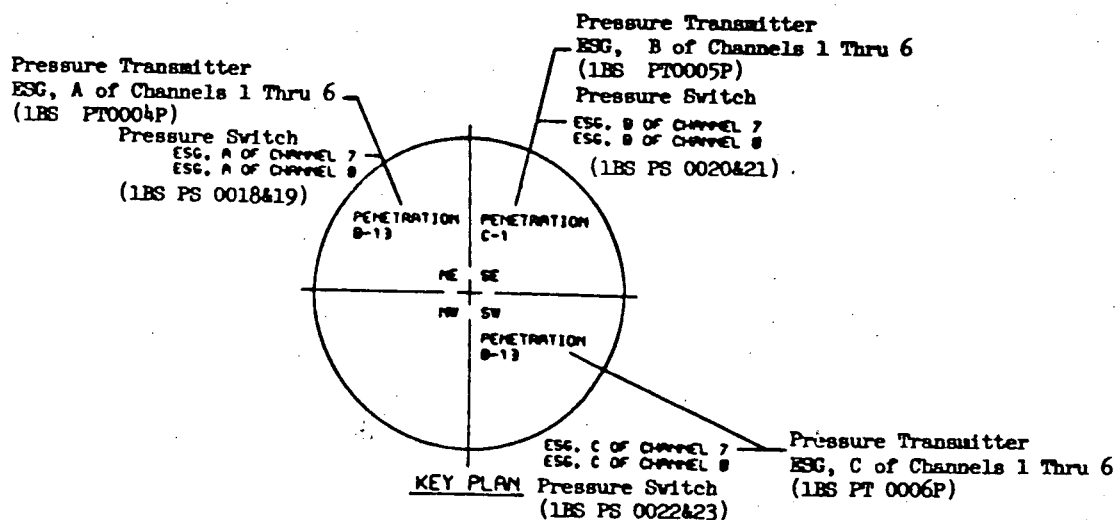
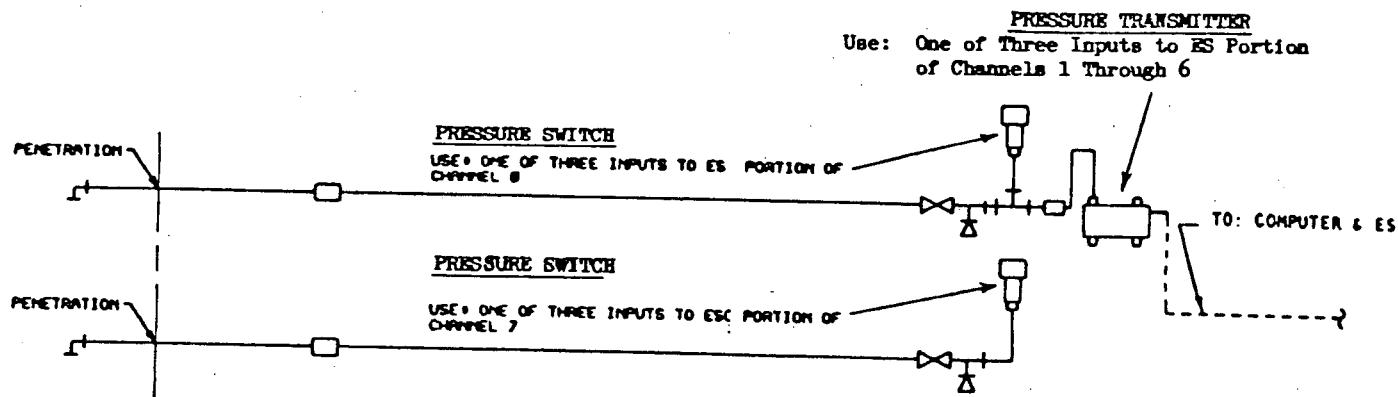
TYPICAL INSTRUMENT INSTALLATION

On this same day, with the new pressure switches installed and electrically isolated, as required by the NSM procedure TN/1/A/2682/00/AK1, Performance Technicians proceeded to pressure test the switches and their associated tubing. At 1338 hours, the Performance Technicians pressurized switch 1BS PS0023 and pressure transmitter 1BS PT0006P causing the transmitter to send a signal through analog Channel C to digital ES Channels 1 through 6 and an alarm to the control room on analog Channel C. The Operators acknowledged the alarm but did not take action. The Operators stated that due to the alarms received on Channel A as a result of the I&E work and the close proximity of the alarm light locations on the panel for Channels A & C that they assumed that the alarm was caused, and would be reset, by I&E. At approximately 1418 hours, with ES analog Channel C tripped, the Performance Technicians pressurized switch 1BS PS0021 and pressure transmitter 1BS PT0005P causing the transmitter to send a signal through analog Channel B to digital ES Channels 1 through 6. This satisfied the two out of three trip logic and caused the unanticipated actuation of ES System Channels 1 through 6.

At the time of this event Unit 1 was in a refueling shutdown with the core partially de-fueled. Fuel movement to reload the core was in progress. When the tubing was pressurized due to the test, the pressure transmitters responded as they were designed and initiated the actuation of Emergency Safeguard (ES) System Channels 1 through 6. The High Pressure Injection

- 1) Procedures TN/1/A/2682/00/AK1 and TN/1/A/2682/00/AL1 were revised to include provisions to isolate the pressure transmitters during the testing.
- 2) The Production Specialist I, Accountable Engineer and Qualified Reviewer were cautioned to adequately review all aspects of a Nuclear Station Modification to insure that their procedures are correct.
