FACIL: 50-269 Oconee Nuclear Station, Unit 1, Duke Power Co.

SUBJECT: LER 90-011-00: on 900627, boron dilution sys do not meet
single failure design criteria due to design deficiency.
W/9 ltr.

Boron Dilution Systems Do Not Meet Single Failure Design Criteria Due to Design Deficiency, Unanticipated Interaction of Systems

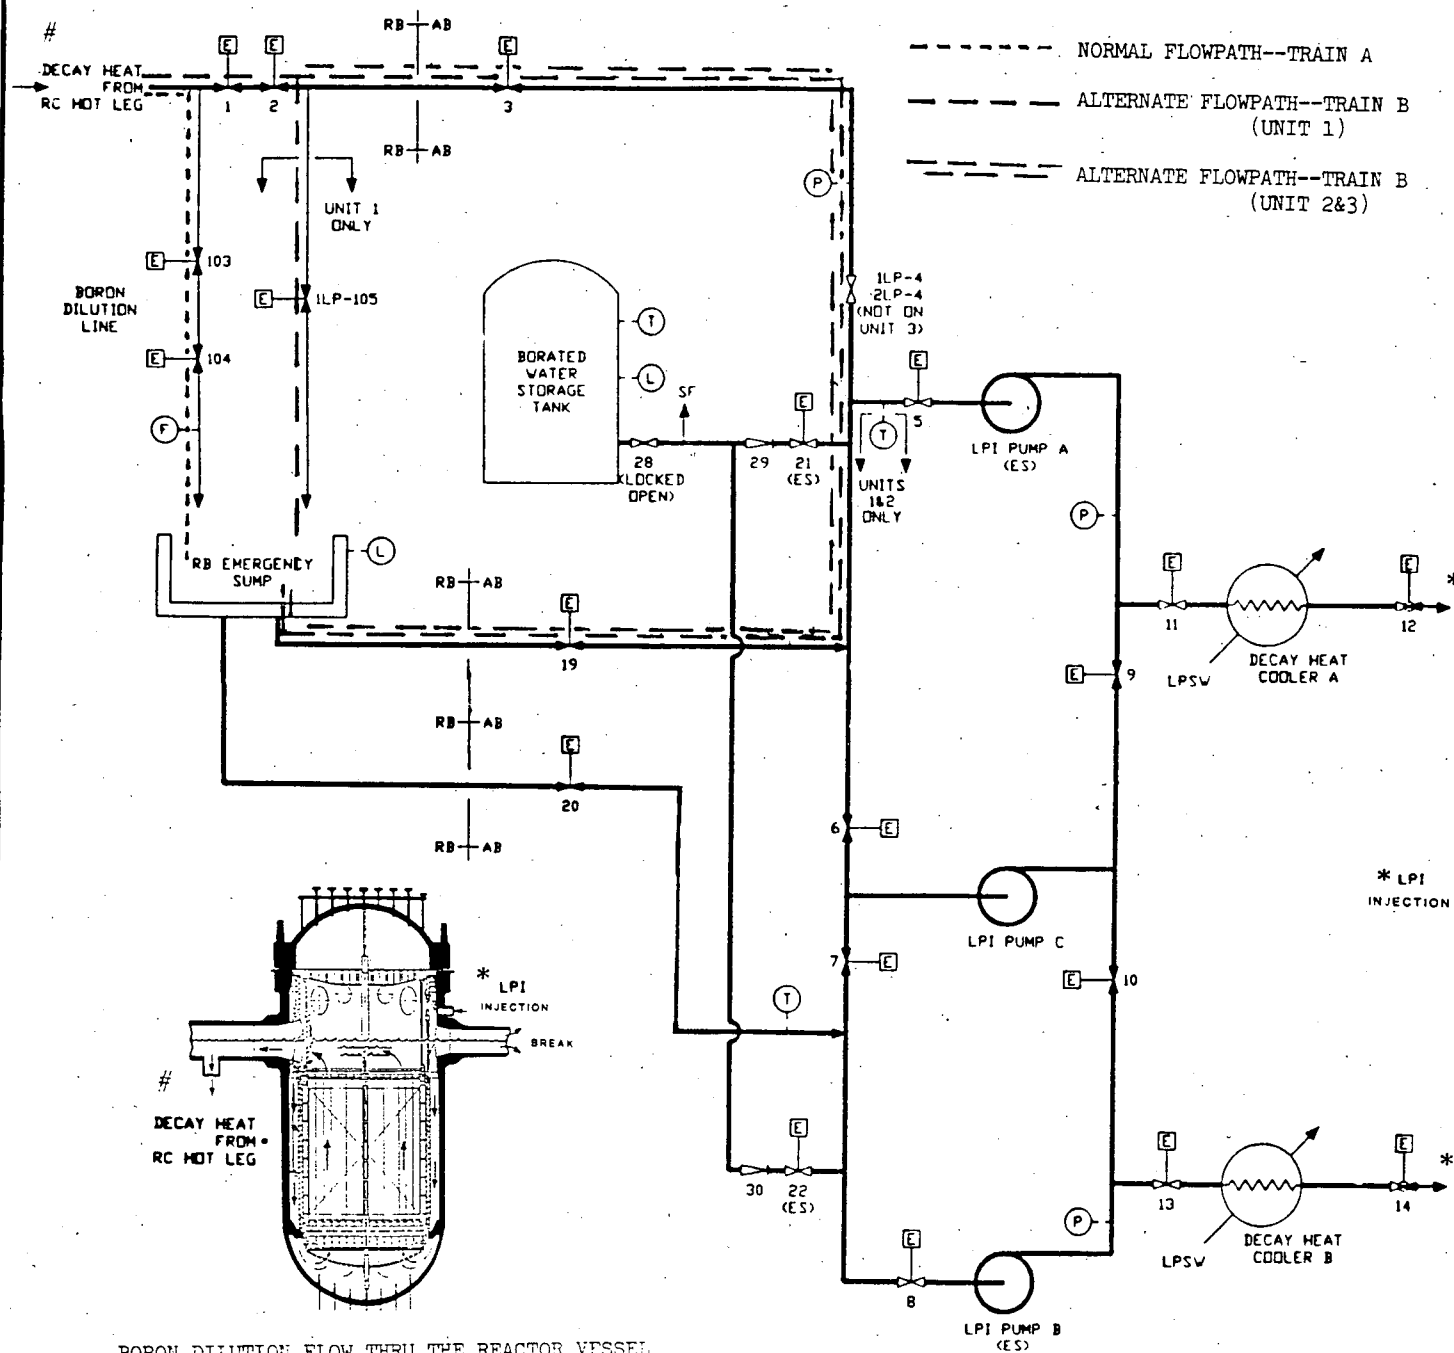
ATTACHMENT 1

The system operates by providing a gravity flow path from the decay heat drop line (off the bottom of the hot leg) to the Reactor Building [EIIIS:NH] emergency (RBE) sump. Two redundant flow paths, or trains, are available. Train A, normal dilution flow path, goes through LP-103 and LP-104 (Post LOCA Boron Dilution valves) directly to the RBE sump. Train B, the alternate boron dilution flow path, runs through LP-1 (LPI Return Block from the Reactor Coolant System), LP-2 (LPI Return Block), and other valves to the RBE sump. (See attachment 1)

Boron Dilution System (BDS) electric motor operated (EMO) valves LP-1, LP-2, and LP-104 currently share a common power supply; motor control center (MCC) XS1. This is a violation of the single failure criteria for the system.

BORON DILUTION FLOWPATHS VIA THE LOW PRESSURE INJECTION SYSTEM

- 1) A Nuclear Station Modification which will result in LP-104 being powered from an alternate power supply.
