Beaver Valley Power Station, Unit Nos. 1 and 2
BV-1 Docket No. 50-334, License No. DPR-66
BV-2 Docket No. 50-412, License No. NPF-73
10 CFR 71.95 Report on 8-120B Cask Certificate of Compliance Noncompliance
Due to the use of a Vendor Supplied Neoprene Gasket on the Vent Port Seal.

Subject: 10 CFR 71.95 Report on the 8-120B Cask

**Failure to Observe Certificate of Compliance Conditions
for the 8-120B Vent Port Pre-Shipment Leak Test**

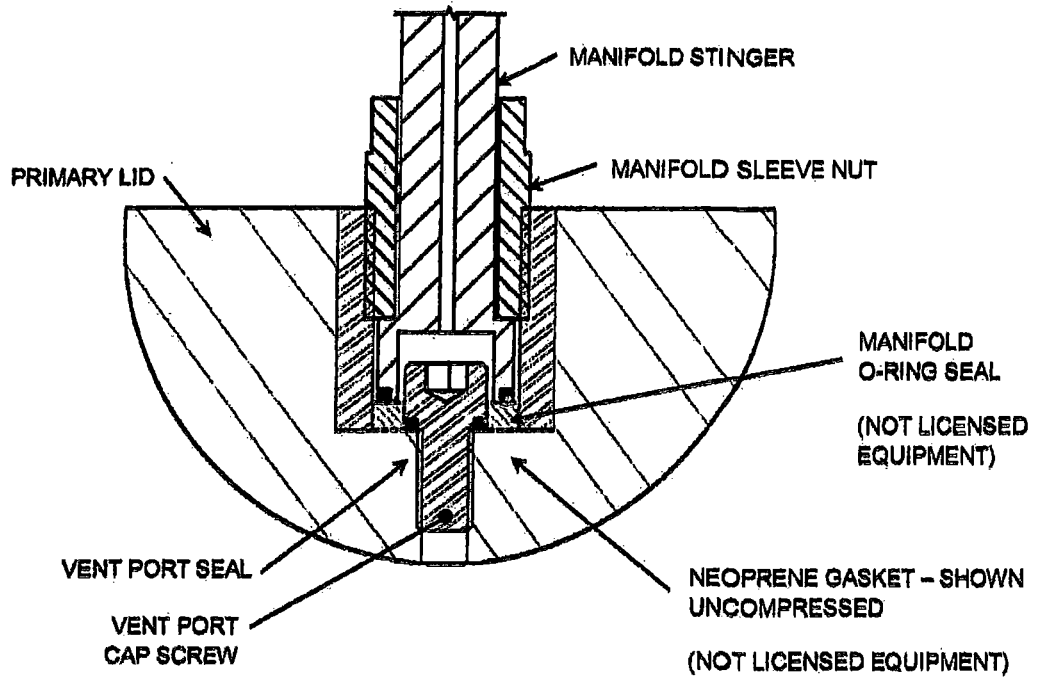
The neoprene gasket can constrict on the head of the vent port plug cap screw when it is compressed by the bottom end of the test manifold stinger, which could reduce the sensitivity of the pre-shipment leak test. Consequently, the vent port pre-shipment leak tests performed using the neoprene gasket may not have provided the required test sensitivity of 1×10^{-3} ref-cm³/sec.

On Monday June 1, 2015, an 8-120B cask user identified a concern that the neoprene gasket could potentially affect the integrity of the vent port seal pre-shipment leak test. Later that week EnergySolutions performed a bench test that confirmed that the neoprene gasket can constrict on the head of the vent port plug cap screw when it is compressed by the manifold, resulting in a reduction of the test sensitivity.

The pre-shipment leak test of the vent port is a pressure drop test performed using a dedicated test manifold. The test manifold is not a part of the licensed package. It includes a stinger (shown below), an O-ring seal that contacts the stinger and the bottom of the vent port hole, and a sleeve nut to compress the O-ring seal. The test manifold was designed so that it surrounds the vent port cap screw, leaving a small gap between itself and the vent port cap screw. The 8-120B cask fleet began to ship with a new lid design in September 2013, and operations staff noted more frequent difficulty getting the manifold to seal. It became desirable to find a better way to seal the bottom of the manifold in order to minimize operator exposure. They found that adding a neoprene gasket (also not part of the licensed package) under the base of the stinger as shown below helped reduce testing time and exposure.
