Peach Bottom Atomic Power Station, Units 2 and 3  
Renewed Facility Operating License Nos. DPR-44 and DPR-56  
NRC Docket Nos. 50-277 and 50-278

Subject: Response to Request for Additional Information Regarding Proposed Relief Request associated with the Common Emergency Service Water (ESW) System Piping for Peach Bottom Atomic Power Station, Units 2 and 3

**Response to Request for Additional Information Regarding  
Proposed Relief Request Concerning I4R-56**

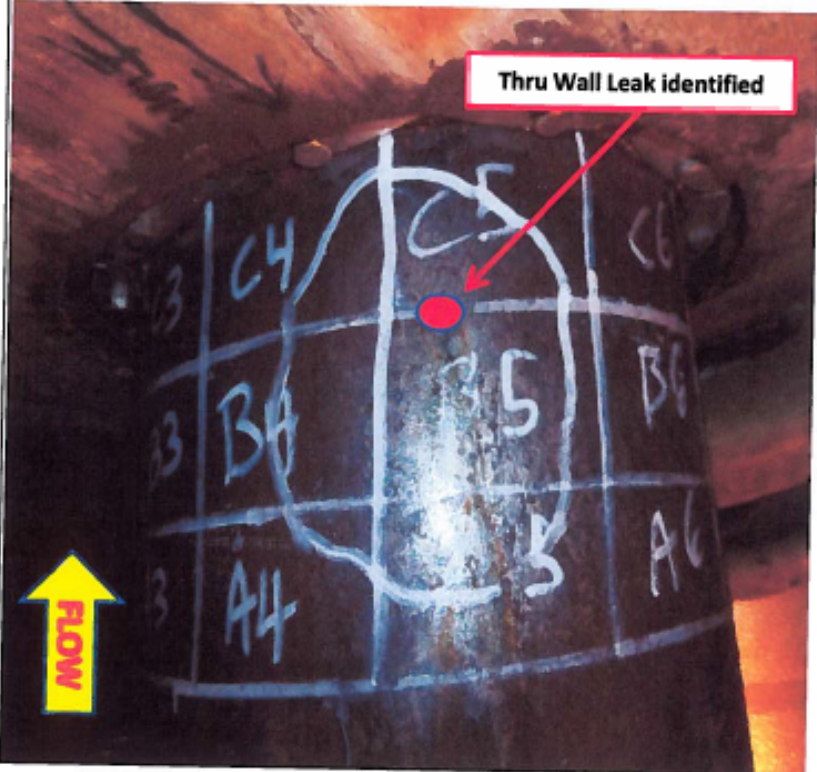
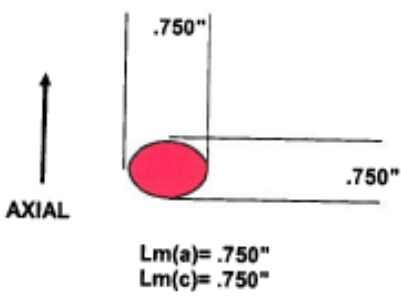
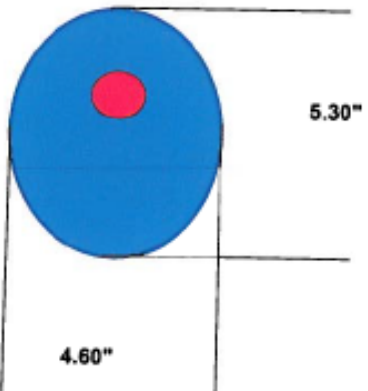
<b>ULTRASONIC EXAMINATION PHOTO SHEET</b>	<b>NDE SUPPORT GROUP</b>
<div style="border: 1px solid black; display: inline-block; padding: 2px 10px;"> <b>ISO-2-33-17 Leak Upstream of MO-2972</b> </div>

</div>	
<b>COMMENTS:</b> Area below Engineering Minimum Wall Thickness is .750" rounded, with the area below .328" approximately 4.6" x 5.30".		
James Martin / III NAME / LEVEL	/ 5/4/15 DATE	n/a / n/a NAME / LEVEL DATE

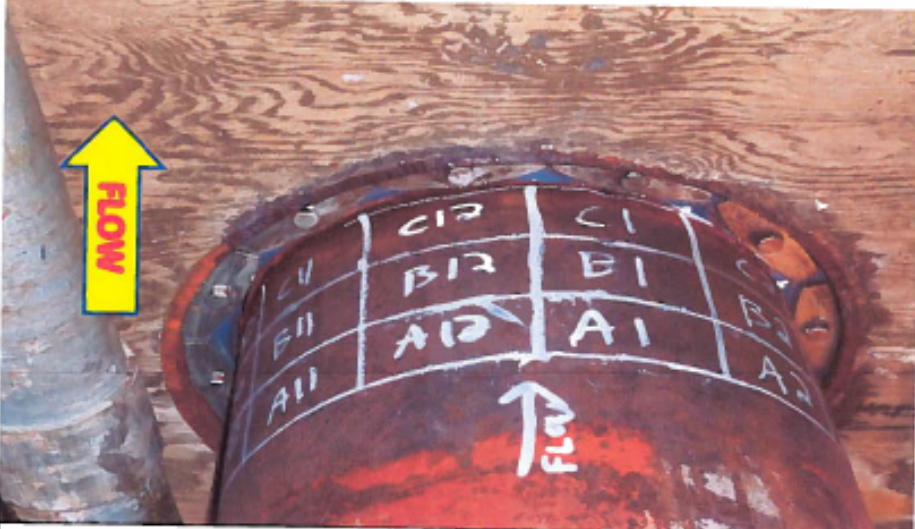
DRAWING ( If Applicable ) <b>ISO-2-33-17 Leak Upstream of MO-2972</b>

<p>*A thru wall leak was identified on ISO-2-33-17 upstream of MO-2972. Mapping was performed as per ASME Code Case N-513-3. Although the low in C5 is a thru wall leak, the lowest recordable reading of the leak was found to be .034" for continuous monitoring purposes.</p>			
					<p><b>30 Day inspection was performed on Grid Location C5. No change in the flaw dimension was observed.</b></p>			
COMMENTS:								
Grid location C5 was identified as below Engineering Min. Wall criteria. See attached Iso bar.								
Material: A-106 GR. B Carbon Steel.					Calibration			
Examination Performed in Accordance with ER-AA-335-004 REV. 7							Actual	Meas.
Reference Min Wall Acceptance Criteria per A1998930-E01								
Surface Condition = Prepped, Paint Removed.							.500"	.500"
James Martin / III / 6/1/15							.300"	.300"

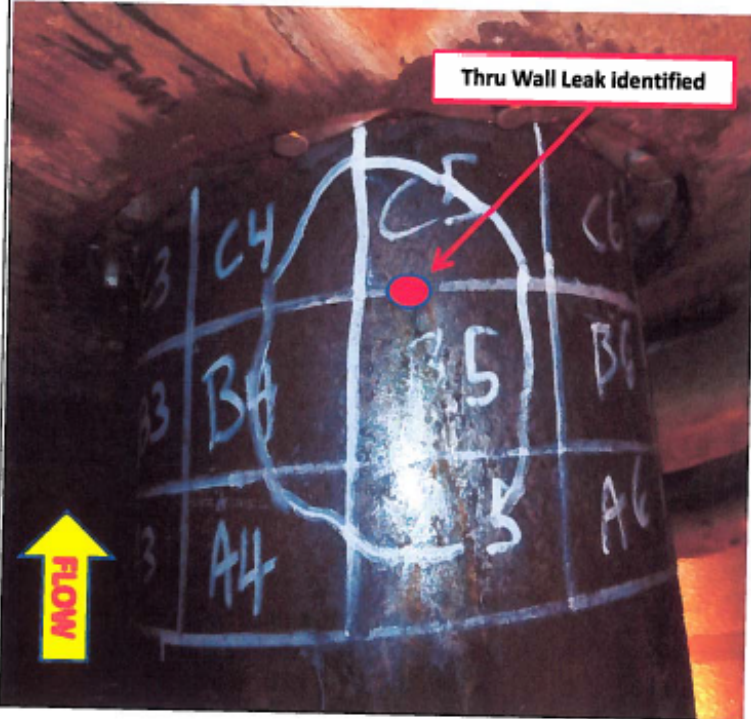
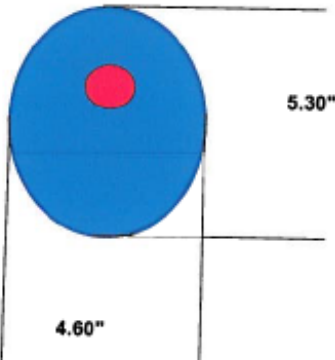
<b>ULTRASONIC EXAMINATION PHOTO SHEET</b>	<b>NDE SUPPORT GROUP</b>
<div style="border: 1px solid black; padding: 5px; display: inline-block;"> <b>ISO-2-33-17 Leak Upstream of MO-2972</b> </div>

</div>	
<b>COMMENTS:</b> Area below Engineering Minimum Wall Thickness is .750" rounded, with the area below .328" approximately 4.6" x 5.30".		
James Martin / III NAME / LEVEL	6/1/15 DATE	<div style="display: flex; justify-content: space-around;"> <div>             n/a              NAME / LEVEL         </div> <div>             n/a              DATE         </div> </div>

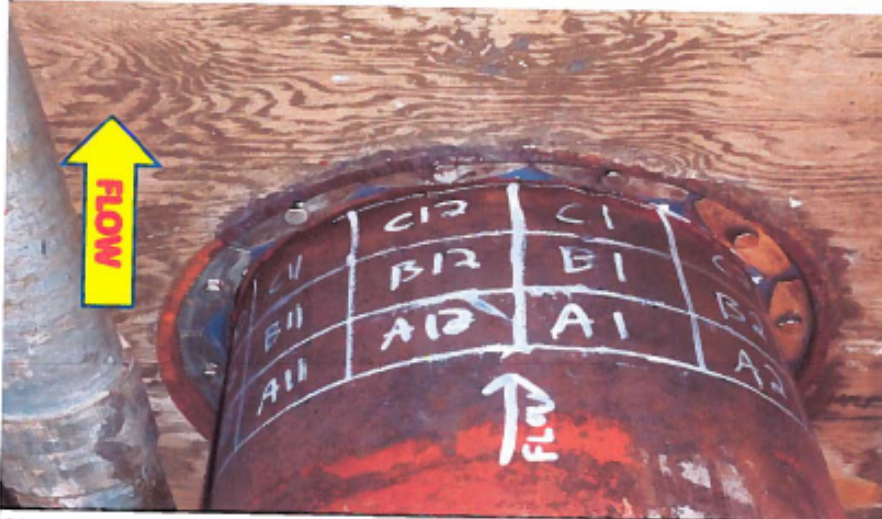
DRAWING ( If Applicable ) <b>ISO-2-33-17 Leak Upstream of MO-2972</b>

<p>*A thru wall leak was identified on ISO-2-33-17 upstream of MO-2972. Mapping was performed as per ASME Code Case N-513-3. Although the low in C5 is a thru wall leak, the lowest recordable reading of the leak was found to be .034" for continuous monitoring purposes.</p>			
						<p><b>30 Day inspection was performed on Grid Location C5. No change in the flaw dimension was observed.</b></p>			
COMMENTS:									
Grid location C5 was identified as below Engineering Min. Wall criteria. See attached Iso bar.									
Material: A-106 GR. B Carbon Steel.						Calibration			
Examination Performed in Accordance with ER-AA-335-004 REV. 7						Actual Meas.			
Reference Min Wall Acceptance Criteria per A1998930-E01									
Surface Condition = Prepped, Paint Removed.									
William Carrasquillo Jr / II / 6/29/15

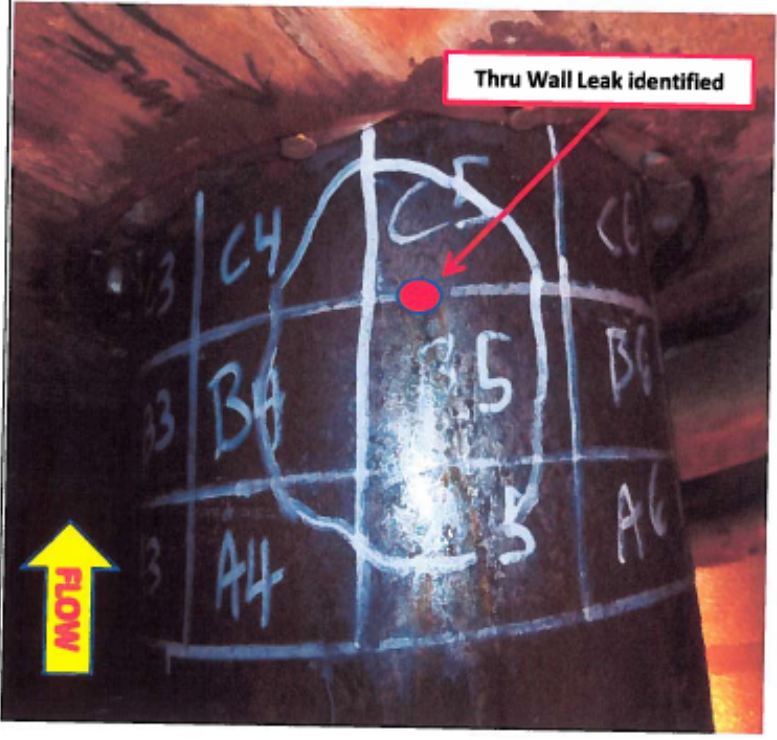
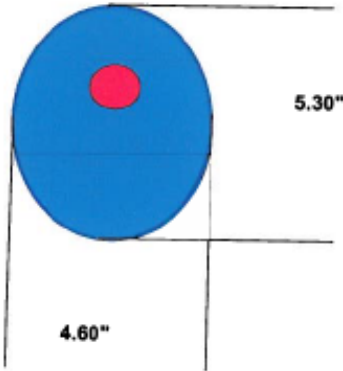
<b>ULTRASONIC EXAMINATION PHOTO SHEET</b>	<b>NDE SUPPORT GROUP</b>
<div style="border: 1px solid black; padding: 5px; display: inline-block;"> <b>ISO-2-33-17 Leak Upstream of MO-2972</b> </div>

</div>	
<b>COMMENTS:</b> Area below Engineering Minimum Wall Thickness is .750" rounded, with the area below .328" approximately 4.6" x 5.30".		
William Carrasquillo Jr / II NAME / LEVEL	6/29/15 DATE	<div style="display: flex; justify-content: space-around;"> <div>             n/a              NAME / LEVEL         </div> <div>             n/a              DATE         </div> </div>

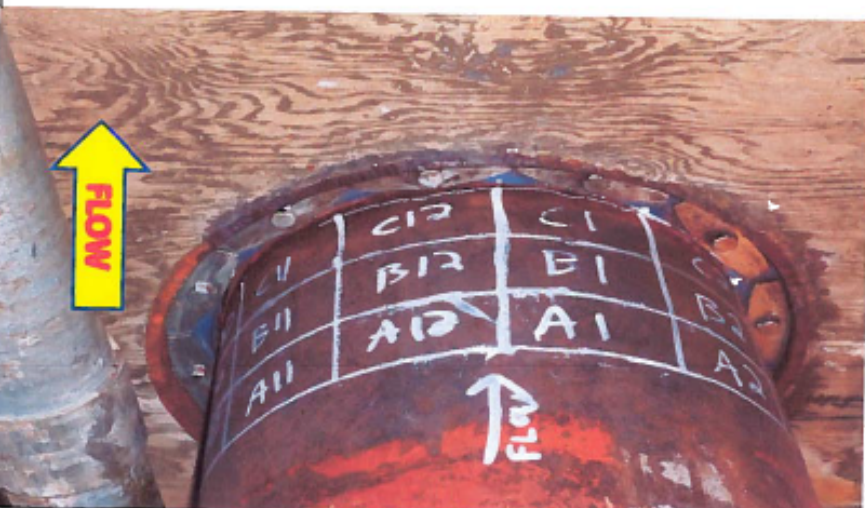
DRAWING ( If Applicable )								
<b>ISO-2-33-17 Leak Upstream of MO-2972</b>

<p>*A thru wall leak was identified on ISO-2-33-17 upstream of MO-2972. Mapping was performed as per ASME Code Case N-513-3. Although the low in C5 is a thru wall leak, the lowest recordable reading of the leak was found to be .034" for continuous monitoring purposes.</p>			
					<p><b>30 Day inspection was performed on Grid Location C5. No change in the flaw dimension was observed.</b></p>			
COMMENTS:								
Grid location C5 was identified as below Engineering Min. Wall criteria. See attached Iso bar.								
Material: A-106 GR. B Carbon Steel.					Calibration			
Examination Performed in Accordance with ER-AA-335-004 REV. 7							Actual	Meas.
Reference: Min Wall Acceptance Criteria per A1988930-E01								
Surface Condition = Prepped, Paint Removed.							.500"	.500"
							.300"	.300"
Julio C Venegas / II / 7/27/15							.200"	.200"

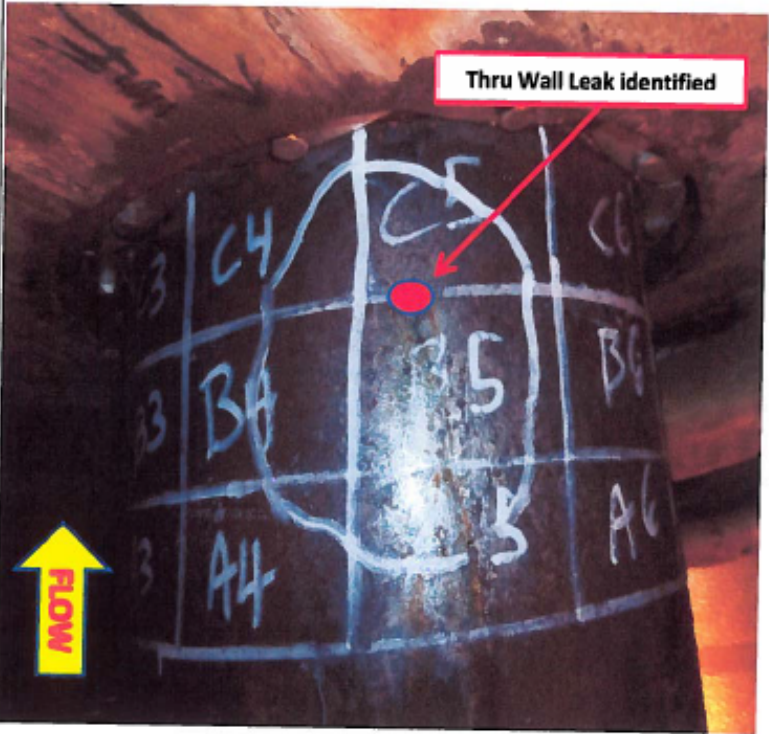
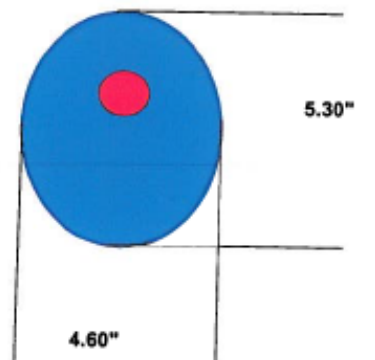
<b>ULTRASONIC EXAMINATION PHOTO SHEET</b>	<b>NDE SUPPORT GROUP</b>
<div style="border: 1px solid black; display: inline-block; padding: 5px;"> <b>ISO-2-33-17 Leak Upstream of MO-2972</b> </div>

<p>5.30"</p> <p>4.60"</p> </div>	
<b>COMMENTS:</b> Area below Engineering Minimum Wall Thickness is .750" rounded, with the area below .328" approximately 4.6" x 5.30".		
Julio C Venegas / II <small>NAME / LEVEL</small>	/ 7/27/15 <small>DATE</small>	n/a / n/a <small>NAME / LEVEL      DATE</small>
