MEMO

Date: July 28, 2015

Subject: Incident Investigation for Release of Yellowcake through Dryer 1 Packing

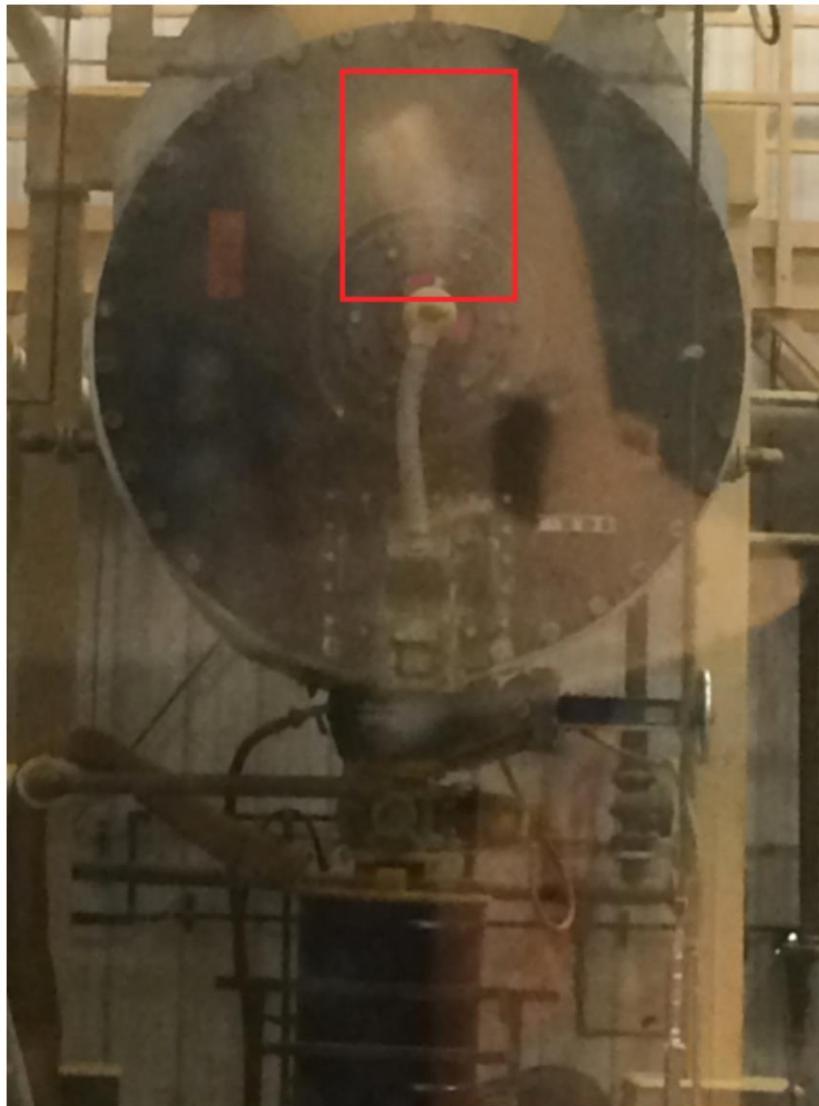
On Sunday July 19, 2015 at approximately 08:00, the RSO visually inspected the side of dryer 1 and determined that the released amount of uranium was relatively small (see residue on side of dryer 1 in Figure 1) compared to other dryer incidents and that performing work in the dryer was safe for standard dryer operations PPE (coveralls, rubber boots, respirator, gloves, and head cover). The breathing zone sample of the dryer operator during the incident had less uranium on it than other routine work such as star valve removals would cause. The plant operator and dryer operator went into the dryer room and tightened the packing and tested the vacuum at approximately 09:30, and the dryer was loaded at approximately 10:15.

The direct cause of this incident was a packing that was too loose. The root cause of this incident was that the dryer operator did not know to ensure the packing on the dryer was sufficiently tight.

Figure 1: Residue from Release through Dryer 1 Packing

1. Ensure that all dryer operators are knowledgeable in how to tighten the packing on the dryer.
2. Review, and amend as necessary, the dryer operations SOPs to ensure they adequately address what to do in this circumstance.
3. Seal any opening in the dryer room wall that could lead to release of material during upset conditions.
4. Sample the air in front of the control room as part of the monthly airborne uranium sampling in the plant. This will continue for the next 6 months to make sure there are no detectable levels of uranium coming through holes in the wall during normal operating conditions.

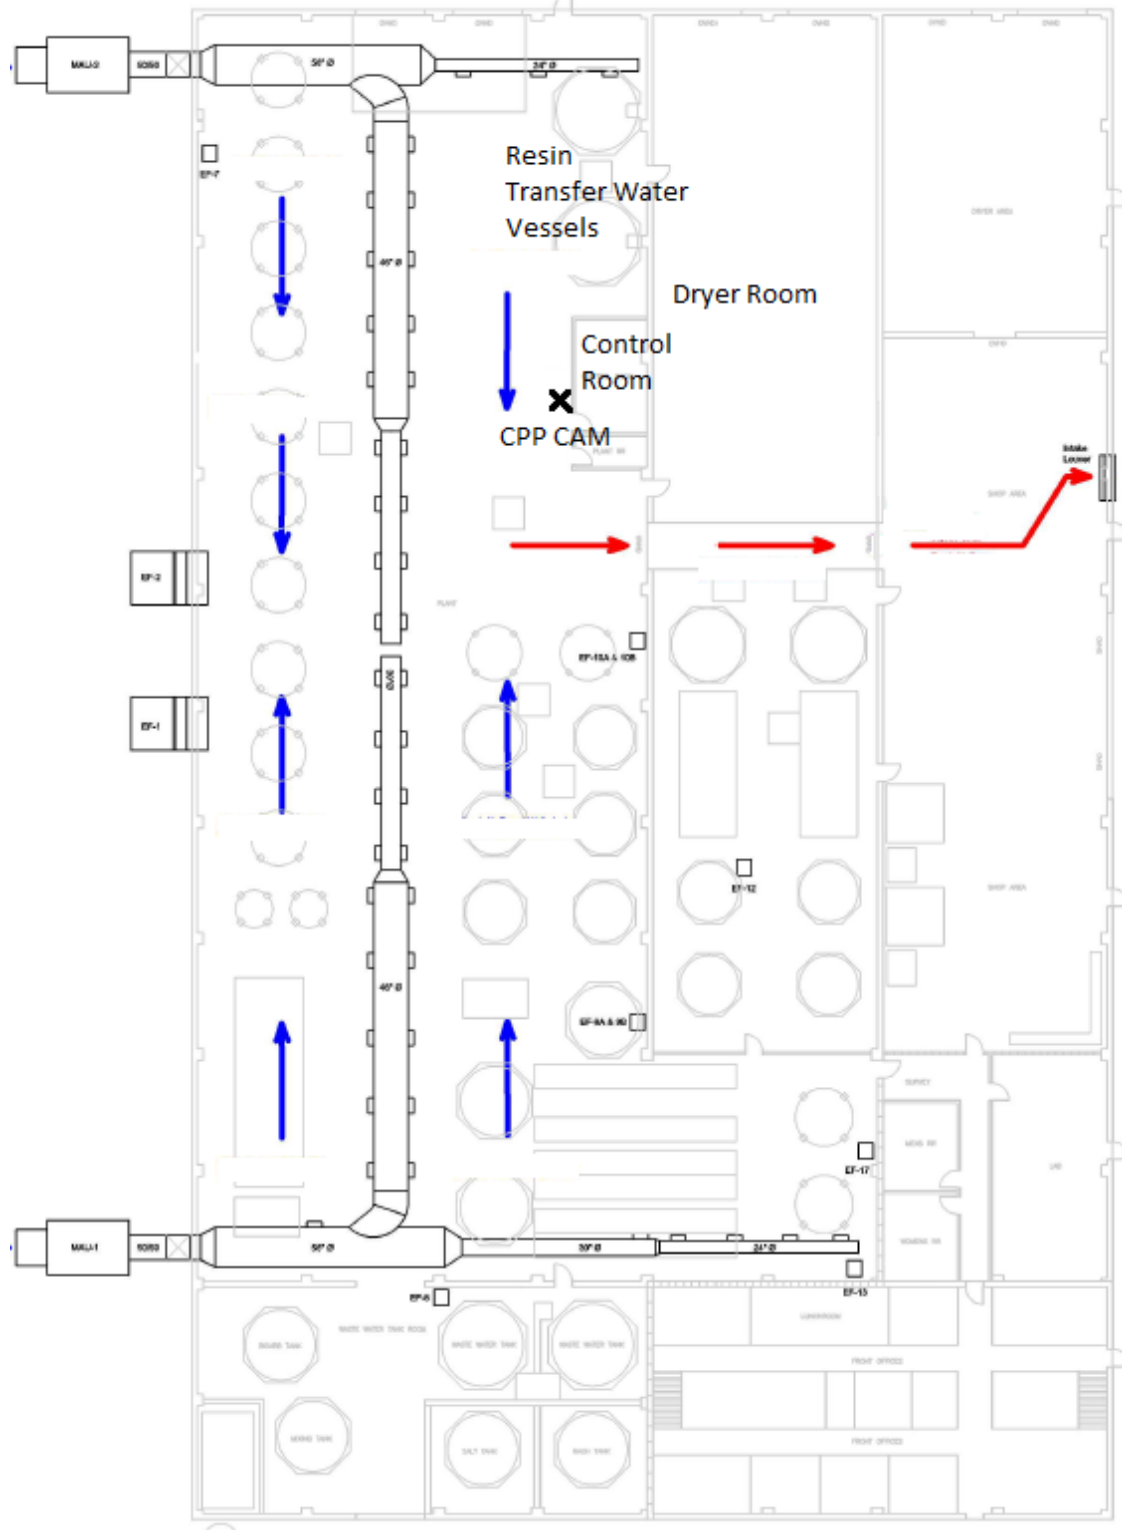
In order for uranium to be collected on the CPP CAM filter the airborne uranium would have to leave the dryer room. Based on the airflow of the plant ventilation (see Figure 2) the most likely place for a release from the dryer room detected on the CPP CAM would have to come from the wall shared by the control room/resin water transfer area and the dryer room.

A plant maintenance worker and the RSO inspected the wall above the control room and behind the Resin Transfer Water Vessels. There were two potential holes noted where the insulation meets the I-beam on the ceiling. The holes appear to have some yellow residue settled on the insulation within a few inches of the hole. Due to obstructions and safety considerations the residue was not sampled.

A smoke test was performed to test the holes coming out of the dryer room. The maintenance worker was up in a Man Lift near the holes, and the smoke bomb was ignited under the end of Dryer 1 where the release occurred. The smoke filled the dryer room. The maintenance worker in the Man Lift was able to smell the smoke before personnel on the ground in front of the control room. The smoke was not visible outside of the dryer room.

Figure 2: Plant Ventilation Air Flow

chance of passing through the small holes in the wall of the dryer room. Sealing up the holes in the wall should help contain similar incidents to the dryer room.
