**Joseph M. Farley Nuclear Plant Units 1 and 2**  
**10 CFR 71.95 Report on Potential Issues Involving Radwaste Cask 8-120B**

**Joseph M. Farley Nuclear Plant Unit 1 and 2**  
**10 CFR 71.95 Report on Potential Issues Involving Radwaste Cask 8-120B**

**Subject: 10 CFR 71.95 Report on the 8-120B Cask**

**Failure to Observe Certificate of Compliance Conditions  
for the 8-120B Vent Port Pre-Shipment Leak Test**

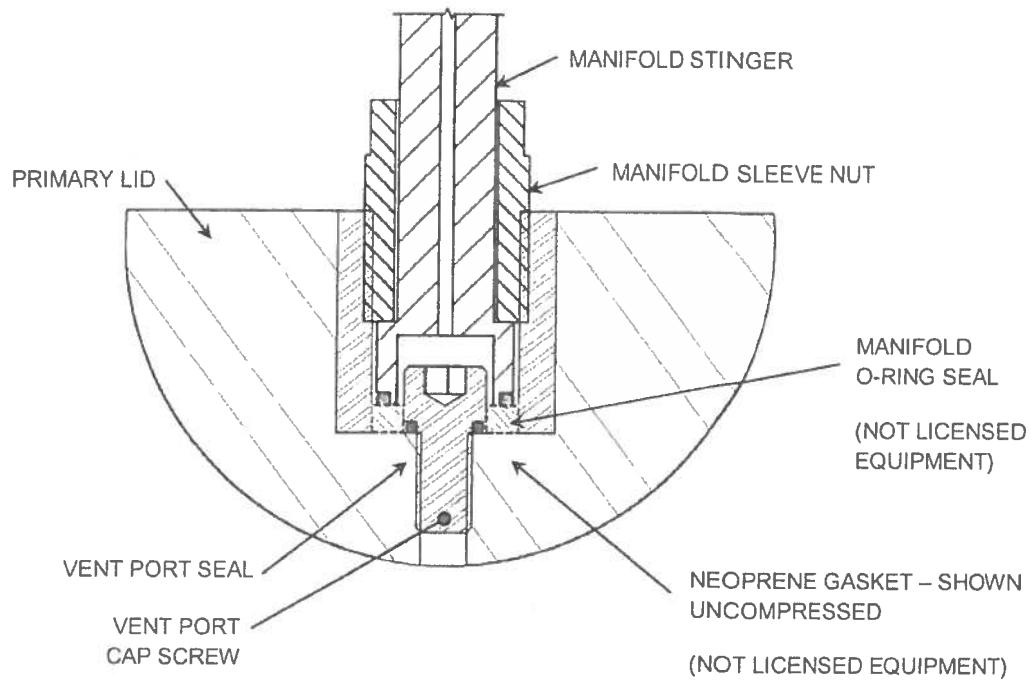
The neoprene gasket can constrict on the head of the vent port plug cap screw when it is compressed by the bottom end of the test manifold stinger, which could reduce the sensitivity of the pre-shipment leak test. Consequently, the vent port pre-shipment leak tests performed using the neoprene gasket may not have provided the required test sensitivity of  $1 \times 10^{-3}$  ref-cm<sup>3</sup>/sec.

On Monday June 1, 2015, an 8-120B cask user identified a concern that the neoprene gasket could potentially affect the integrity of the vent port seal pre-shipment leak test. Later that week EnergySolutions performed a bench test that confirmed that the neoprene gasket can constrict on the head of the vent port plug cap screw when it is compressed by the manifold, resulting in a reduction of the test sensitivity.

The pre-shipment leak test of the vent port is a pressure drop test performed using a dedicated test manifold. The test manifold is not a part of the licensed package. It includes a stinger (shown below), an O-ring seal that contacts the stinger and the bottom of the vent port hole, and a sleeve nut to compress the O-ring seal. The test manifold was designed so that it surrounds the vent port cap screw, leaving a small gap between itself and the vent port cap screw. The 8-120B cask fleet began to ship with a new lid design in September 2013, and operations staff noted more frequent difficulty getting the manifold to seal. It became desirable to find a better way to seal the bottom of the manifold in order to minimize operator exposure. They found that adding a neoprene gasket (also not part of the licensed package) under the base of the stinger as shown below helped reduce testing time and exposure.
