DOMINION NUCLEAR CONNECTICUT, INC.
MILLSTONE POWER STATION UNIT 2
LICENSEE EVENT REPORT 2015-002-00
DEGRADED EMERGENCY CORE COOLING SYSTEM CHECK VALVE

LICENSEE EVENT REPORT 2015-002-00
DEGRADED EMERGENCY CORE COOLING SYSTEM
CHECK VALVE

MILLSTONE POWER STATION UNIT 2
DOMINION NUCLEAR CONNECTICUT, INC.

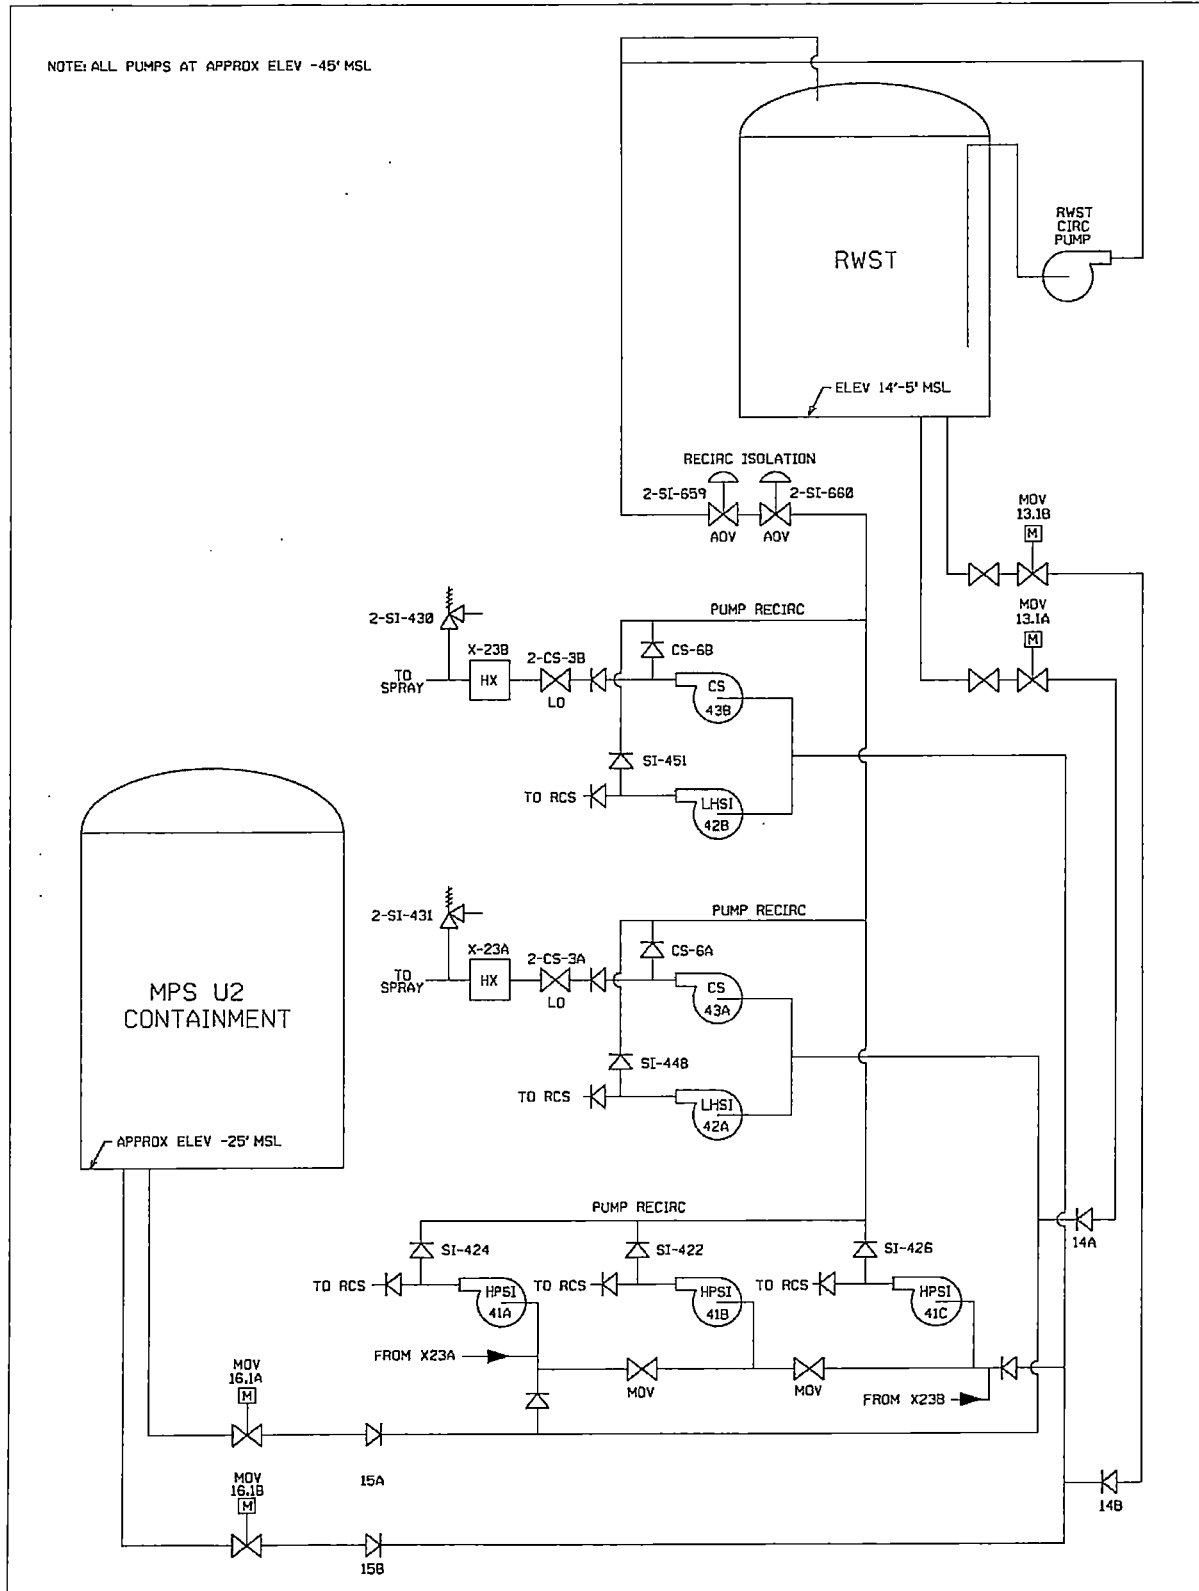
phase; however, the recirculation line is isolated from the RWST when transferring to sump recirculation. All seven ECCS/CS pumps (2 LPSI, 2 CS, and 3 HPSI) have minimum flow recirculation lines that tie into one common header to the RWST. Exhibit A attached to this LER is a sketch depicting the configuration.

Evaluation of this failure identified that during a Small Break Loss of Coolant Accident (SBLOCA), concurrent with a loss of power to the "A" train associated with the leaking 2-CS-6A, the operating (opposite) train HPSI pump would pressurize the common recirculation header during the recirculation phase of the accident as was described above. In the operator response to this postulated event when the 2-CS-6A leaks to the RWST, suction 2-CS-13.1A is manually isolated terminating the release to the RWST. However, it was additionally identified that the "A" train suction header would pressurize because of the continued back leakage and none of the "A" train pumps flowing due to loss of power and no open flow path (to containment spray or RWST). This pressurization would continue, exceeding the design pressure of the suction header (60 psig) ultimately reaching 500 psig, the lift setpoint for the "A" train shutdown cooling heat exchanger relief valve downstream of the "A" CS pump and the relief valve on the common LPSI discharge header. These relief valves discharge to the EDST (Emergency Drain Sump Tank) which is located and vented outside the filtered ventilation boundary. Upon emptying of the RWST and initiation of sump recirculation, the described back-leakage flow path would contain sump fluid. This additional unidentified release path from the original design of the plant was reported to the NRC as a follow-up notification on July 10, 2015.

The failed check valve 2-CS-6A has been repaired. Additional corrective actions are being taken in accordance with the station's corrective action program.
