HOLTEC INFORMATION BULLETIN (HIB)*

Title of the Bulletin: VCT Restraint Strap Weld Failure

CoC Holder:	Holtec International	HIB No. (sequential):	67	Revision Log:		
					<u>Name</u>	<u>Date</u>
System Name:	Lift System VCT	Ref. Nuclear Plant:	Diablo Canyon Power Plant	Author (Rev. 0):	Arthur Barrett	7/28/15
				Reviewer (Rev 0):	Robert Tindal	7/28/15
Holtec Program No.:	1027	Period of Occurrence (m/y):	05/2015	Author (Rev. 1):		
				Reviewer (Rev 1):		
Affected Component(s):	Diablo VCT	Affected equipment or part	Diablo Lift Systems VCT	Author (Rev. 2):		
				Reviewer (Rev 2):

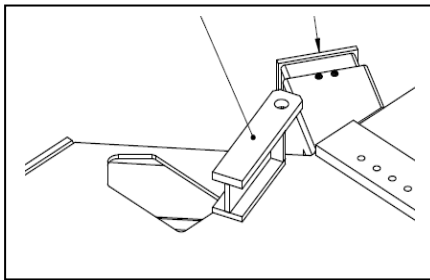
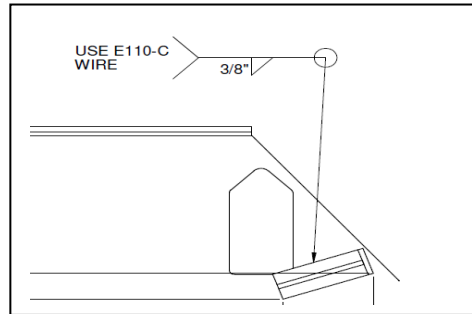
Diablo Canyon has a Lift Systems VCT, which was the first generation of transporters supplied by Holtec to its clients. Upon review, Diablo's Lift System design is unique as it pertains to the strap cylinder mount and the weld at the base. The RH Chassis Assembly part number is identified as 103862. See below for the design and weld detail for the strap cylinder mount.

The Diablo VCT was designed to withstand a high seismic event as well be able to climb steep inclines. Therefore the belly band and cylinder are much larger than those provided with the standard VCT used at every other site. The failure of the weld occurred while tightening the belly band as required by procedure.

Diablo's investigation into the issue determined the potential cause to be a legacy issue with weld quality during original transporter fabrication along with the weld being undersized during fabrication.

As a corrective action, a weld repair of the failed belly band mount was performed by Diablo Canyon. In addition, the driver's side mount, which did not fail, was also proactively repaired as there were sections of weld not meeting the minimum weld size called out on fabrication drawing (see attached pictures). Once both sides were successfully repaired, the transporter was used to finish out Diablo's 2015 loading campaign with no further VCT weld issues reported.

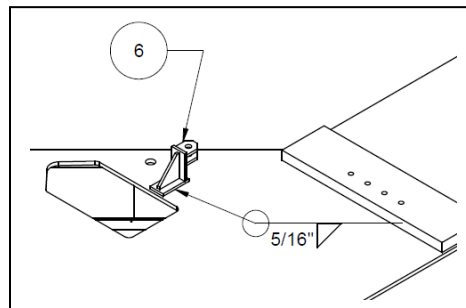
Thirteen (13) other Lift System VCT's were fabricated and delivered to clients. These thirteen other systems were reviewed and all had a different RH Chassis Assembly part number than Diablo's design. All but one had a 100393A part number. See below for the strap fitting mount for the other VCT's.

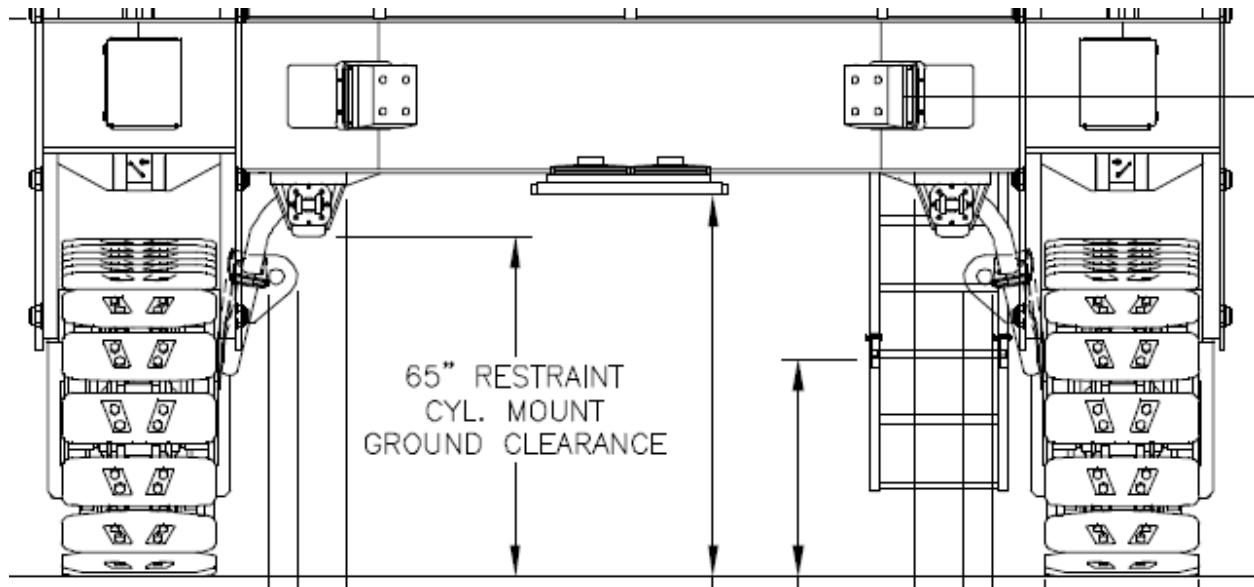
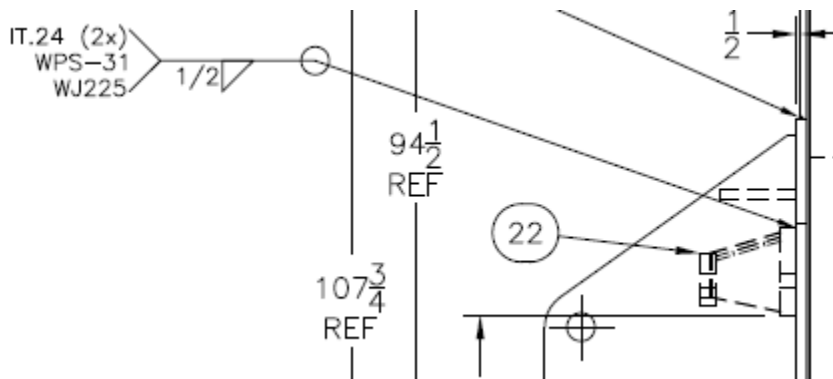
J&R Engineering

for each mounting system design. Both designs are shown below. J&R has the mounting welded to the underside of the VCT with a $\frac{1}{2}$ " all around fillet weld. MMH/KoneCranes design consisted of a pin connection with a welded subassembly to the VCT top deck. Both designs differ from the Lift Systems design and there is no reason to think that these designs are inadequate for their intended use.

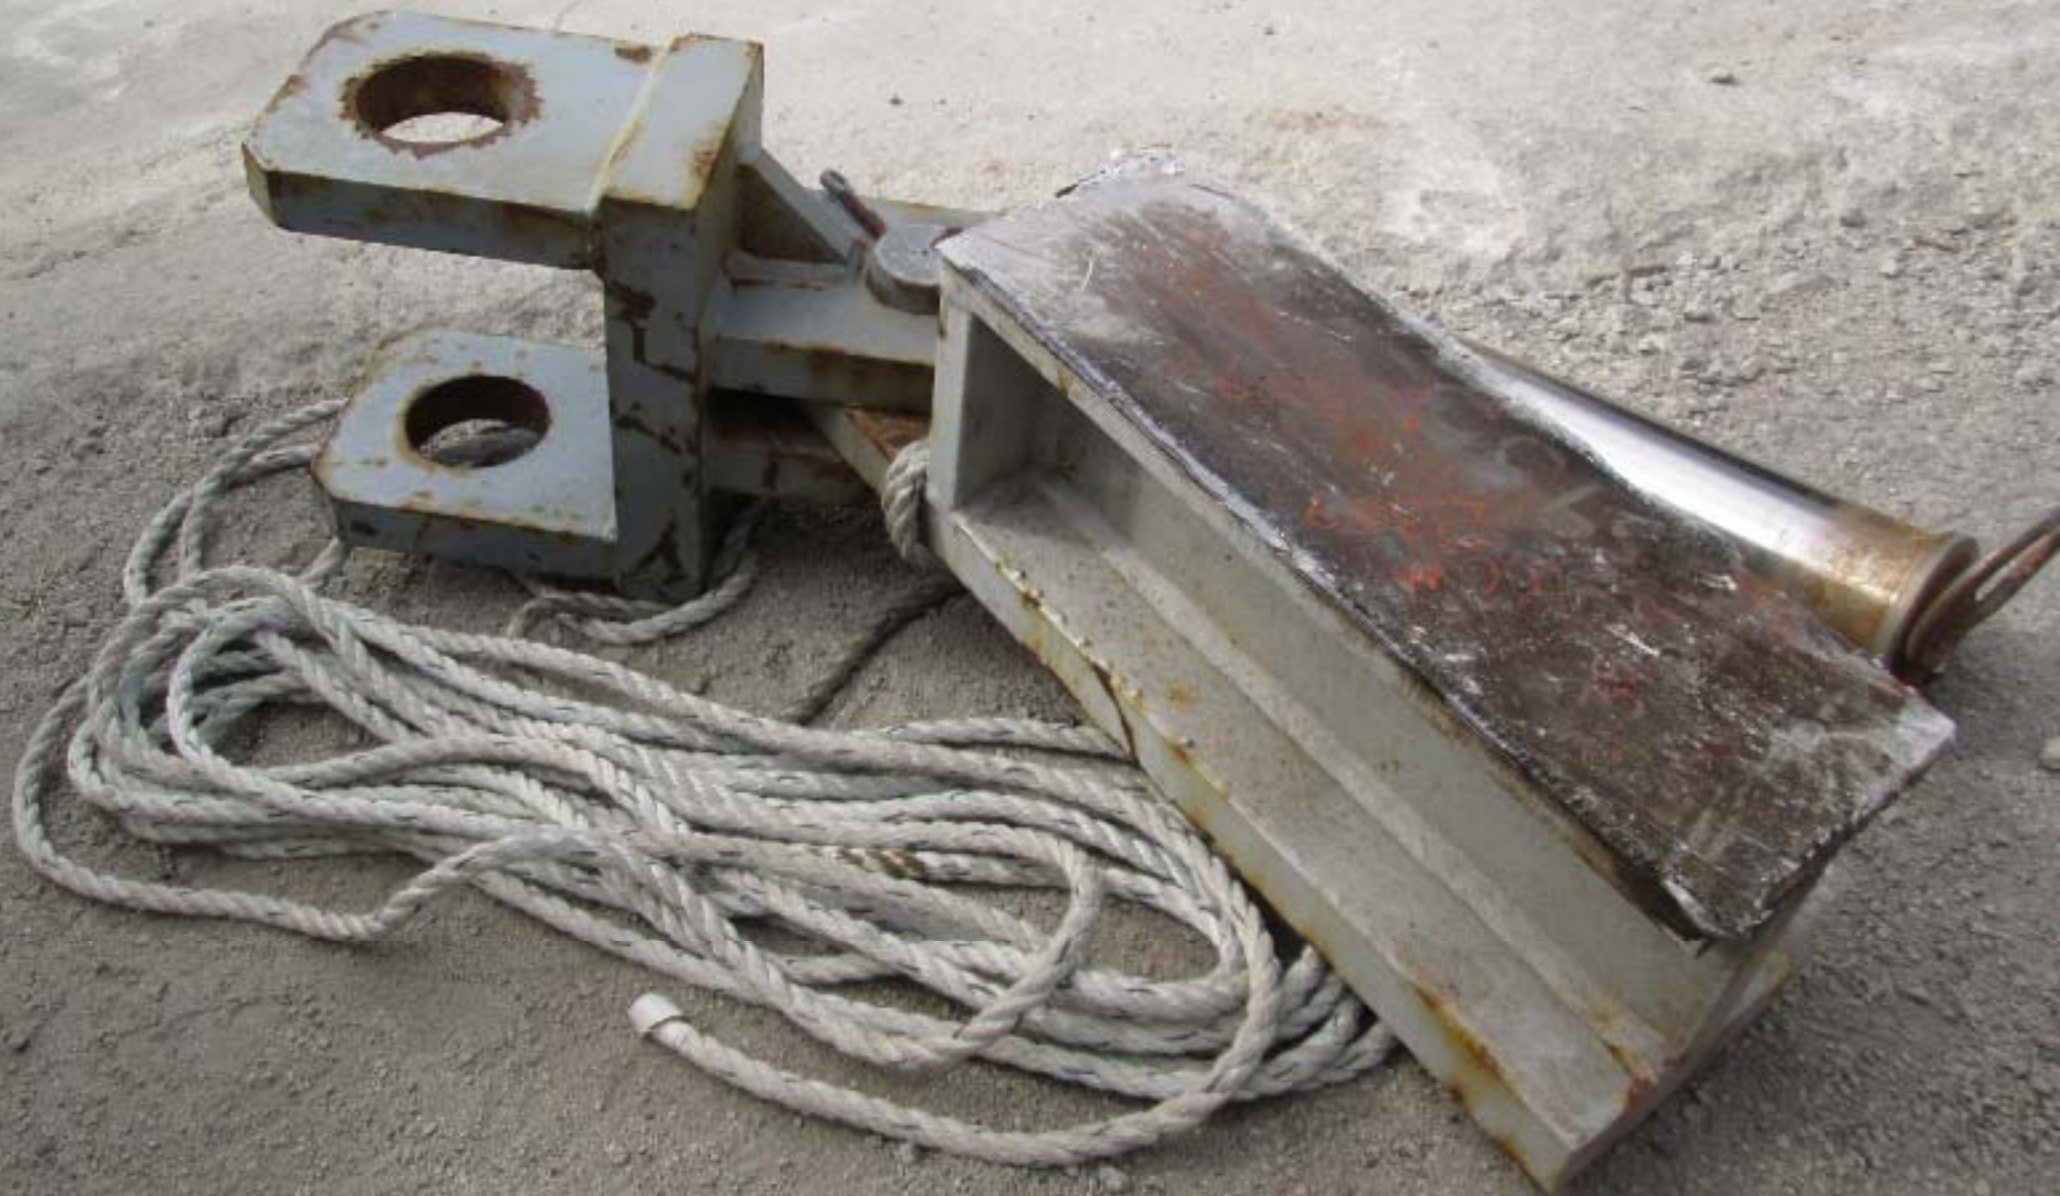
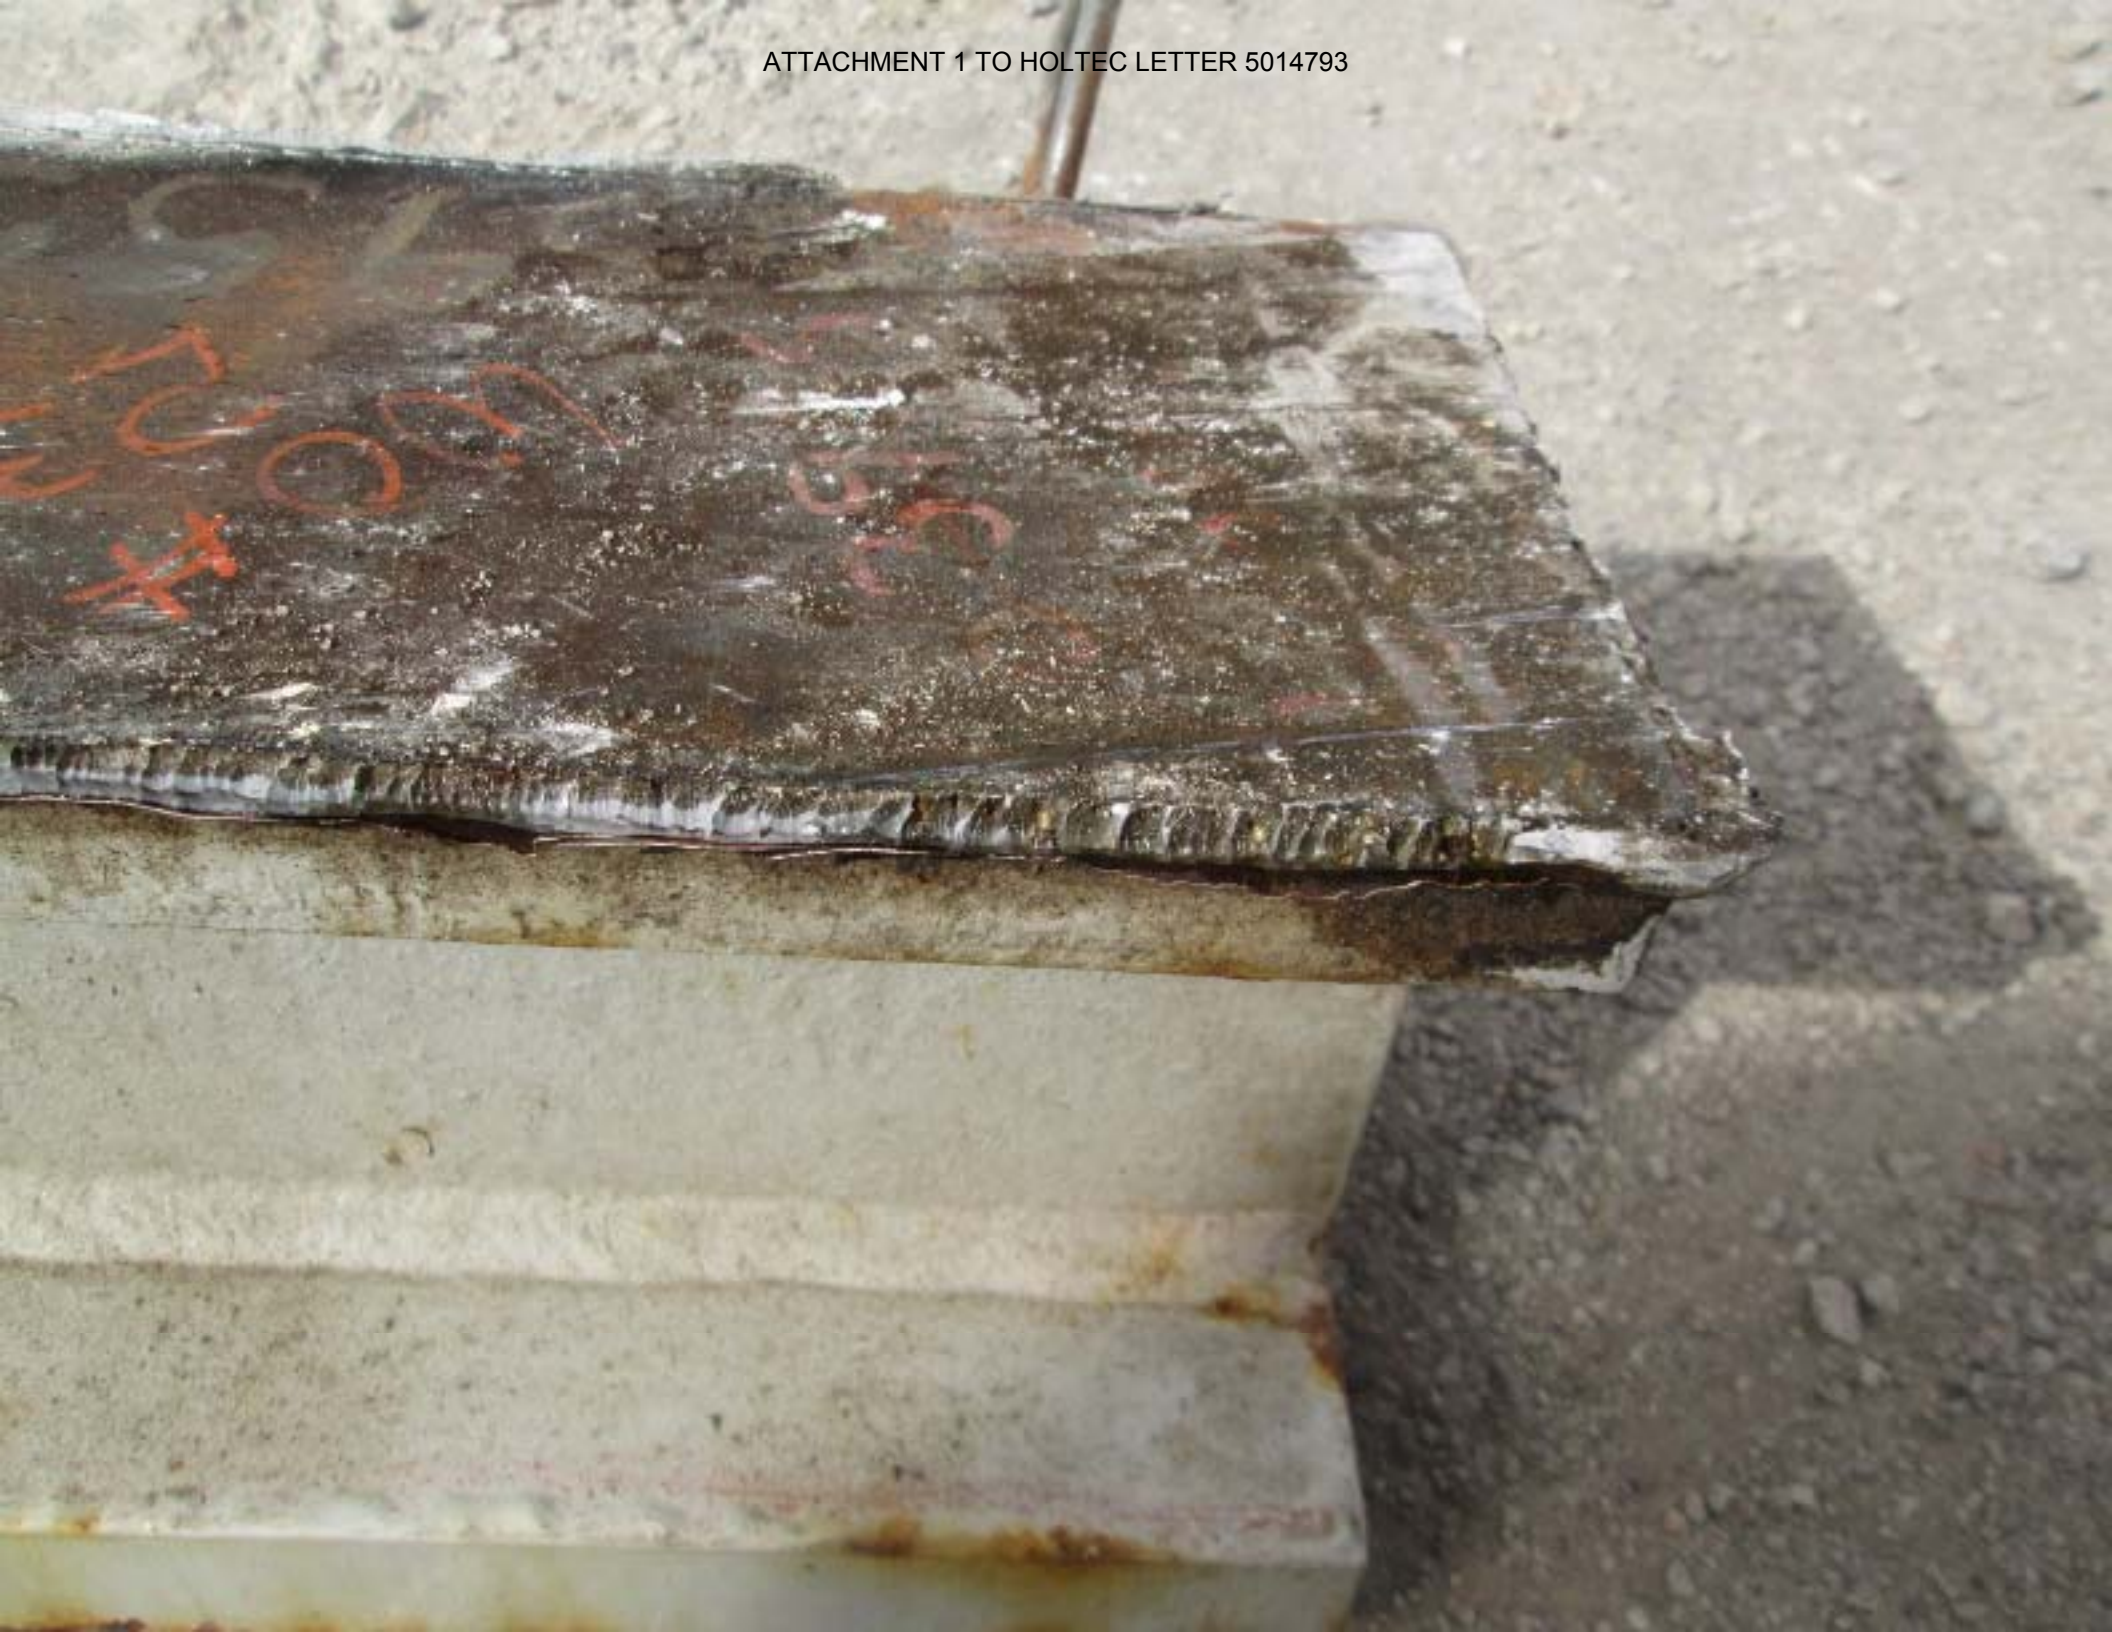
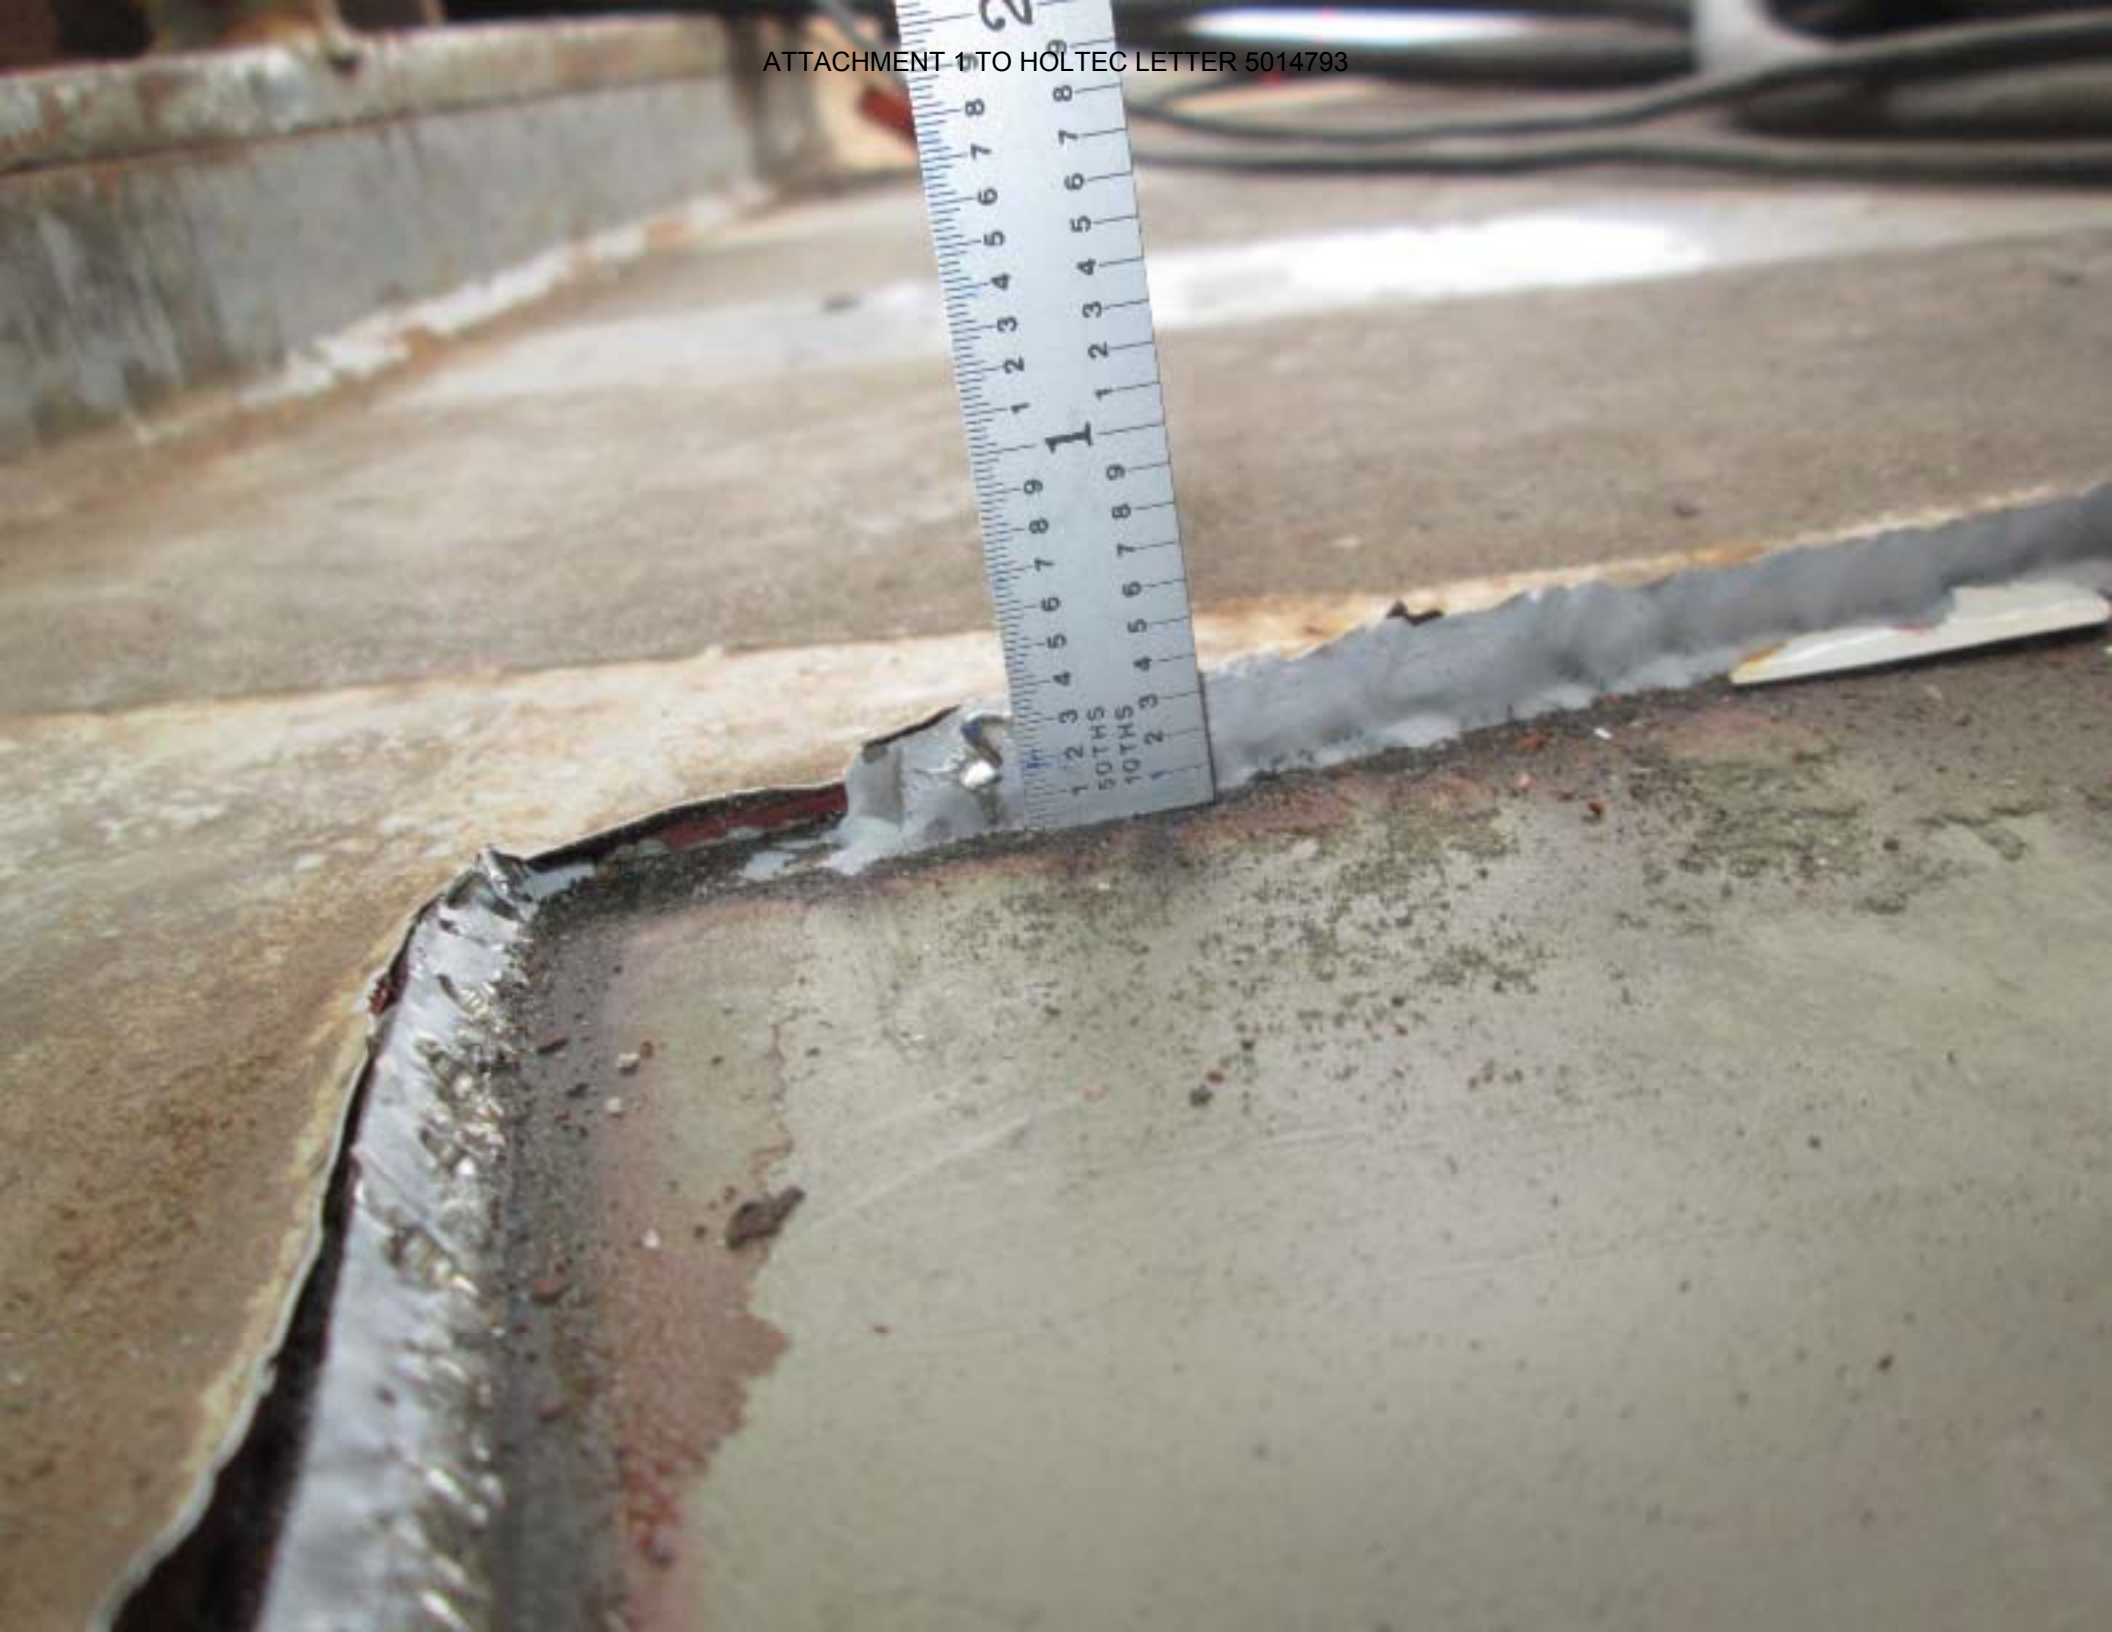
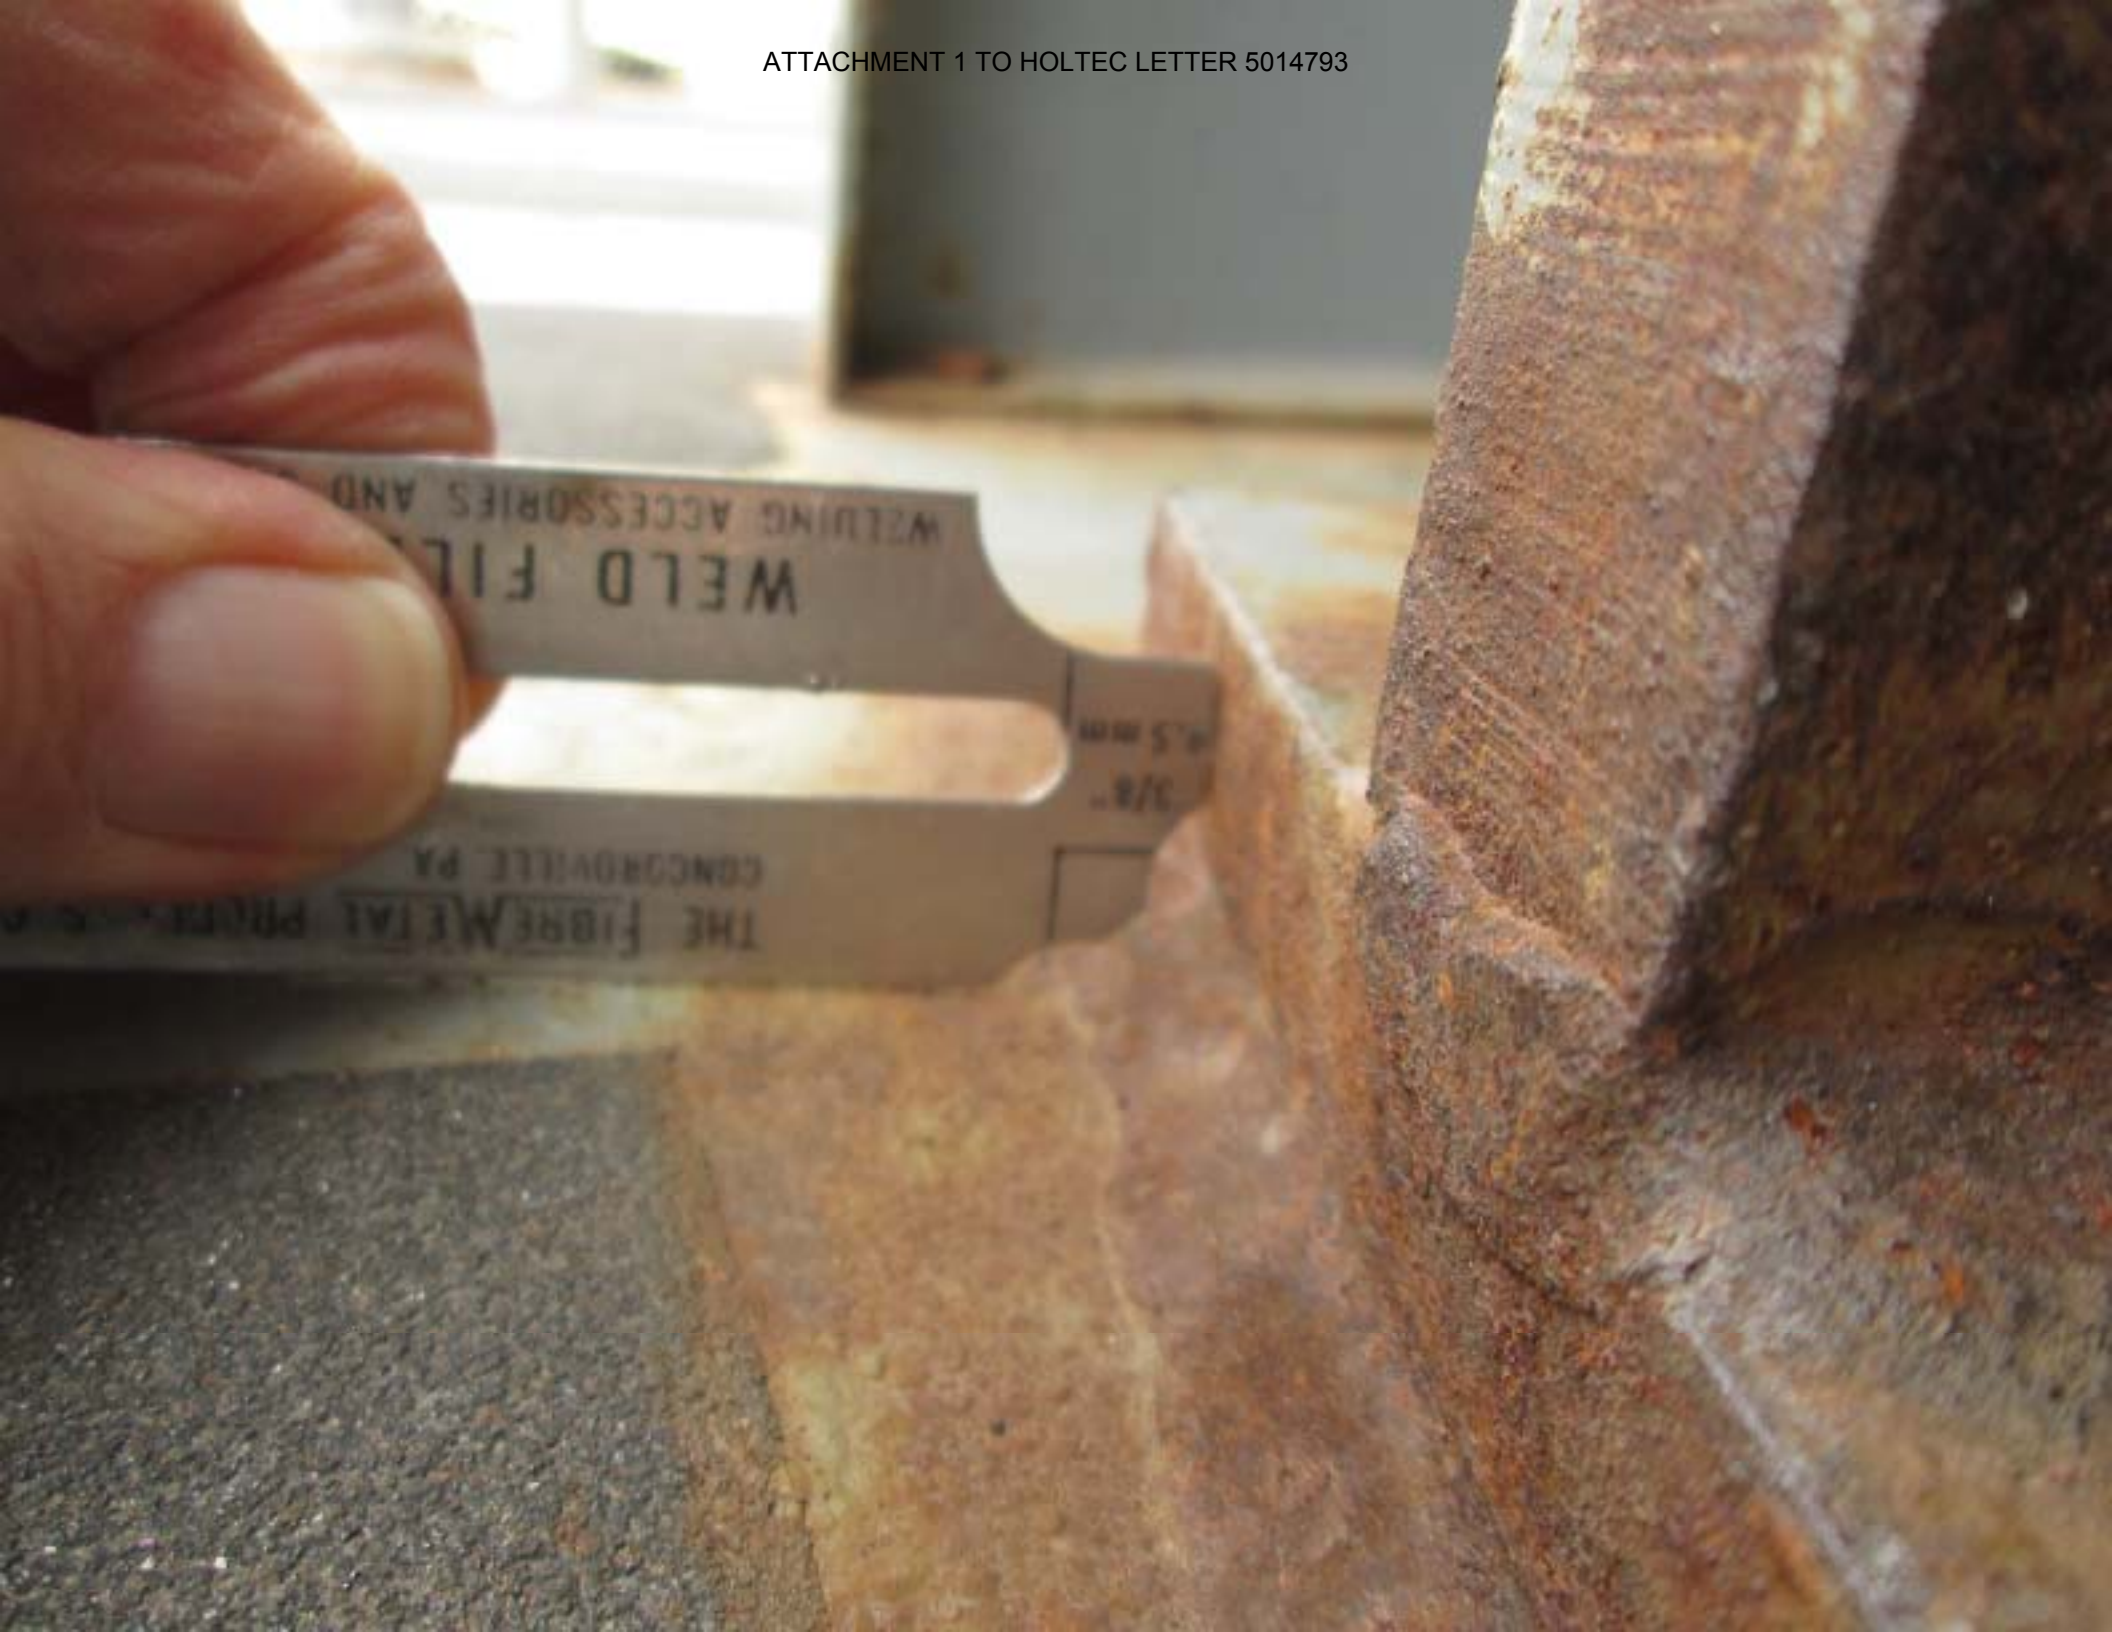
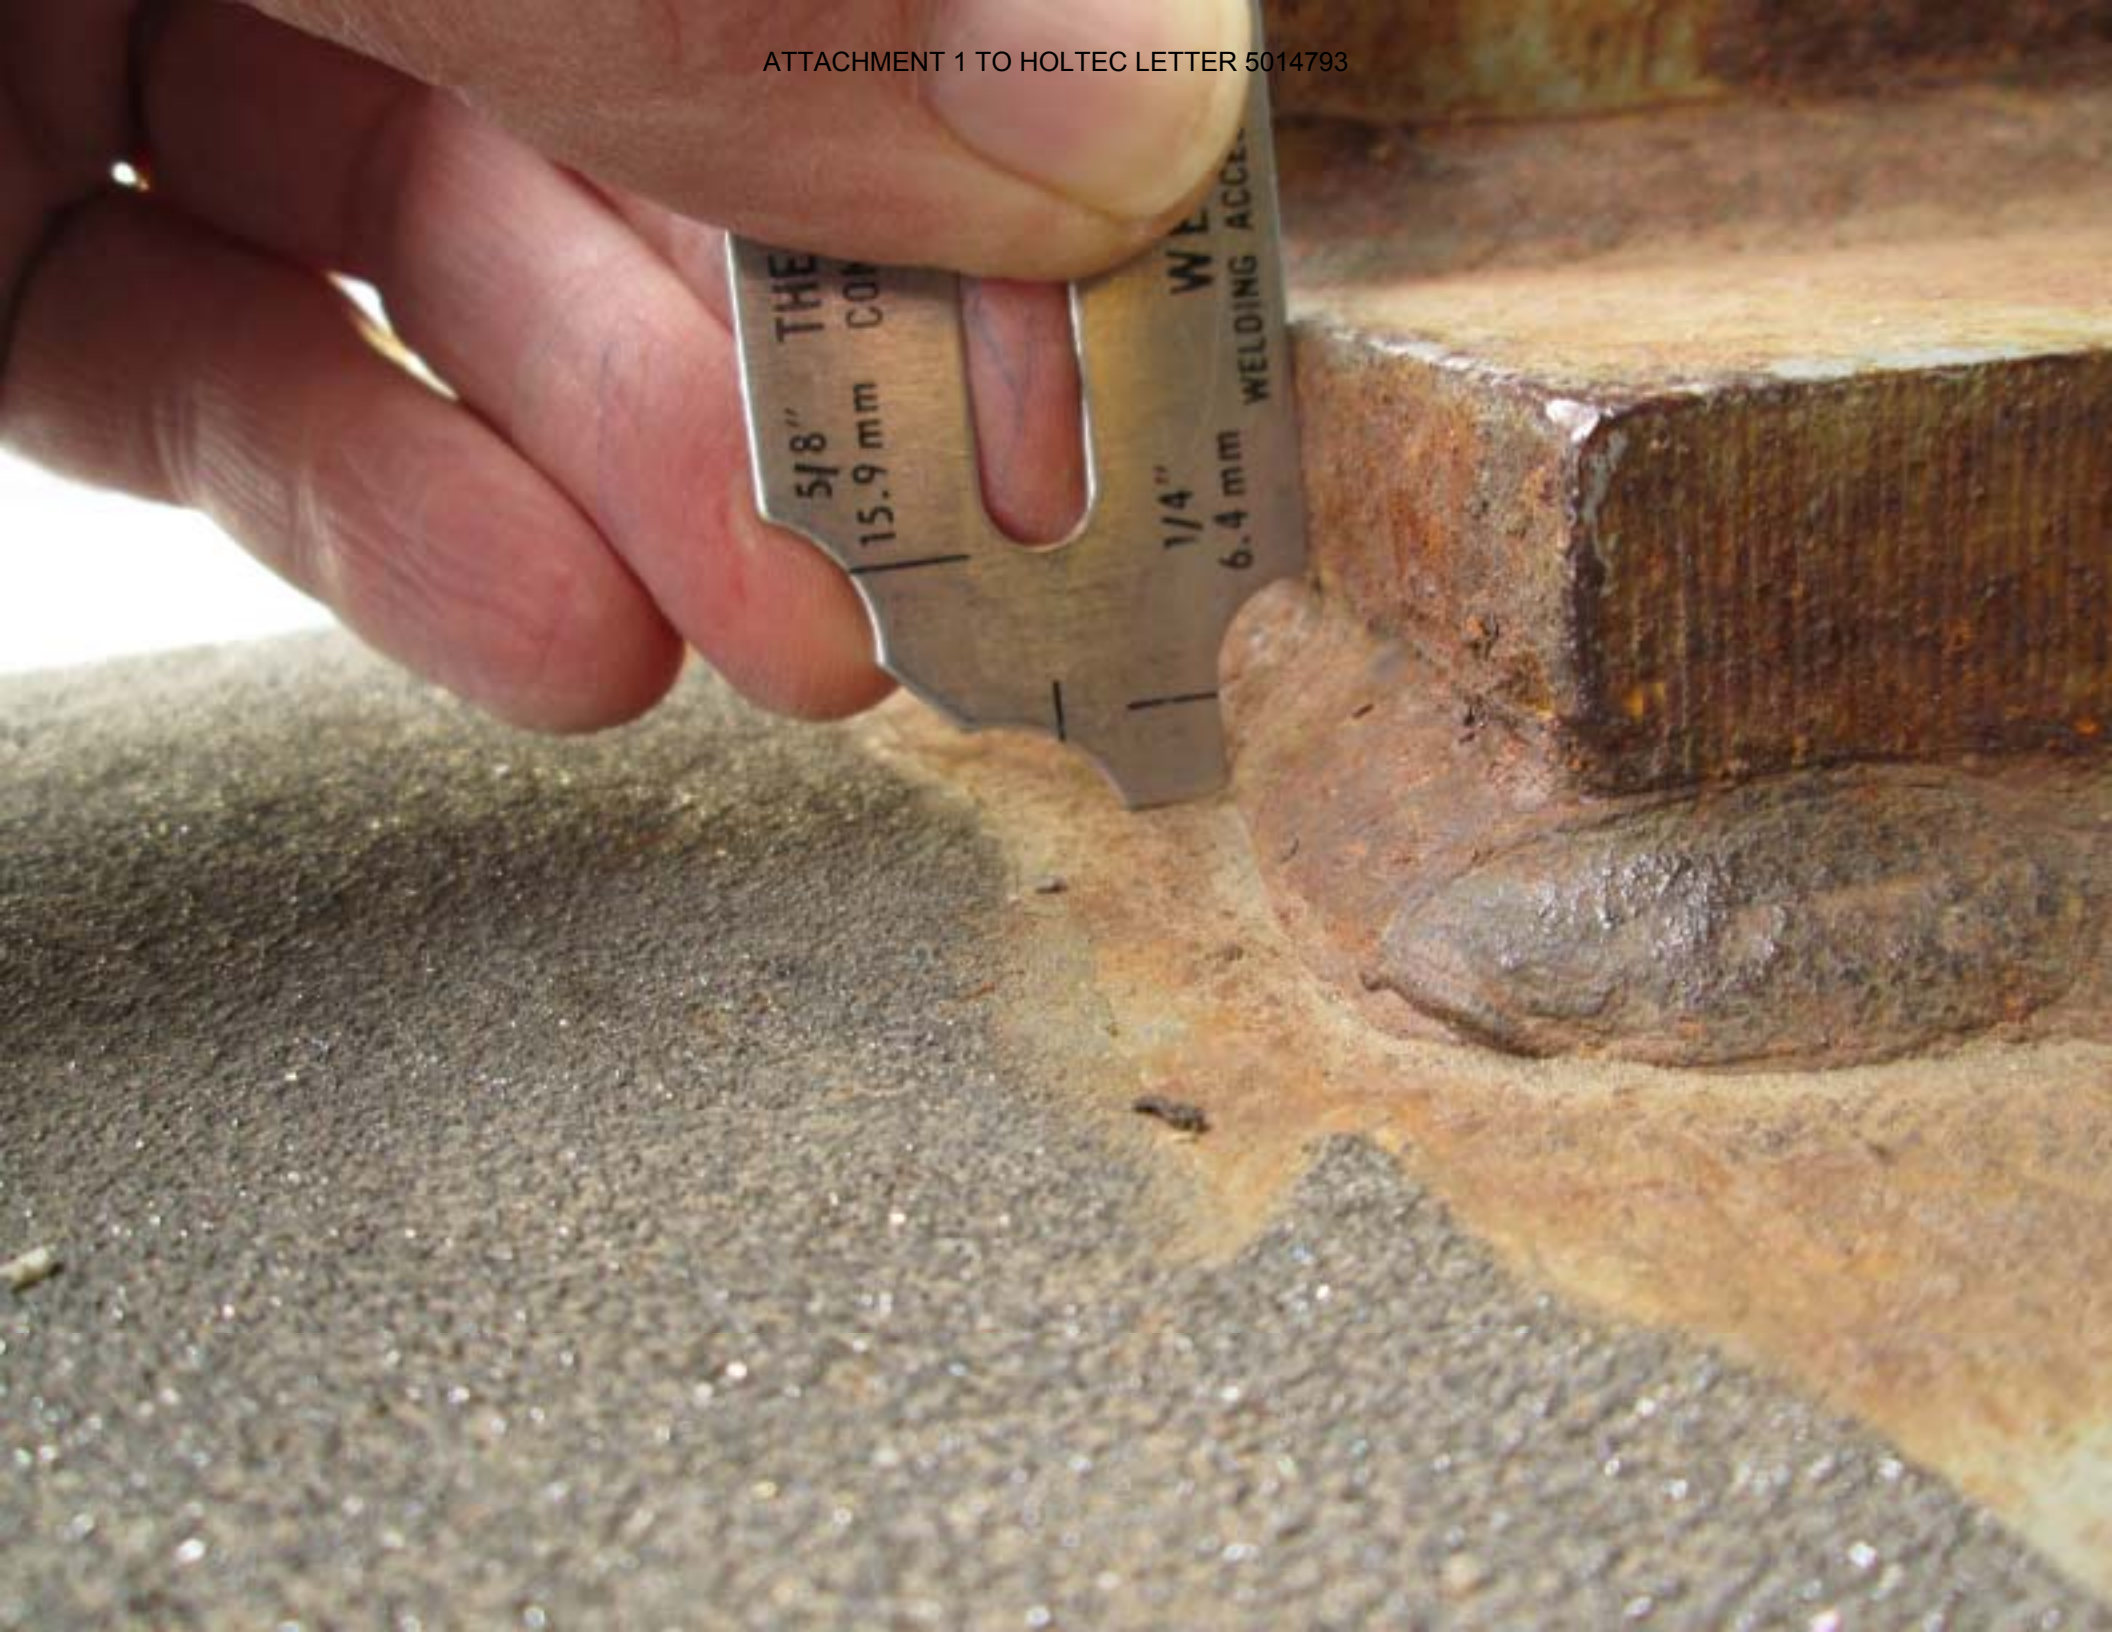
ATTACHMENTS (List all attachments, if any): Photos (provided by courtesy of Diablo Canyon)

- The weld performed on the VCT restraint strap mounts did not meet the minimum weld size of a 3/8" fillet weld specified by the drawing (pictures attached).

- The drawing calls for an all-around weld which was not possible as the mount partially extended over a cutout in the VCT deck for routing of hydraulic hoses. The weld ended adjacent to the cutout and did not wrap down and along the bottom of the mount to weld the transporter plate at the hole. If this had been done then the weld would have met the intentions of an "all around" fillet weld.

- Paint was present at the base metal where the mount was welded. Standard practices were not followed which led to the weld being deposited over a painted surface.

- Large porosity pores were noted in some portions of the failed weld, likely a result from welding on the painted surface.
- Lack of fusion at the weld root was noted in some instances.

- Rusting on the underside of the weld suggests this weld had failed over an extended period of time.

- Holtec recommends that all users owning a Lift Systems manufactured VCT add a visual inspection of the clevis to deck assembly weld into their VCT maintenance programs and perform this inspection prior to their next campaign. If there are visible cracks or stress induced defects to the weld, the weld should be repaired accordingly.
- Owners of J&R and MMH/KoneCrane manufactured VCTs may add the equivalent systems weld to their VCT maintenance programs as a defense in depth approach, however this matter is believed to be isolated to a single vendor at this time.
- Sites shall continue to stress the importance of situational awareness practices and instruct workers to stay clear of anchorage points in pre-job briefings.
