August 19, 2015
NRC-15-0085

Reference: Fermi 2
NRC Docket No. 50-341
NRC License No. NPF-43

Subject: 10 CFR 71.95 Report on the 8-120B Shipping Cask

**10 CFR 71.95 Report - Failure to Observe Certificate of Compliance
Conditions for the 8-120B Vent Port Pre-Shipment Leak Test**

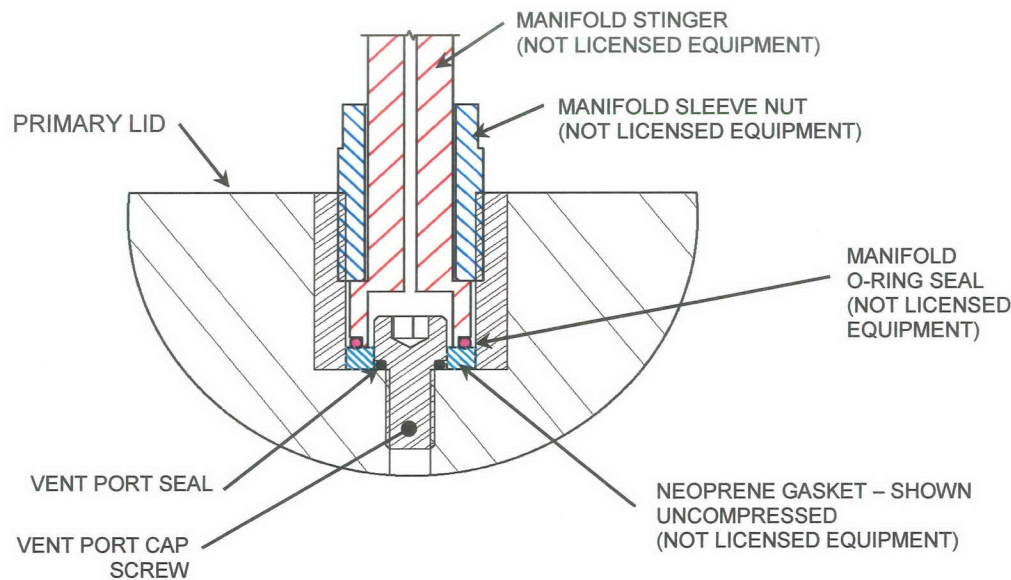
The neoprene gaskets provided by EnergySolutions can constrict on the head of the vent port plug cap screw when it is compressed by the bottom end of the test manifold stinger, which could reduce the sensitivity of the pre-shipment leak test. Consequently, the vent port pre-shipment leak tests, if performed using the neoprene gasket, may not have provided the required test sensitivity of 1×10^{-3} ref-cm³/sec.

Test Seal Configuration with Neoprene Gasket

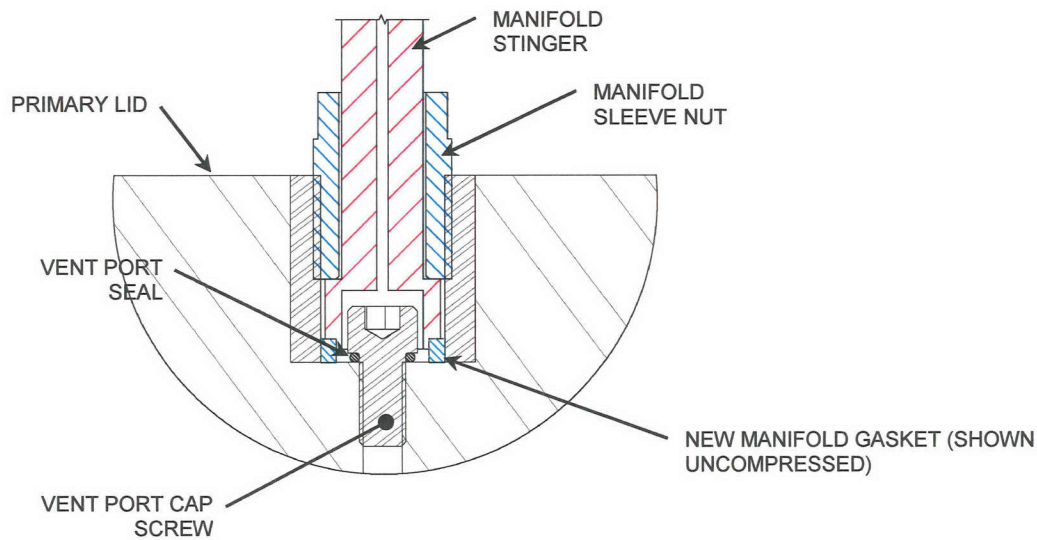
Modified Test Seal Configuration

- The large neoprene gaskets are no longer supplied with the casks.
- *EnergySolutions* designed and tested a new manifold gasket that does not constrict onto the head of the vent port cap screw when compressed, and therefore, does not

reduce the test sensitivity. The new gaskets have been distributed to all upcoming shipment users. The new manifold gasket design and configuration is shown in Attachment 1.
