Edwin I. Hatch Nuclear Plant
10 CFR 71.95 Report on Potential Issues Involving Radwaste Cask 8-120B

Edwin I. Hatch Nuclear Plant Unit 1 and 2
10CFR 71.95 Report on 8-120B Cask to NRC by EnergySolutions

**Failure to Observe Certificate of Compliance Conditions
for the 8-120B Vent Port Pre-Shipment Leak Test**

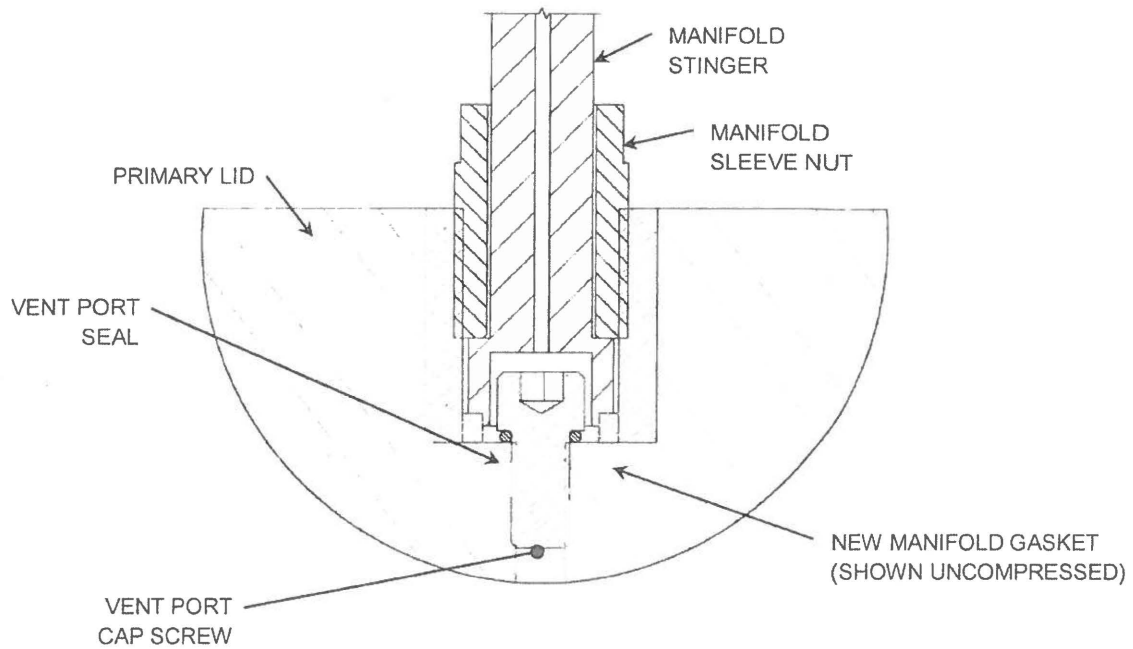
Corrective Action – Modified Test Seal

The pre-shipment leak test of the vent port is a pressure drop test performed using a dedicated test manifold. The test manifold is not a part of the licensed package. It includes a stinger (shown below), an O-ring seal that contacts the stinger and the bottom of the vent port hole, and a sleeve nut to compress the O-ring seal. The test manifold was designed so that it surrounds the vent port cap screw, leaving a small gap between itself and the vent port cap screw. The 8-120B cask fleet began to ship with a new lid design in September 2013, and operations staff noted more frequent difficulty getting the manifold to seal. It became desirable to find a better way to seal the bottom of the manifold in order to minimize operator exposure. They found that adding a neoprene gasket (also not part of the licensed package) under the base of the stinger as shown below helped reduce testing time and exposure.

The new manifold gasket design, shown below, replaces the manifold O-ring seal and neoprene gasket previously used with a neoprene gasket that fits within the notch at the base of the manifold stinger.
